공학박사학위논문

**A study on damaged zone around an opening in rock-like  
material due to thermo-mechanical loading**

서울대학교 대학원  
에너지시스템공학부

**ZHANG Nan**

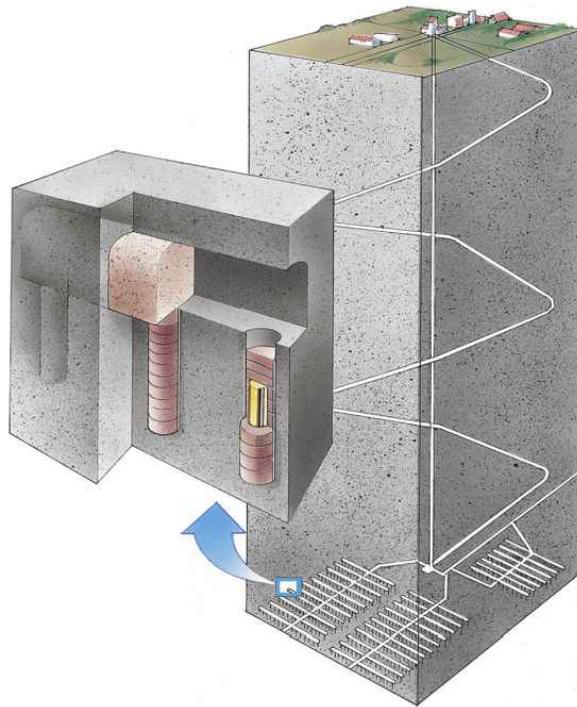
Figure 1.1 Schematic illustration of KBS-3V repository (SKB, 2004).

One of the concepts for deep geological disposal of HLW which proposed by Swedish Nuclear Fuel and Waste Management Company (SKB) is the KBS-3V method as shown in Figure 1.1. In this method, the HLW will be encapsulated in copper canisters and deposited in vertical deposition holes, then canisters are embedded in a buffer consisting of compacted bentonite clay, and above all, the deposition galleries should be excavated at about 500 m depth in crystalline rock.

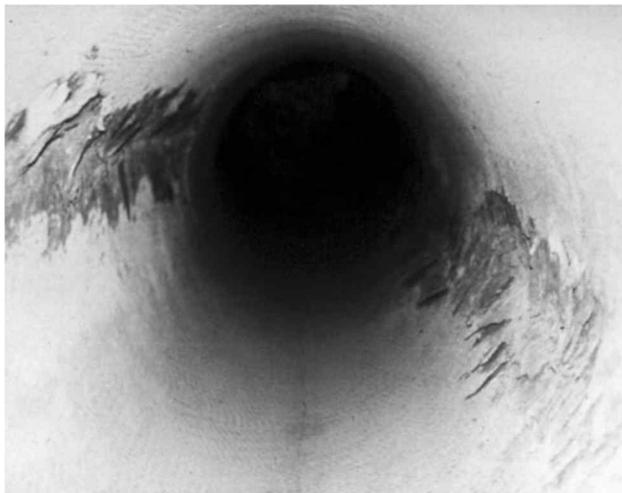
Figure 1.2 Spalling in a vertical raise bored shaft in an underground mine (Hoek and Martin, 2014).

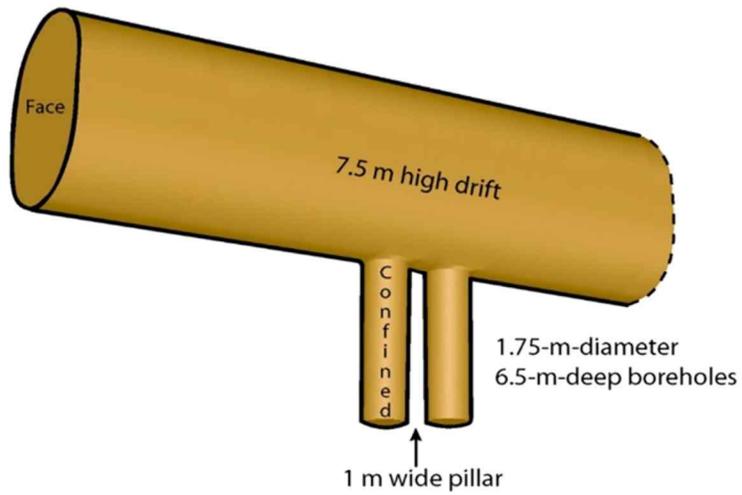
Figure 1.4 Äspö Pillar Stability Experiment (APSE) at the experiment tunnel (Andersson, 2007).

The international cooperative project DECOVALEX-2011 (DEvelopment of COupled models and their VALidation against EXperiments) Task B selected the Äspö Pillar Stability Experiment (APSE, Figure 1.4) at SKB's Hard Rock Laboratory (HRL) as research target for validation and comparison of different numerical models in reference to the numerical modelling of the failure process and the spalling phenomena (Figure 1.5) in crystalline rock under coupled thermo-mechanical loading condition (Andersson, 2007).

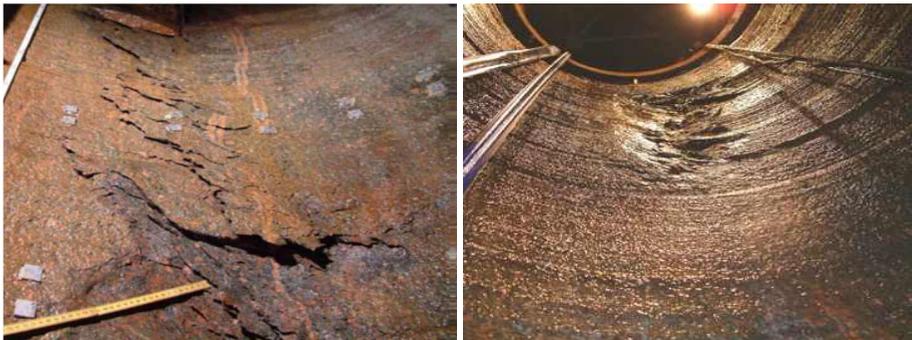
(a) v-shaped notch

(b) spalling slabs

Figure 1.5 Spalling observed at APSE pillar: (a) v-shaped notch; (b) spalling slab (Andersson, 2007).

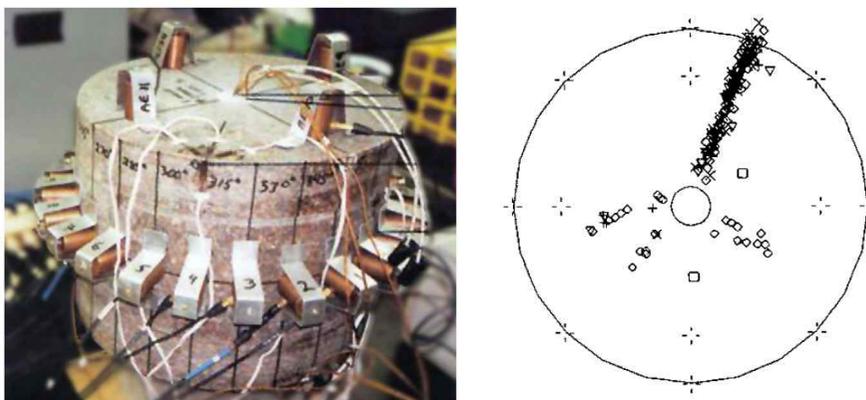
Figure 1.6 The Lac du Bonnet granite specimen during the heated experiment and recorded AE source locations (Wanne and Young, 2008).

In terms of laboratory scale heater tests, Carlson et al. (1993) conducted a heater test using Lac du Bonnet granite cylinder specimen (300mm in diameter and 220mm in length) to study thermally- induced cracking processes. A cartridge heater was placed into central hole to heat the cylinder specimen until 245°C (Figure 1.6). The test results shown that a macrocrack formed and initiated from the outer surface of the specimen.

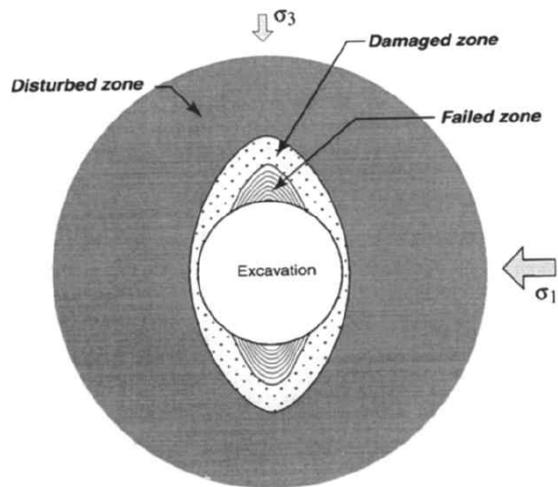
Figure 2.1 Sketch of failed, the damaged and the disturbed zone (Bäckblom and Martin, 1999).

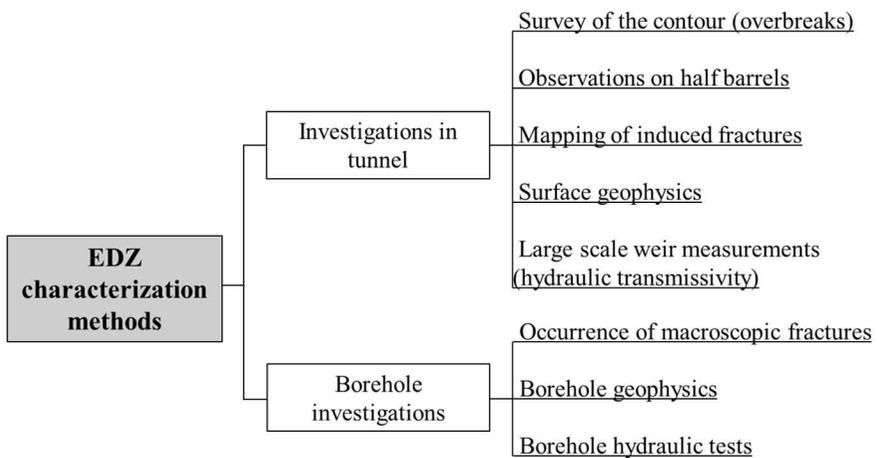
Figure 2.2 Summary of the EDZ characterisation methods (modified from Hudson et al., 2009)

The EDZ characterisation methods were systematically summarized by Hudson et al. (2009) as shown in Figure 2.2. Bäckblom (2008) made an overview of the field experiments conducted related to the EDZ research and summarized the main findings of the field experiments as shown in Table 2.1.

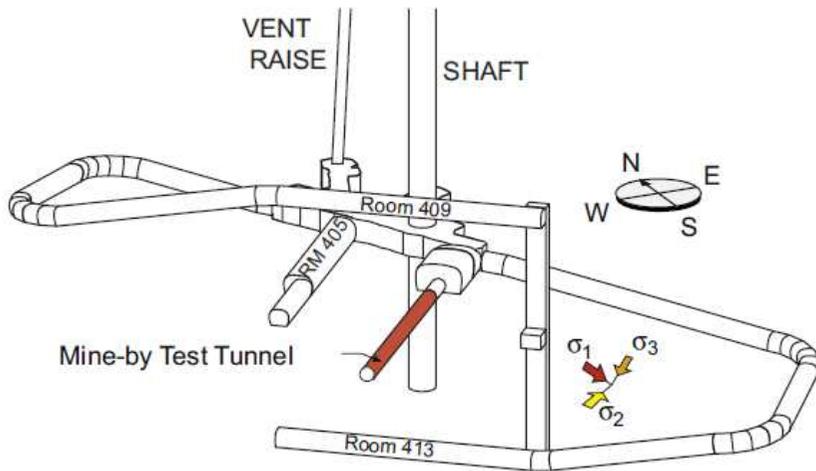
Figure 2.3 Location of AECL's Mine-by test tunnel and in-situ stress orientation (Martin and Christiansson, 2009).

The Mine-By Experiment (MBE) was carried out in a test tunnel (Figure 2.3) at 420 m depth in the AECL's URL which seated in highly stressed Lac du Bonnet granite (Read, 2004). Spalling were found in the roof and floor of the test tunnel as shown in Figure 2.4.

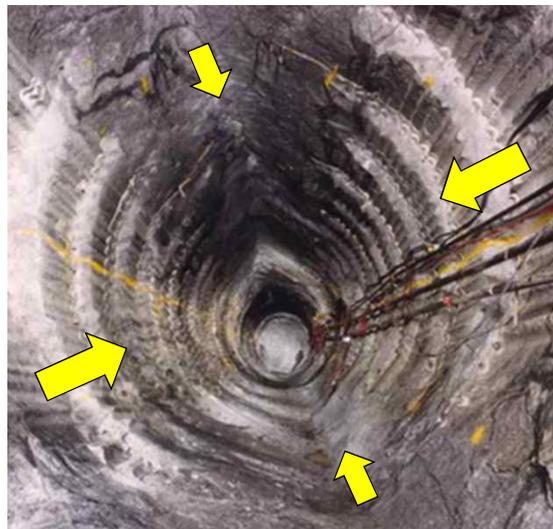
Figure 2.4 Spalling in the roof and floor at AECL's Mine-by test tunnel (Read and Martin, 1996).

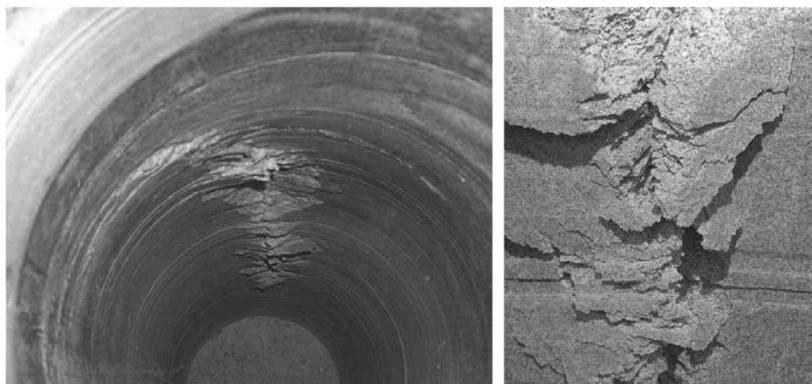
Figure 2.5 Spalling developed in stage 1 of the HFT: view from top of borehole HFT and close-up view of breakout (Read, 2004).

As the first in situ large scale heater test, HFT (1993-1996) was implemented in the same area as the MBE test tunnel. The main objective of HFT was to investigate the thermal effects on excavation damage development around the opening. The HFT were executed at the tunnel floor in four stages for the purpose of assessing the effects of drilling/heating sequence, borehole interaction and internal confining pressure on the development of excavation damage. Two 600mm diameter holes were bored for making the pillar between them. Four electrical heaters located about 1 meter from the hole walls were used to heat the pillar up to 85 °C in 20 days (Read et al., 1997). The observed spalling at stage 1 of the HFT where heating commenced after completion of drilling is shown in Figure 2.5. The observed spalling in the borehole was a radial extent of 45 mm. The experiment results shown that spalling initiated through localized damage. The combination of stress localization due to the developing spalling geometry and increasing tangential stress due to heating caused the spalling to extend into relatively undamaged rock (Read, 2004).

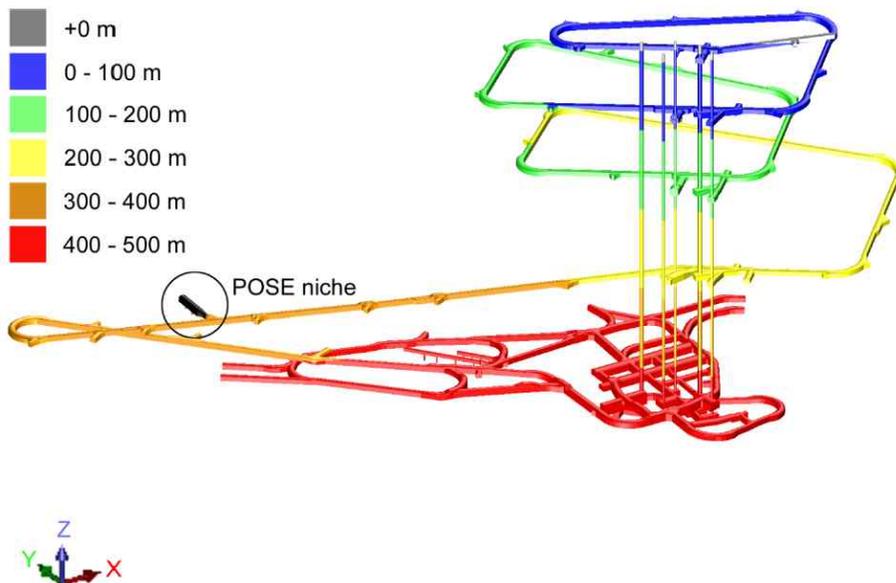
Figure 2.7 Layout of ONKALO URL and the POSE-niche (Valli et al., 2013).

POSIVA had plans for the disposal of HLW which are based on the SKB's KBS-3 concept. The rock mass at Olkiluoto consists of migmatitic gneiss with pegmatitic granites. Because the gneissic rocks can behave differently from the granitic rock in the HFT test and APSE experiment, the Posiva's Olkiluoto Spalling Experiment (POSE) was designed and carried out in the ONKALO URL at depth of 345m as shown in Figure 2.7 (POSIVA, 2009).

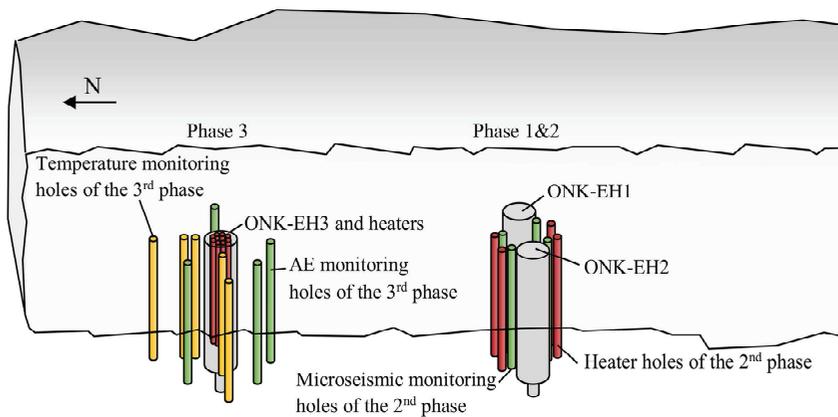
Figure 2.8 Schematic representation of the experimental area in the ONKALO underground facility (Siren et al., 2015).

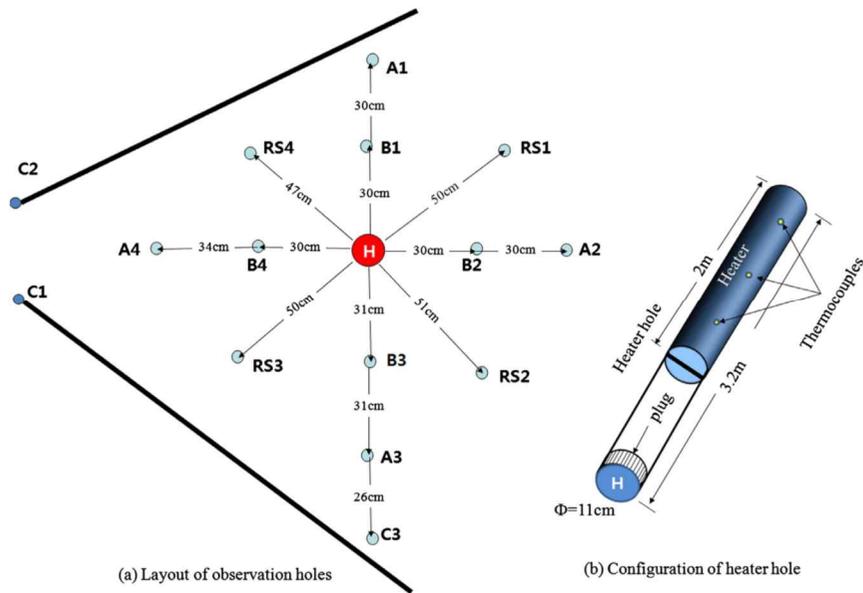
Figure 2.13 Layout of the boreholes drilled for the BHT (Kwon et al., 2013).

A 3.2 m long horizontal heater hole was drilled with a diameter of 110 mm. Heater (2m in length) with a maximum power of 5 kW was designed and manufactured with aluminum. Totally fifteen observations holes (38 mm in diameter) were drilled around the heater hole as shown in Figure 2.13.

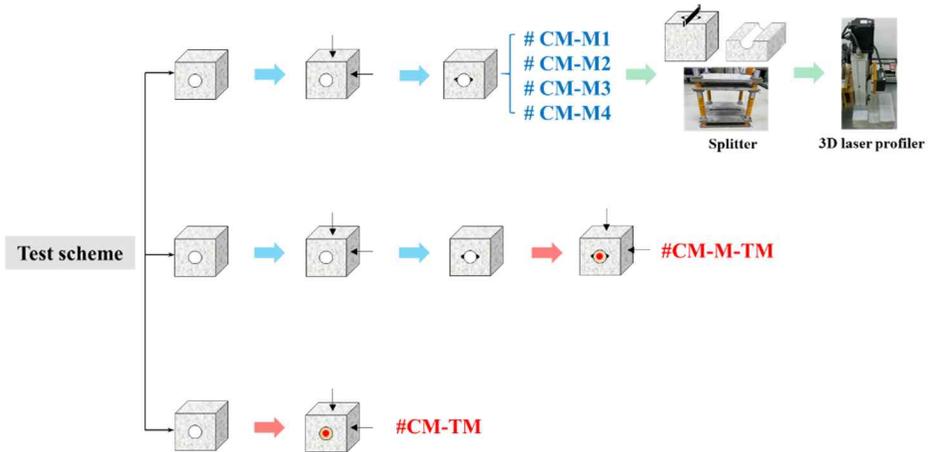
CM: cement mortar; M: biaxial compression test; TM: heater test under thermo-mechanical loading condition (i.e. confined condition).

Figure 3.1 Schematic diagram of the experimental scheme.

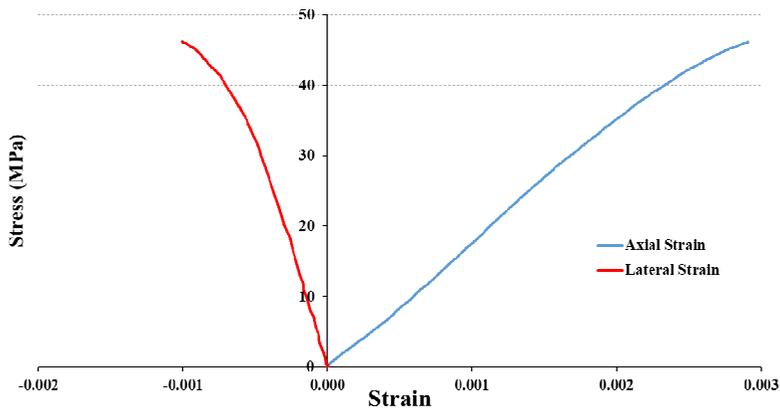
Figure 3.3 Stress-strain curve of cement mortar obtained from uniaxial compression test.

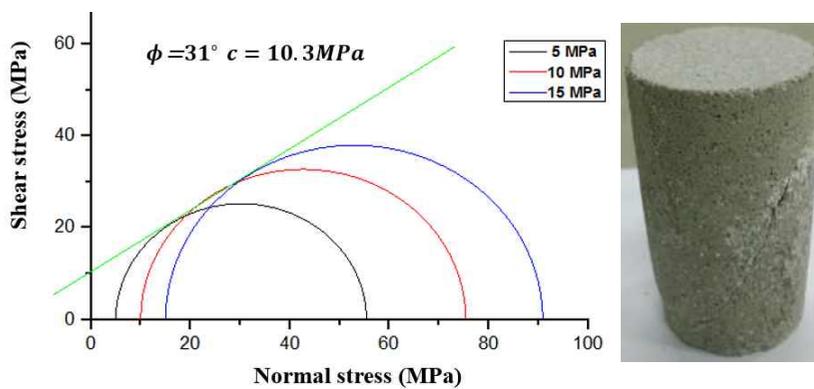
Figure 3.4 Mohr's failure envelope obtained from triaxial tests and typical failure pattern of cement mortar specimen after triaxial test.

The Mohr's failure envelope obtained from triaxial tests and typical failure pattern of cement mortar specimen after triaxial test are shown in Figure 3.4. The physical and mechanical properties of the cement mortar were summarized in Table 3.2.

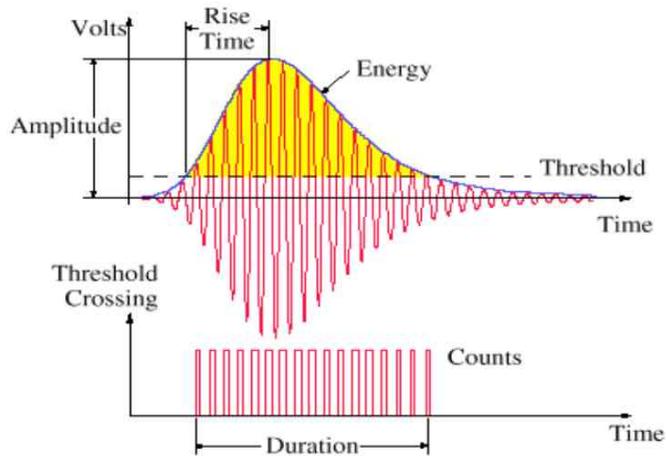
Figure 3.8 Main parameters of AE waveform (Huang et al., 1998).

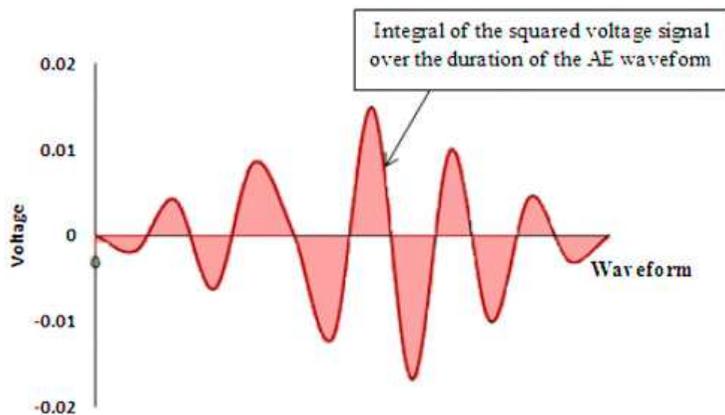
Figure 3.9 Absolute energy features (Shahidan et al., 2016).

Shahidan et al. (2016) pointed out that the shaded area (Figure 3.9) in the AE waveform illustrates the true value of the absolute energy. Shahidan et al. (2013) used absolute energy feature for damage identification and crack detection in concrete materials. Duan et al. (2014) analyzed the AE signal parameters of granite under uniaxial loading and concluded that absolute energy can describe rock damage perfectly. Khazaei et al. (2015) analyzed the damage of intact rocks during uniaxial compression tests using absolute energy feature. It should be noted that the AE energy analysis in the following sections of this research is referred particular to the analysis of absolute AE energy.

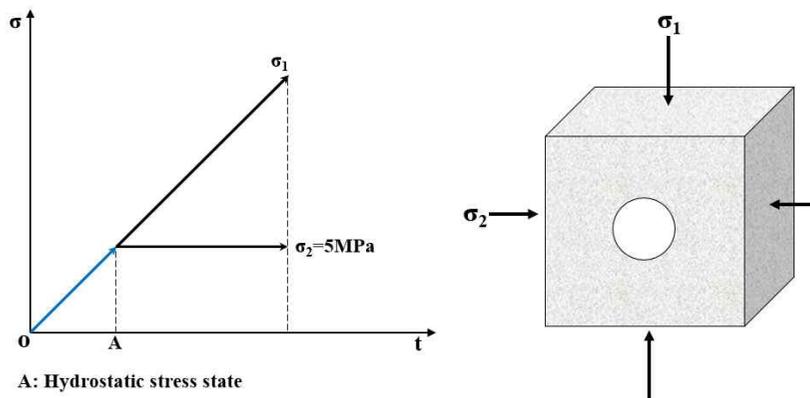
Figure 3.13 Loading mode used in the biaxial compression test.

The loading mode of biaxial compression test is presented in Figure 3.13. The biaxial compression test consisted of two loading phases. Firstly, specimen was loaded by vertical stress ( $\sigma_1$ ) and confining stress ( $\sigma_2$ ) until 5 MPa under hydrostatic loading condition. Then confining stress ( $\sigma_2$ ) was maintained at 5 MPa, vertical stress was monotonically applied until heavy spalling happened and subsequently specimen was unloaded before it reaches the completely failure state for the purpose of maintain the integrity of the specimen which will be used in the following heater test.

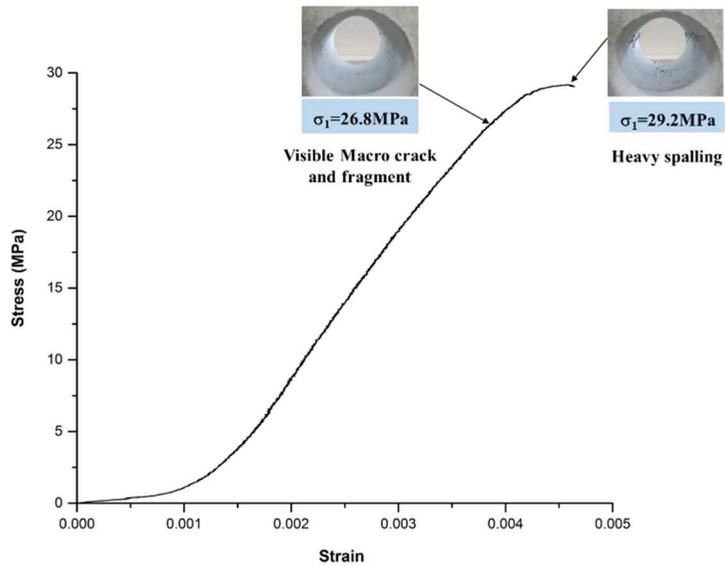
Figure 3.14 Brittle failure process around a circular opening.

A typical example (#CM-M1) of the brittle failure process around a circular opening under biaxial compression loading condition is shown in Figure 3.14.

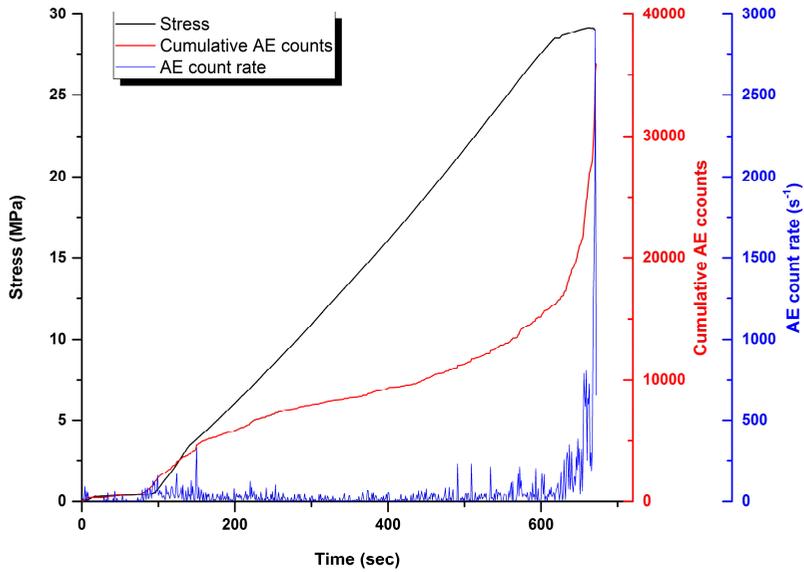
Figure 3.16 Cumulative AE counts and count rate (#CM-M1).

The cumulative AE counts, count rate and stress versus time from biaxial compression test on specimen #CM-M1 were shown in Figure 3.16. The AE counts were gradually increased from the beginning of loading until a drastically rising happens around 27.6MPa ( $\sigma_1/\sigma_c = 0.6$ ).

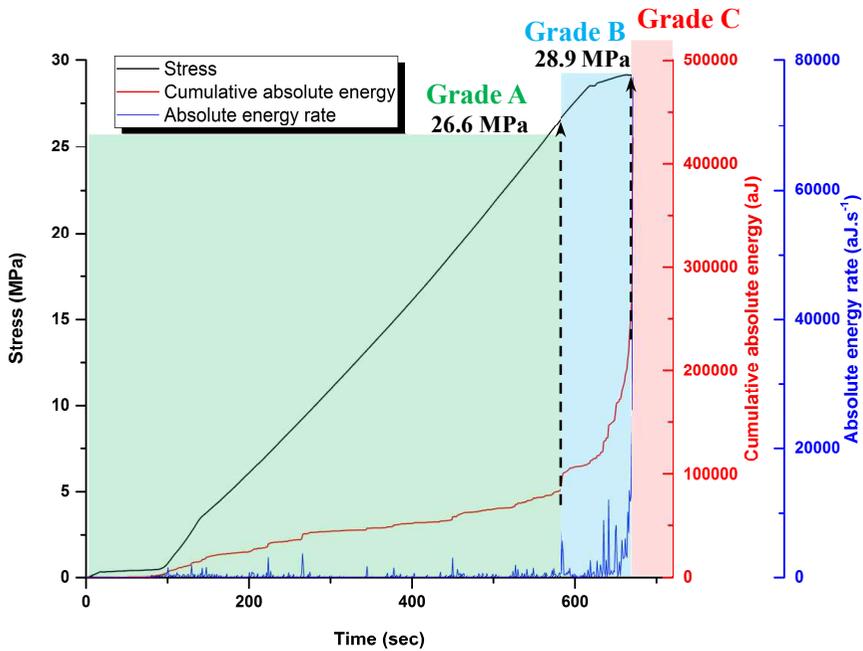
Figure 3.17 Cumulative absolute energy and absolute energy rate (#CM-M1).

The cumulative absolute energy, energy rate and stress versus time of specimen #CM-M1 were presented in Figure 3.17. At the initial loading period, the energy rate was quite low until vertical stress ( $\sigma_1$ ) close to about 26.6 MPa ( $\sigma_1/\sigma_c=0.58$ ), a big rising of energy rate was distinguishable. From the cumulative absolute energy curve, it can be found a rapid increasing tendency also. Then absolute energy rate rises up significantly when  $\sigma_1$  is around 28.9 MPa ( $\sigma_1/\sigma_c=0.63$ ), the dramatically increases of cumulative energy was also found.

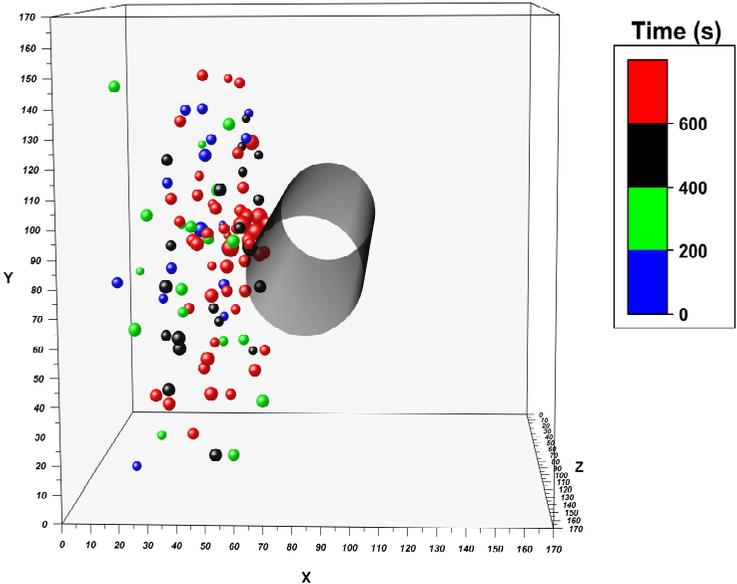
Figure 3.18 AE source locations in three-dimensional view (#CM-M1).

The three-dimensional view of AE source locations which generated in the biaxial compression test was presented in Figure 3.18. The AE sources are shown in different colors including blue, green, black and red which indicate the sources occurred in different time periods. And the different amplitude of the sources were depicted with different ball size, the higher of source amplitude and the larger of ball size. The projections of AE source locations are displayed in a top view (i.e. projection to the xz-plane) of the specimen as shown in Figure 3.19.

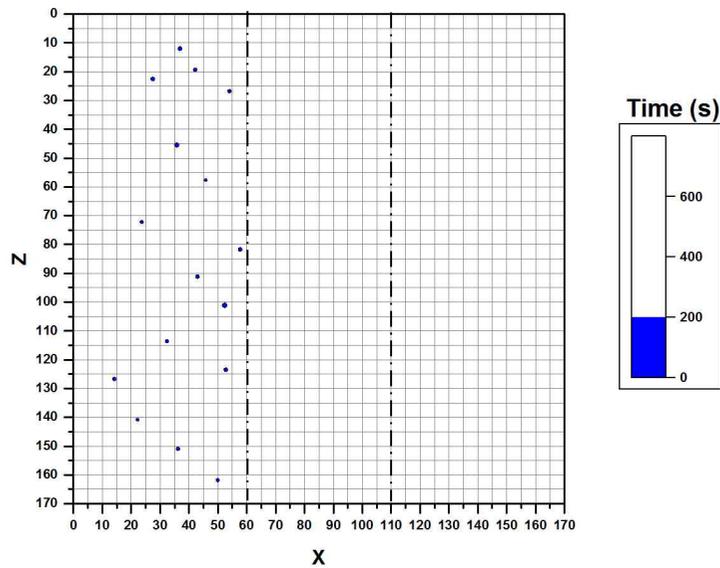
(a) 0~200 seconds

The results were plot with a time interval of 200 second. The AE sources were randomly distributed around the specimen at the first 200 seconds (Figure 3.19 (a)). In the time period from 200 to 600 seconds, the number of AE sources began to increase as shown in Figure 3.19 (b) and (c). When time exceed 600 seconds, it is observed that AE sources getting more concentrated around the sidewall of the circular opening where is the expected failure region (Figure 3.19 (d)). The AE source locations in the whole time period is shown in Figure 3.19 (e).

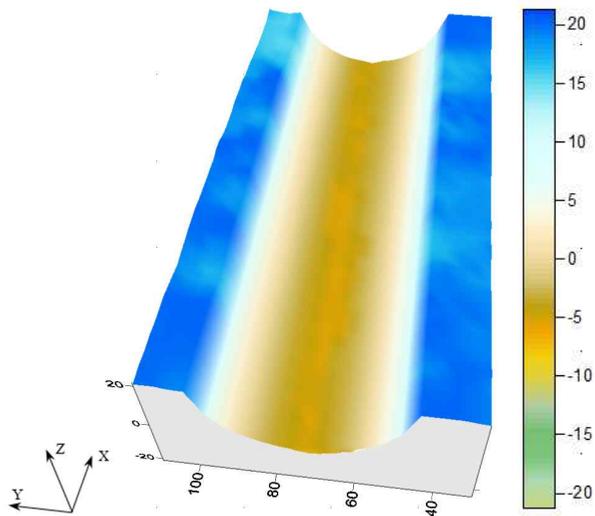
Figure 3.22 3D contour of failed zone (#CM-M1). (Unit: mm)

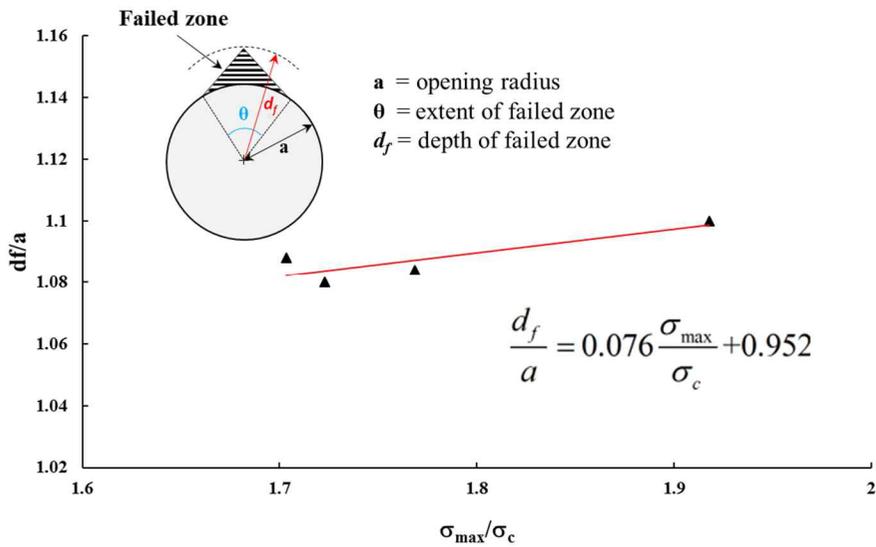
Figure 3.24 Relationship between normalized depth ( $d_f/a$ ) of failed zone and the stress level ( $\sigma_{\max}/\sigma_c$ ) in this research.

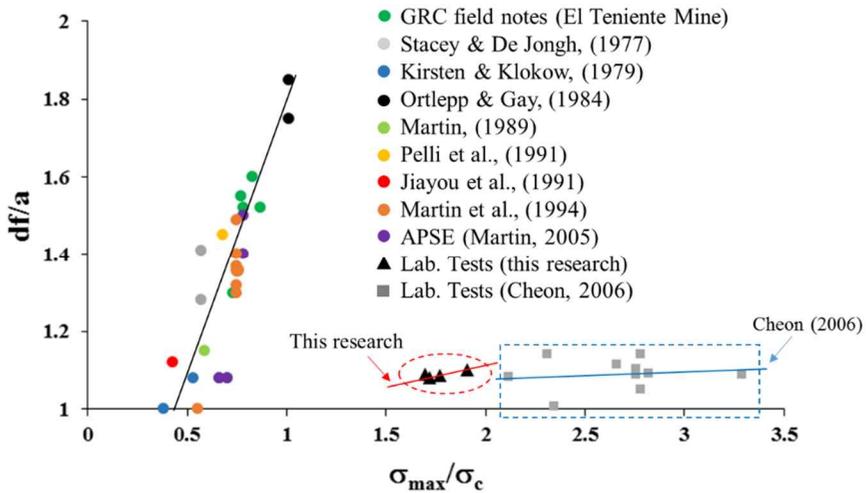
Figure 3.25 Comparison of normalized depth ( $d_f/a$ ) of failed zone and the stress level ( $\sigma_{\max}/\sigma_c$ ) between laboratory test results and field observations (modified from Martin et al., 1999 and Cheon, 2006)

A comparison of normalized depth of failed zone and the stress level between laboratory test results including both this research and Cheon (2006) and field observations (Martin, 1999 and Martin, 2005) is shown in Figure 3.25.

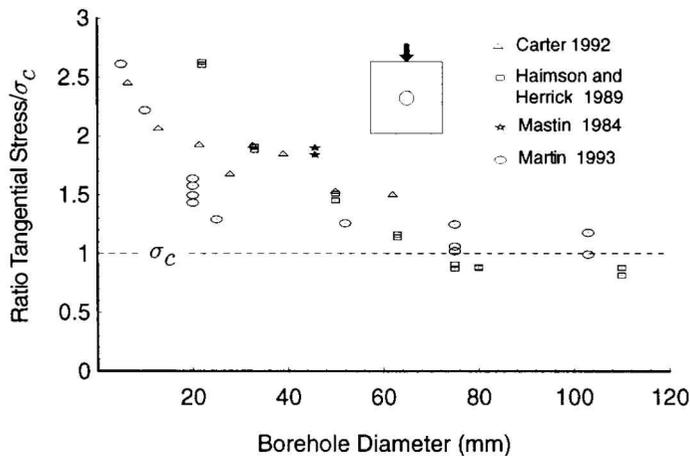
Figure 3.26 Summary of uniaxial testing of blocks containing a circular opening (Martin, 1997).

Martin (1997) summarized the previous laboratory test results and showed that as the opening size increases the tangential stress approaches the uniaxial compressive strength of the material, but significant strength-scale effect was observed when openings less than 75 mm in diameter as shown in the Figure 3.26. A noticeable change in the effect of scale was found between the laboratory and in situ results as shown in Figure 3.27.

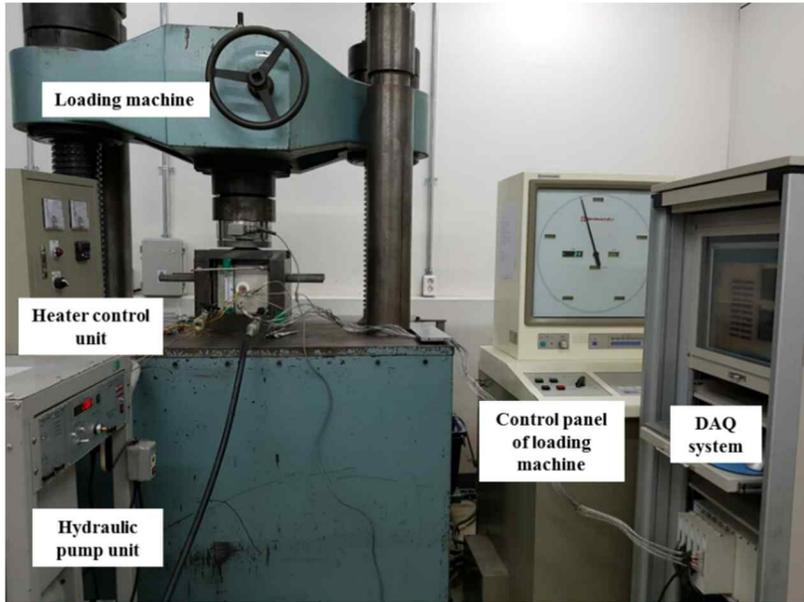
Figure 3.32 Experimental setup of heater test.

Before heater test, holes were drilled on the front surface of the specimen for the installation of six thermocouples. The cartridge heater was placed into the central circular opening and the interfacial gaps between cartridge heater and the opening surface were filled with standard sand. In order to insure the heater was in the center of the opening and to prevent the leakage of the sand, a pair of ceramic rings were used to seal the ends of the opening. The details of the preparation process of heater test are presented in Appendix B. After the installment of thermocouples and AE sensors, the final experimental setup were shown in Figure 3.32 and a close-up view was given in Figure 3.33.

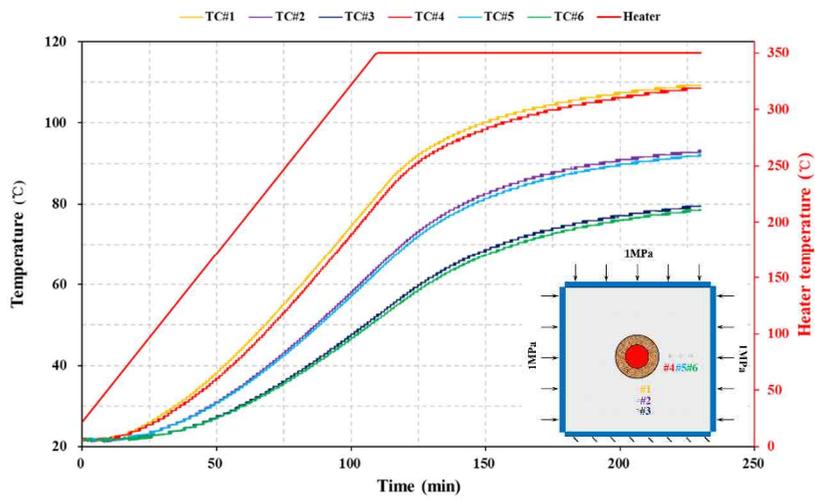
Figure 3.34 Temperature evolution at six temperature monitoring points in heater test (#CM-TM).

As the specimen was the intact one (i.e. not damaged), it was reasonable to get these results. The small temperature difference may be due to the monitoring points of thermocouples cannot be exactly at the same depths into the specimen.

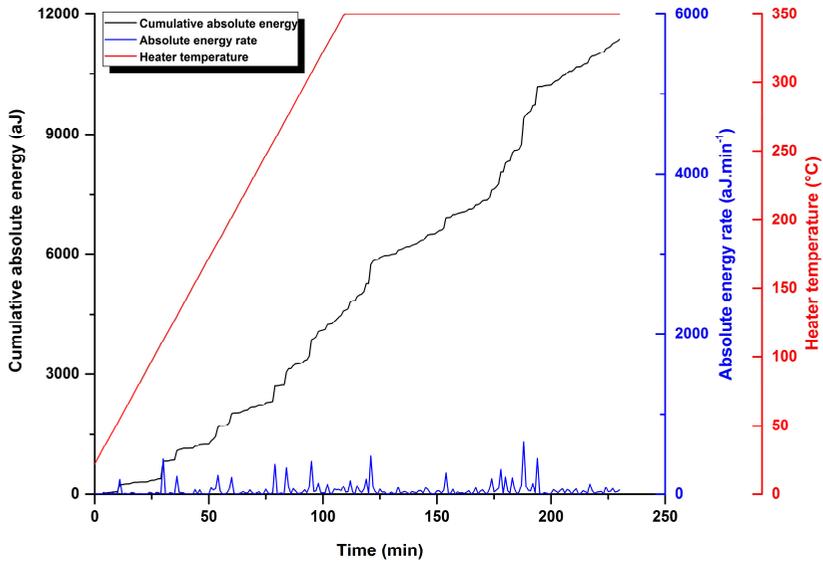
Figure 3.35 Cumulative absolute energy, absolute energy rate and heater temperature in heater test (#CM-TM).

The absolute AE energy results are shown in Figure 3.35, heater temperature is also plotted in this figure. The cumulative absolute energy rise up gradually with increasing temperature. No significant rising of absolute energy rate was found in the tests. The AE source locations are shown in Figure 3.36. Different colors indicate the sources occurred in different time periods. The AE source locations are randomly distributed in the specimen and some sources clustered near to the sidewall of the circular opening.

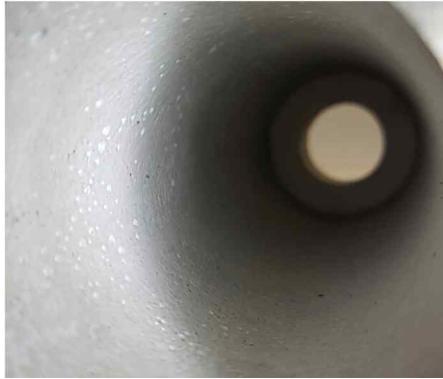
Figure 3.37 Close-view of the circular opening after heater test (#CM-TM).

Heater and packing sand were removed after heater test. A close observation of the circular opening is shown in Figure 3.37. No obvious macrocracks were observed on the surface of circular opening. In addition, no macrocracks were found on the outer surface of the specimen. In contrast, when specimen was heated under unconfined condition as found by Carlson et al. (1993), Jansen et al. (1993) and Ishida et al. (2004), macrocrack initiation was observed from the outer surface of the specimen as shown in Figure 1.6.

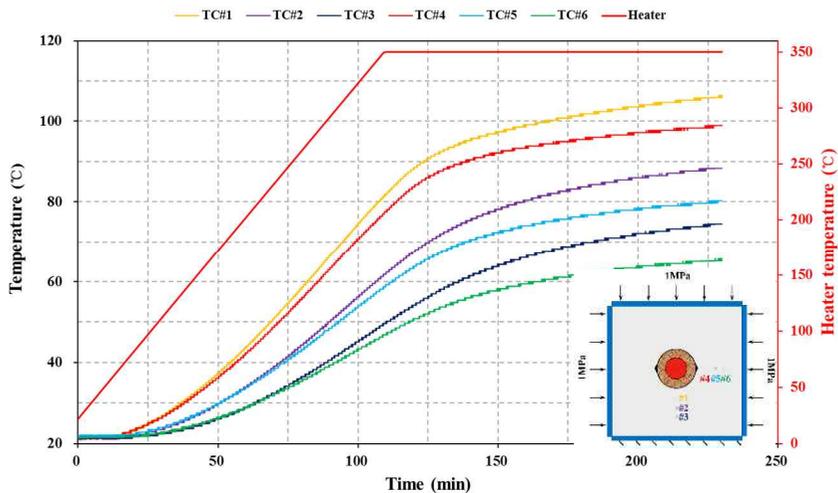
Figure 3.38 Temperature evolution at six monitoring points in heater test (#CM-M-TM).

The temperature differences between vertical and horizontal direction can be explained by the presence of pre-existing failed zone (Figure 3.40) located at side wall of the circular opening which was generated in biaxial compression test may explain due to the low thermal conductivity of air filled cracks which were formed in this zone during the biaxial compression tests. The variation of recorded absolute energy with time is presented in Figure 3.39. It can be seen that the cumulative absolute energy rise up gradually and a sharp rising of the absolute energy rate was found around 94 minutes. The sharp rising of energy rate maybe proved by the experimental observations.

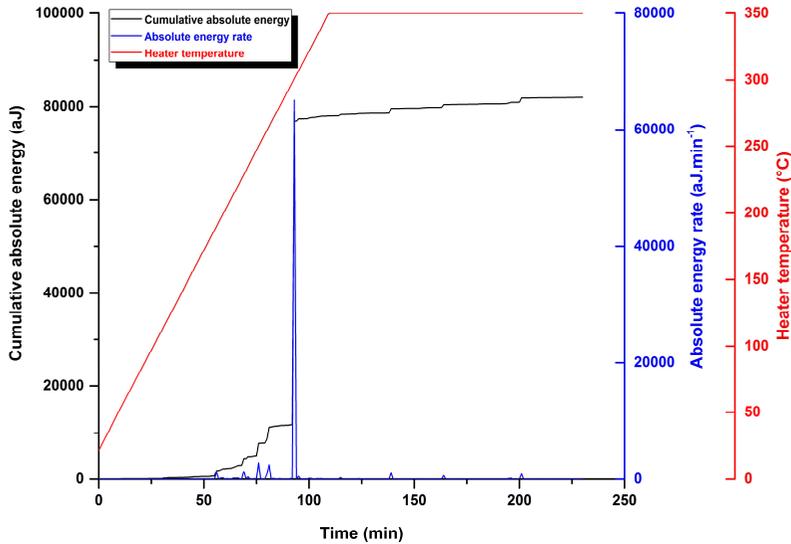
Figure 3.39 Cumulative absolute energy, absolute energy rate and heater temperature in heater test (#CM-M-TM).

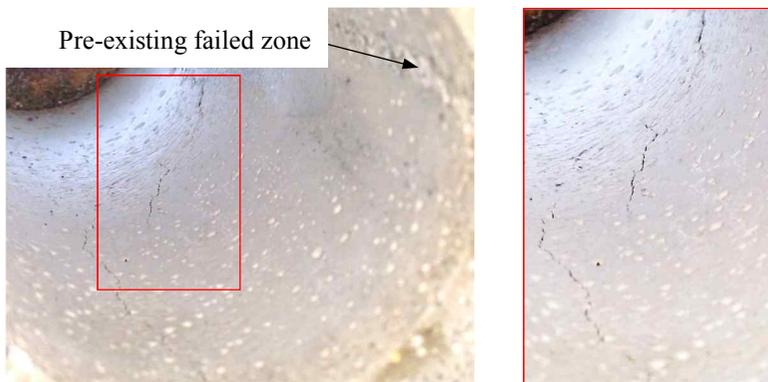
Figure 3.40 Fractures were initiated on the surface of the circular opening (#CM-M-TM).

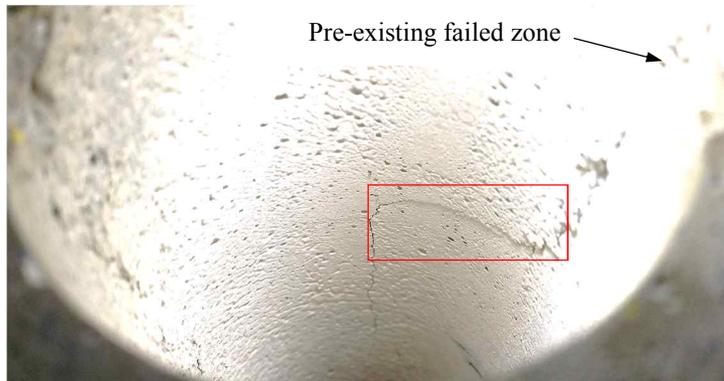
Figure 3.41 Fractures coalescence with the pre-existing failed zone (#CM-M-TM).

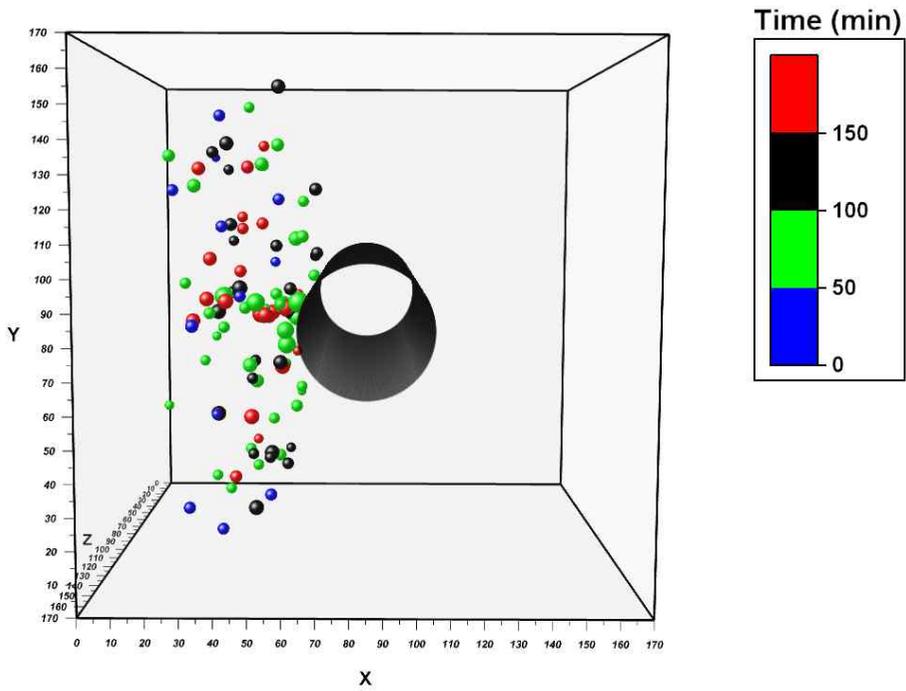
Figure 3.42 AE source locations in heat test (#CM-M-TM).

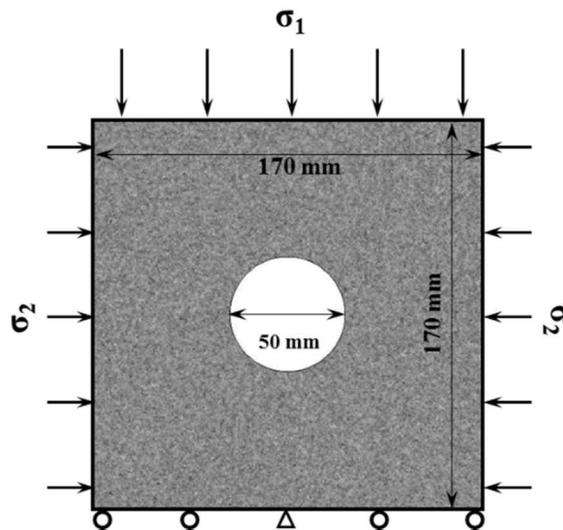
Figure 4.3 Geometry of numerical specimen and boundary condition.

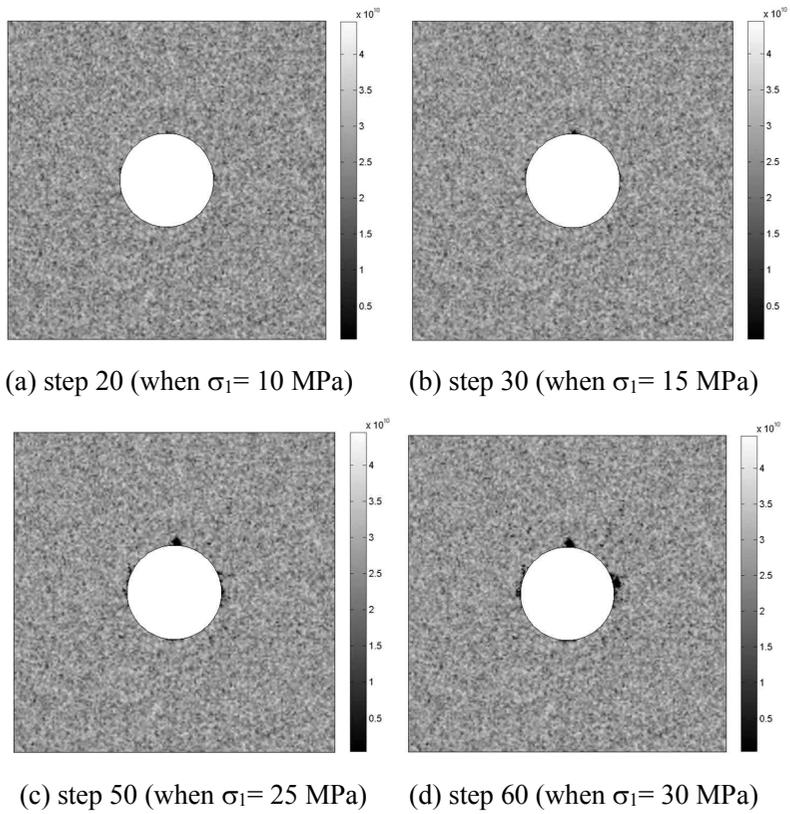
Figure 4.4 Simulation results of the damaged zone (distribution of Young's modulus) around circular opening under biaxial compression loading condition: (a) step 20 (when  $\sigma_1 = 10$  MPa); (b) step 30 (when  $\sigma_1 = 10$  MPa); (c) step 50 (when  $\sigma_1 = 10$  MPa); (d) step 60 (when  $\sigma_1 = 10$  MPa). (Unit: Pa)

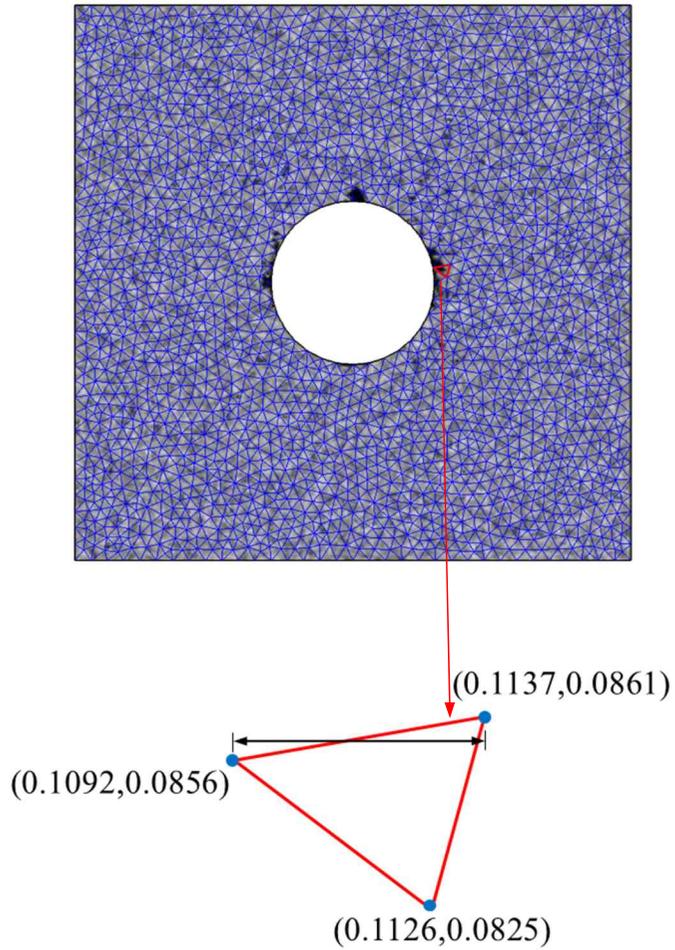
Figure 4.5 Coordinates of the triangular mesh. (Unit: m)

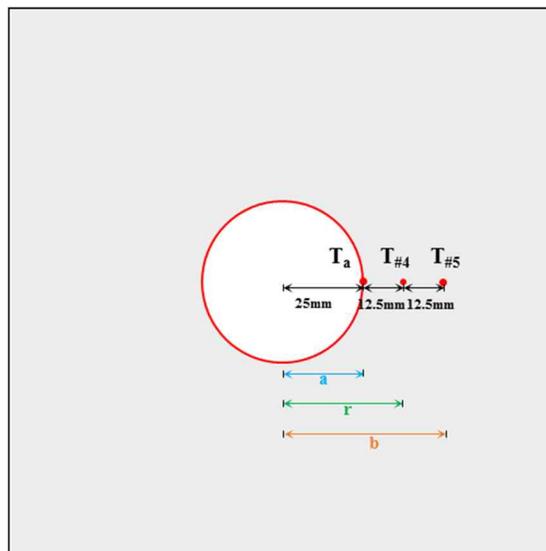
Figure 4.9 Schematic view of the method for calculating the temperature at the surface of the circular opening (#CM-TM).

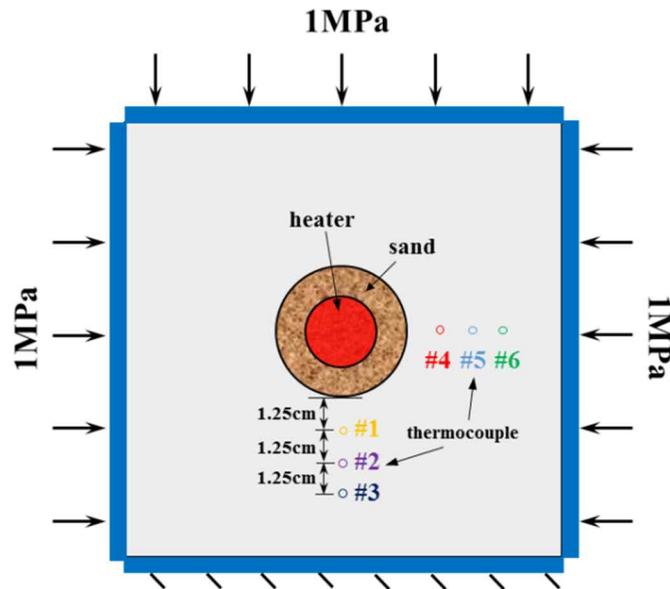
Figure 4.12 Schematic view of test condition of heater test (#CM-TM).

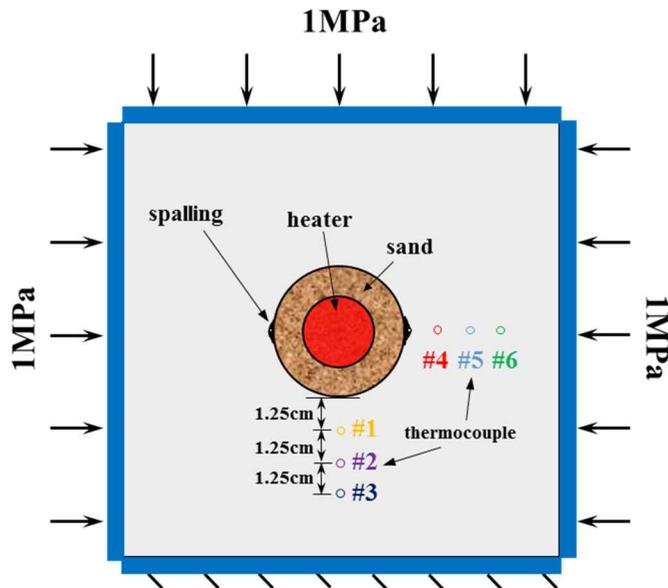
Figure 4.15 Schematic view of the test condition of heater test (#CM-M-TM).

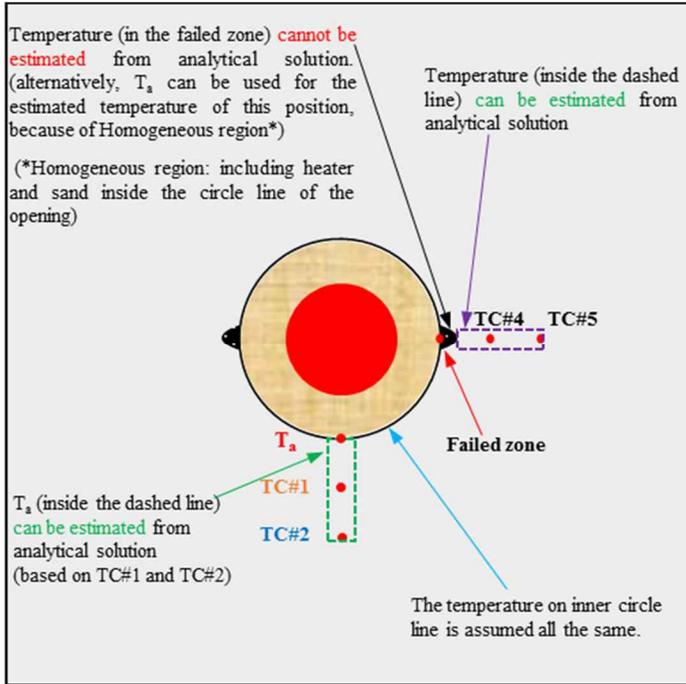
Figure 4.16 Schematic view of the method for calculating the temperature at the surface of the circular opening (#CM-M-TM).

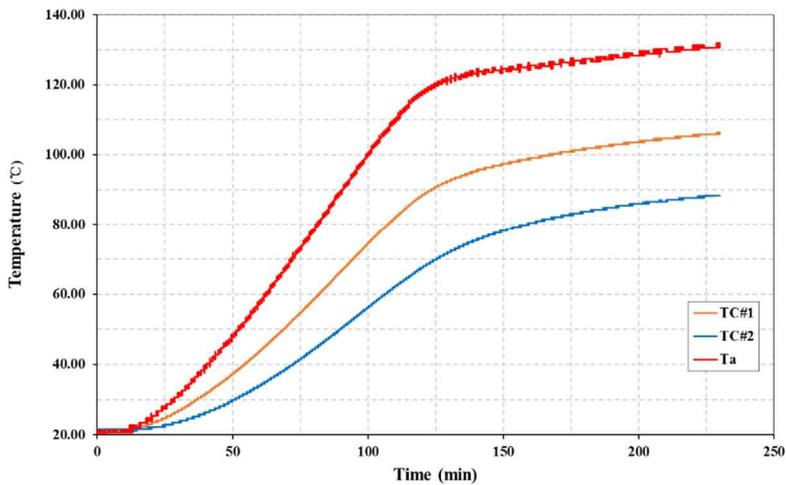
Figure 4.17 The calculated temperature evolution curve at the surface of the circular opening ( $T_a$ ).

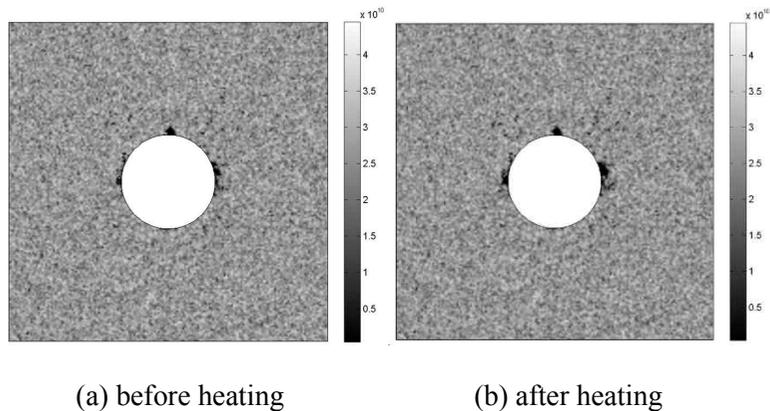
Figure 4.19 Simulated damaged zone around circular opening: (a) before heating; (b) after heating (#CM-M-TM). (Unit: Pa)

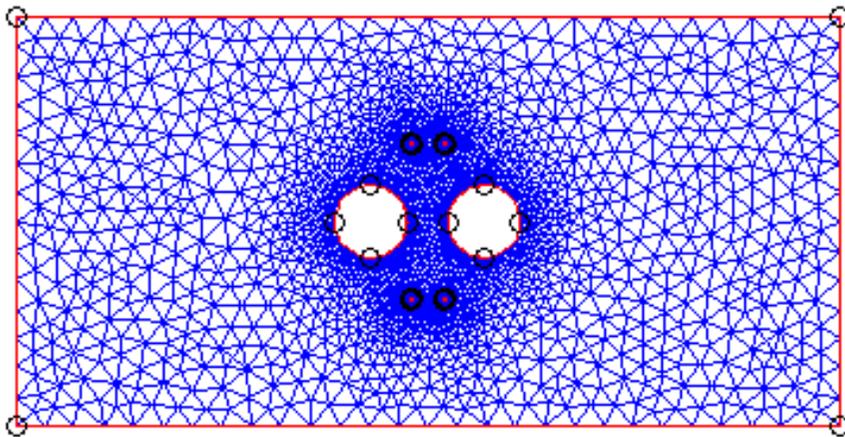
Figure 4.27 Mesh of 2D numerical model ( $20\text{m} \times 10\text{m}$ ).
