공학박사학위논문

**A study on damaged zone around an opening in rock-like  
material due to thermo-mechanical loading**

서울대학교 대학원  
에너지시스템공학부

**ZHANG Nan**

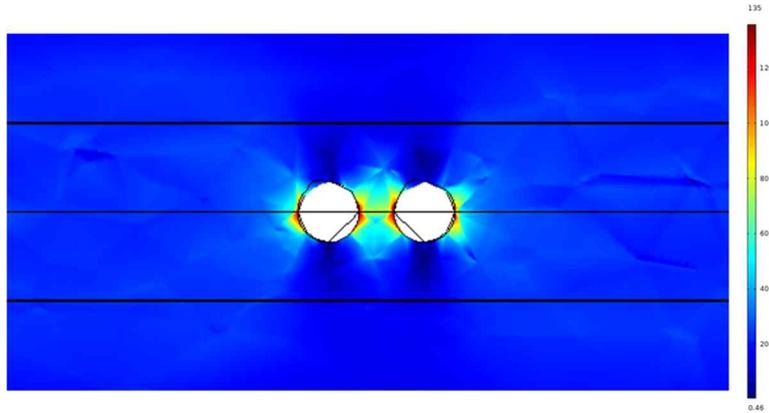
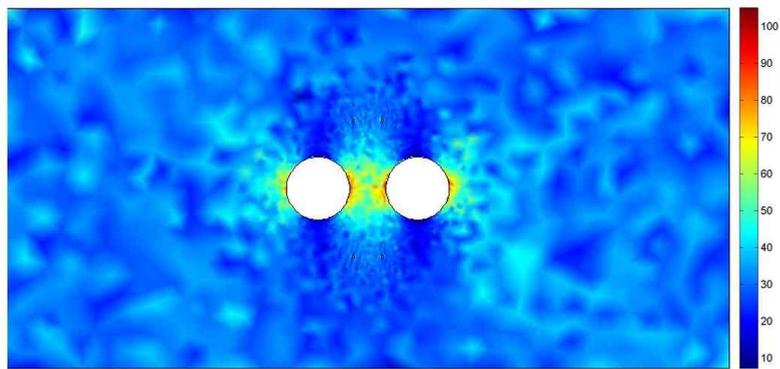
(a) 3D model (cross-section at 3.5m below the tunnel floor) after final excavation step

(b) 2D model

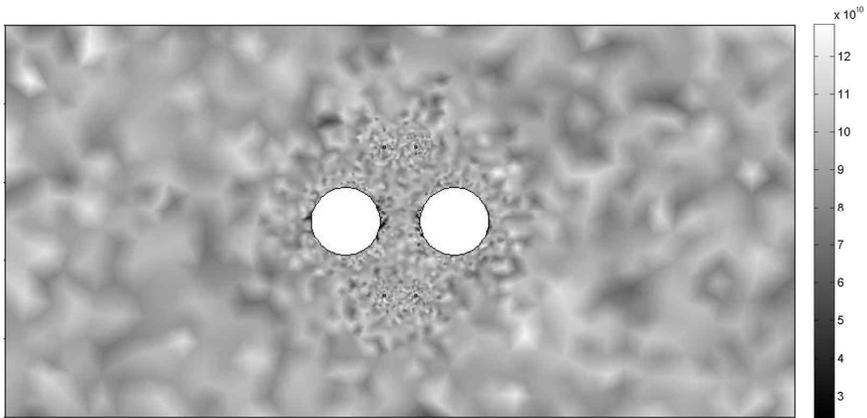
Figure 4.31 Simulated damaged zone after heating 66 days.

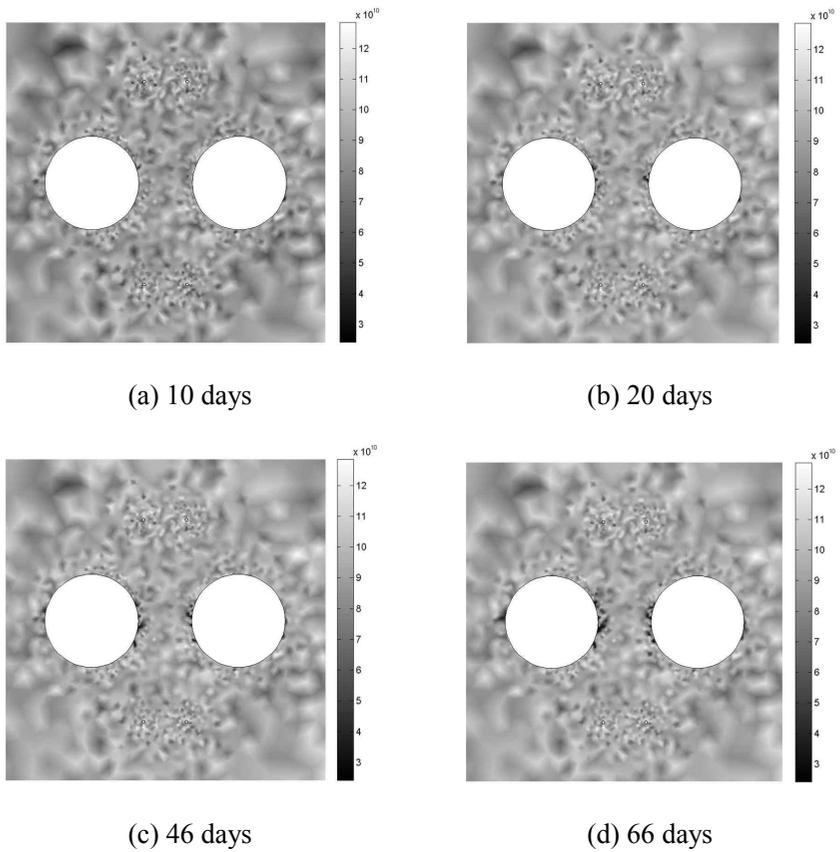
Figure 4.32 Simulated damaged zone: after heating (a) 10 days; (b) 20 days; (c) 46 days; (d) 66 days. (Unit: Pa)

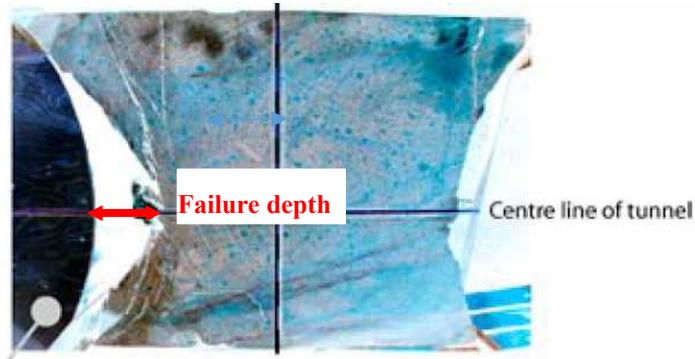
Figure 4.33 Photographs of failure pattern on rock pillar in APSE (Andersson, 2007).

The in-situ observation of the failure pattern on rock pillar can be seen in Figure 4.33. V-shaped failed zone (notch) was found at the left side of rock pillar. The confining pressure which applied on the right side borehole has clearly influence to the failure depth, the failure depth at the right side of rock pillar is obviously smaller than the left side.

The simulated damaged zone on rock pillar were compared with previous studies as shown in Figure 4.34. It was found that the simulated depths of the damaged zone in the rock pillar are generally agreed with the simulation results obtained from other numerical codes as shown in Table 4.7. The simulated depth of the damaged zone at the left side of rock pillar in COMSOL is relatively larger, however, it is more comparable to the field experimental findings at the rock pillar as shown in Figure 4.33.

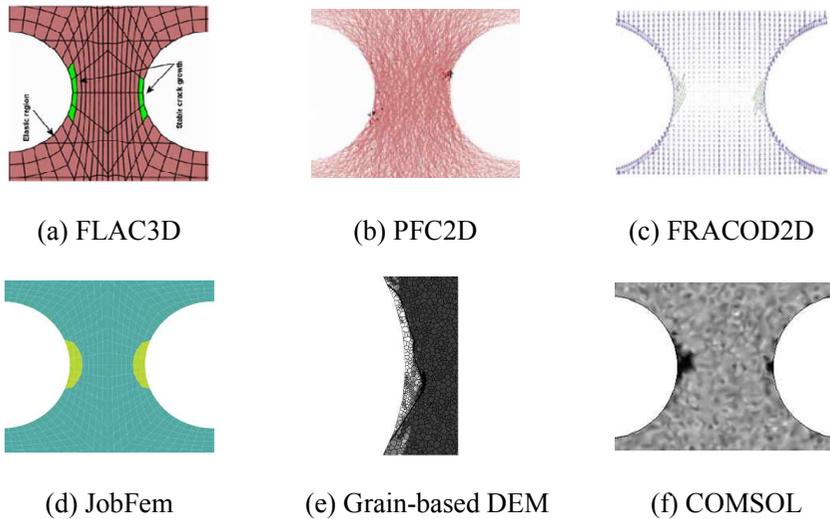
Figure 4.34 Failure depths simulated by different numerical codes:  
 (a) FLAC3D (Wanne et al., 2004); (b) PFC2D (Wanne et al., 2004);  
 (c) FRACOD2D (Rinne et al., 2004); (d) JobFem (Fredriksson et al., 2004);  
 (e) Grain-based DEM (Lan et al., 2013); (f) COMSOL (this research).
