공학박사 학위논문

**Liquid Droplet Impingement
Erosion Mechanism of Low-Alloy
Steels in the Secondary Side of
Pressurized Water Reactors**

서울대학교 대학원

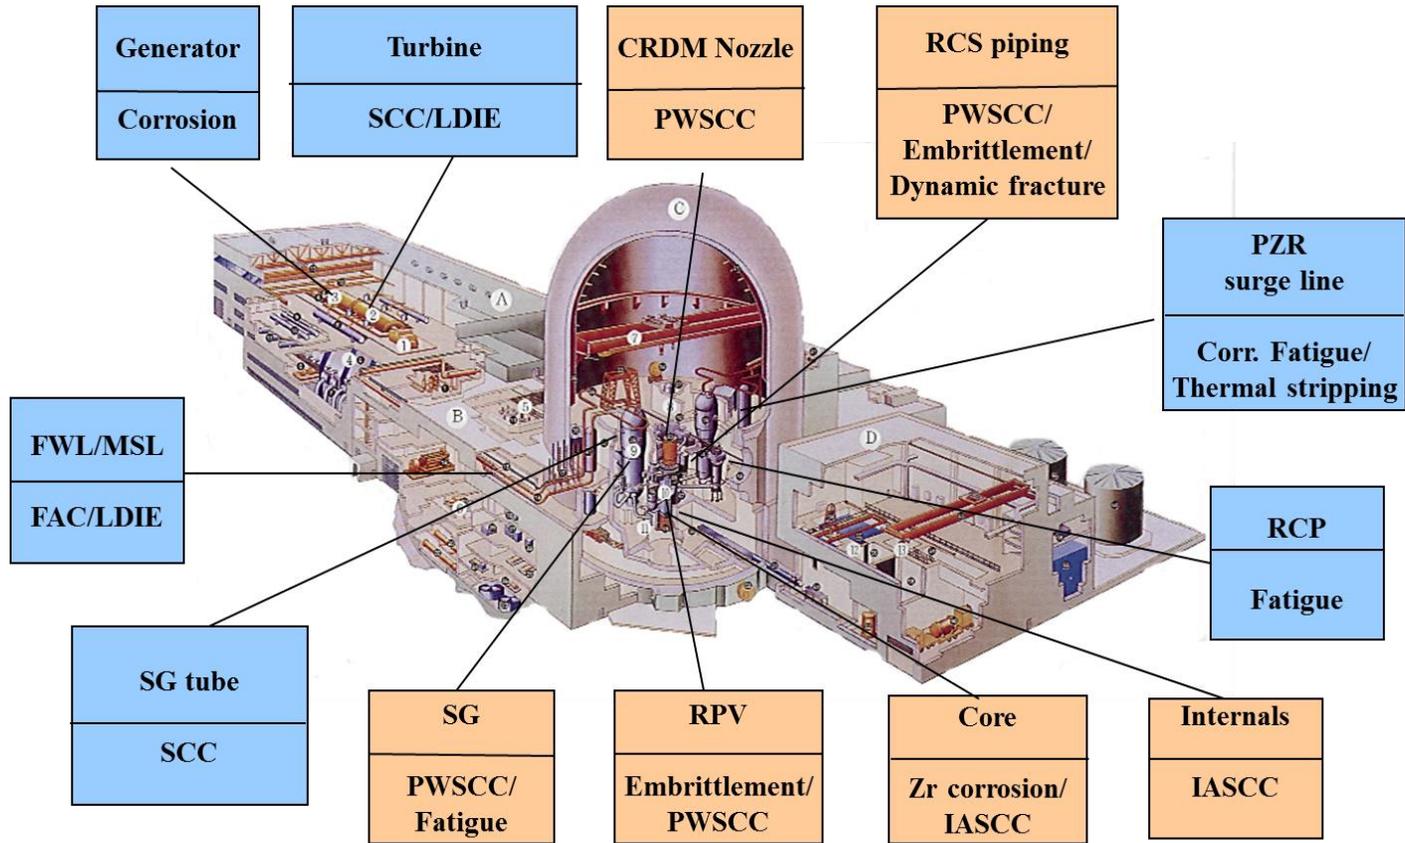
Figure 1.1 Material aging and degradation issues in the primary and secondary side of PWRs.

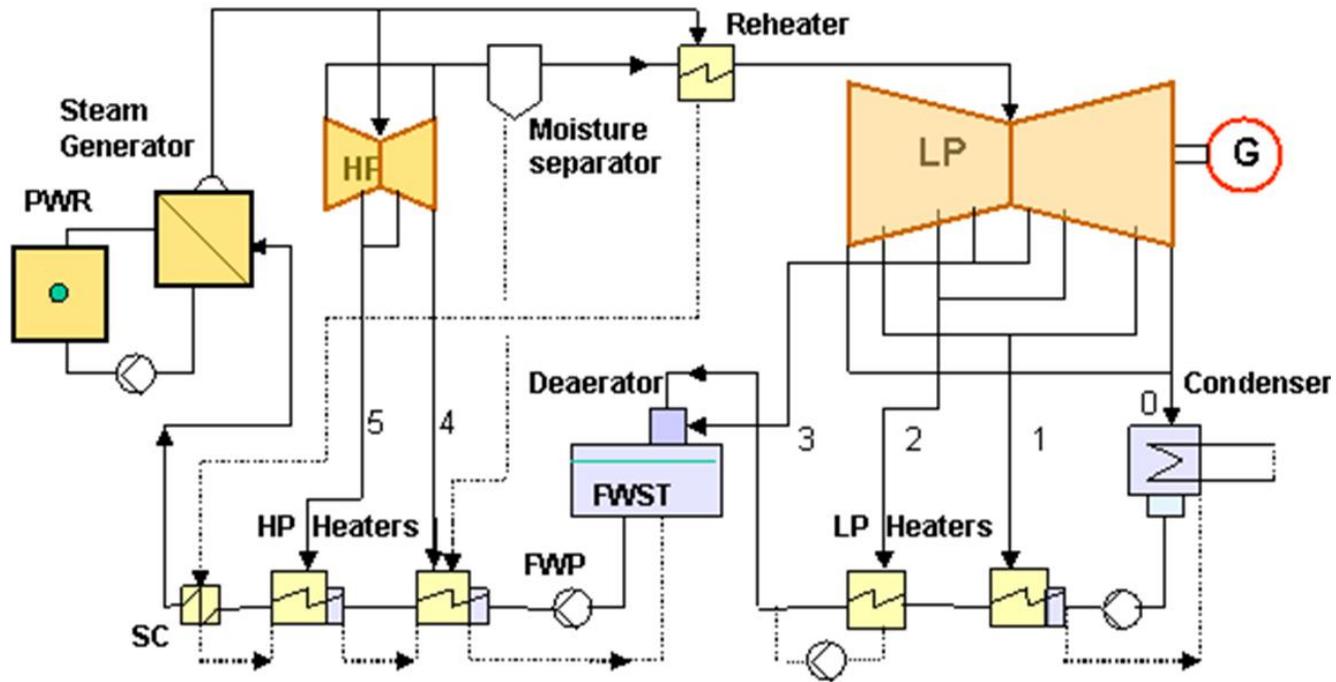
Figure 1.2 Diagram of the secondary cooling system of PWRs(HP-high pressure turbine, LP-low pressure turbine, FWST-feedwater storage tank, FWP-feedwater pump)[24].

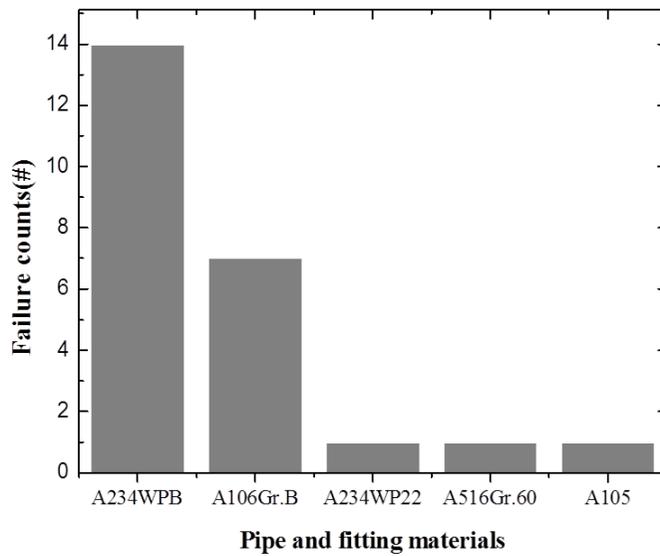
Figure 1.3 Wall-thinning and leak failures occurred in domestic PWRs (as function of materials)[4].

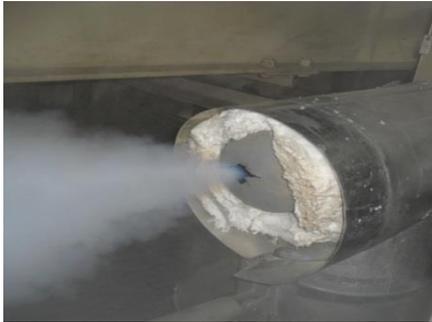
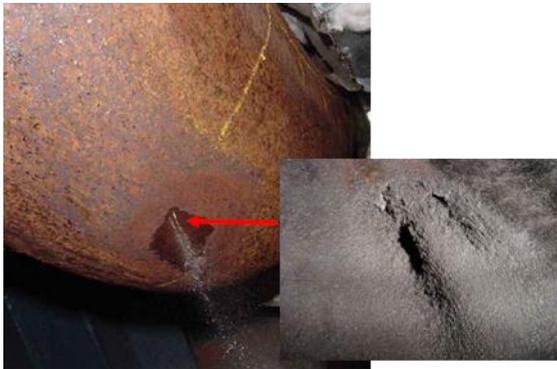
(a) Korean Unit Y #2

(b) Korean Unit W #1

(c) Belgium Tihange Unit #1

Figure 1.4 Failure components by liquid droplet impingement erosion in the secondary side of PWRs-(a)Korean Unit Y #2, HP FW HTR to Re-heater, A106 Gr.B, (b) Korean Unit W #1, FW Re-heater, A234 WPB, (c) Belgium Tihange Unit #1, LP turbine casing, no information about material[4,5].

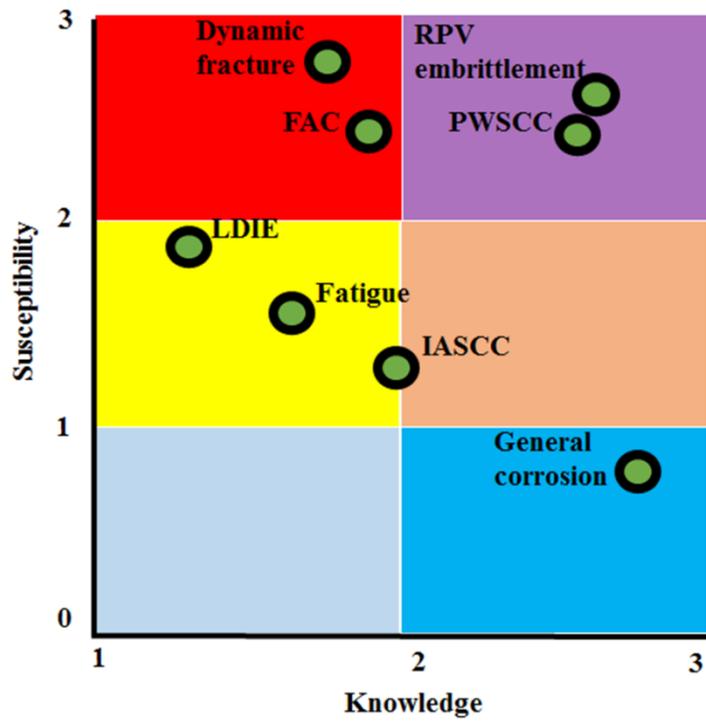
Figure 1.5 Phenomena identified ranking table (PIRT) for the structural material degradation mechanism of SSC in PWRs[13-15].

Figure 1.5 shows the phenomena identified ranking table (PIRT) about the relationship between our knowledge basis and the susceptibility recognizing

in operating PWRs[1,15,and 23]. Compared with other damage mechanisms, the knowledge level of LDIE is relatively low, while the degradation susceptibility in PWR is above the average level. Even worse, there is no prediction model to manage LDIE. Plant outages due to LDIE have been about 20 days per year[4].

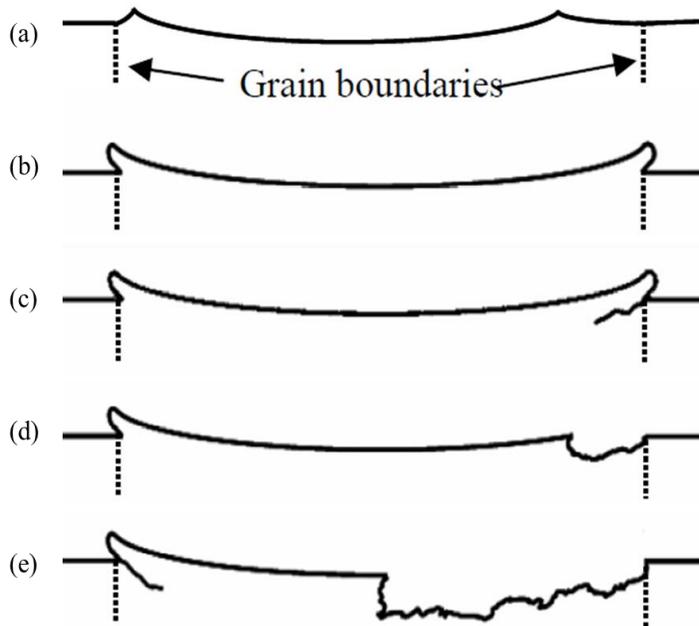
Figure 2.2 Schematic illustration of erosion damage process by liquid droplet impingement in ductile materials-(a) initial stage of erosion (b) plastic deformation at grain boundaries (c) crack initiation by fatigue (d) erosion on surface (e) further eroded surface[31].

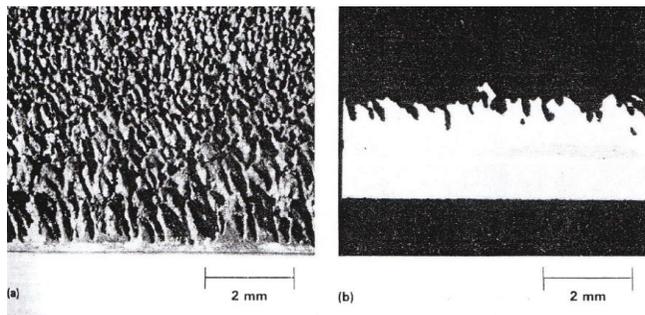
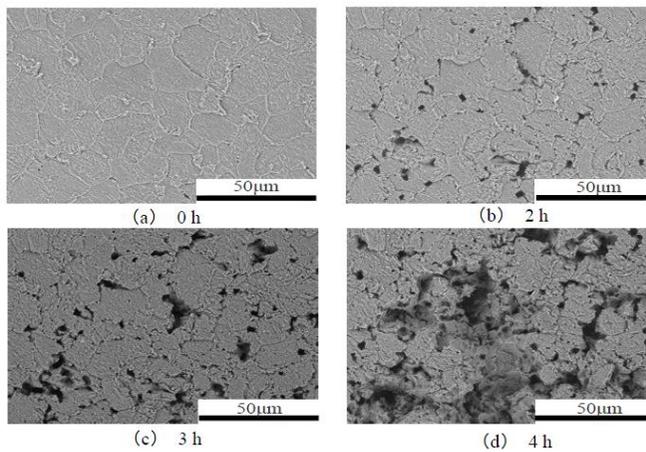
(a) Type 403 martensitic stainless steel

(b) S15C carbon steel

Figure 2.3 Microstructure of LDIE damaged specimen-(a) Type 403 martensitic stainless steel[28], (b) S15C carbon steel tested at 160 m/s of droplet velocity[31].

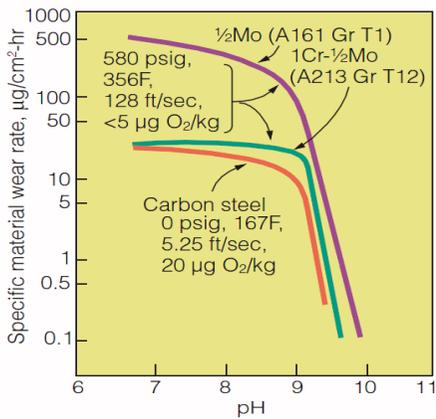
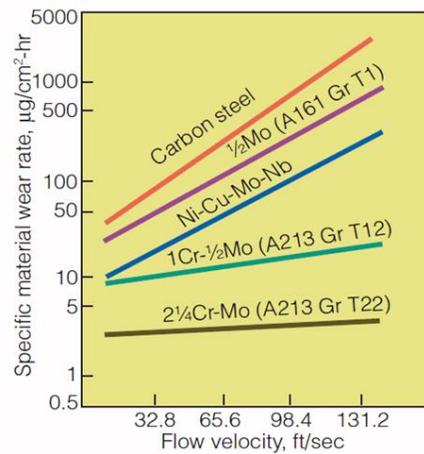
Figure 2.4 The environmental factor dependence on erosion-corrosion rate- (a) pH effect[41], (b) dissolved oxygen effect[39], (c) temperature effect[41], (d) flow velocity effect[41].

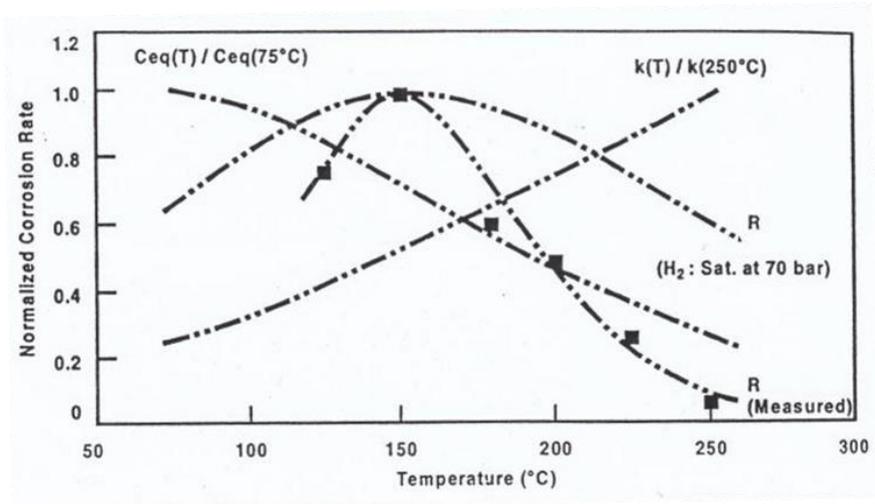
Figure 2.5 Temperature dependence of single-phase flow-accelerated corrosion with ammonia at pH 9.0(C_{eq} is magnetite solubility and k is mass transfer coefficient)[42].

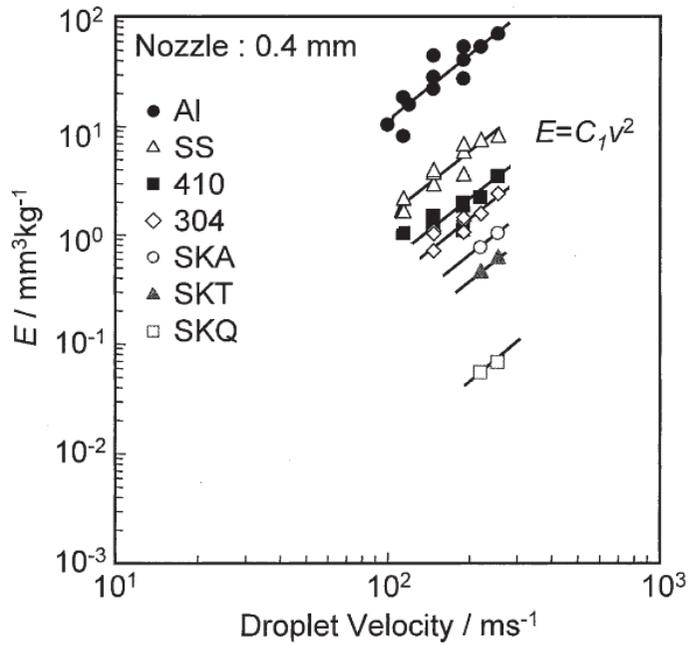
Figure 2.6 Wall thinning rate due to liquid droplet impingement[52].

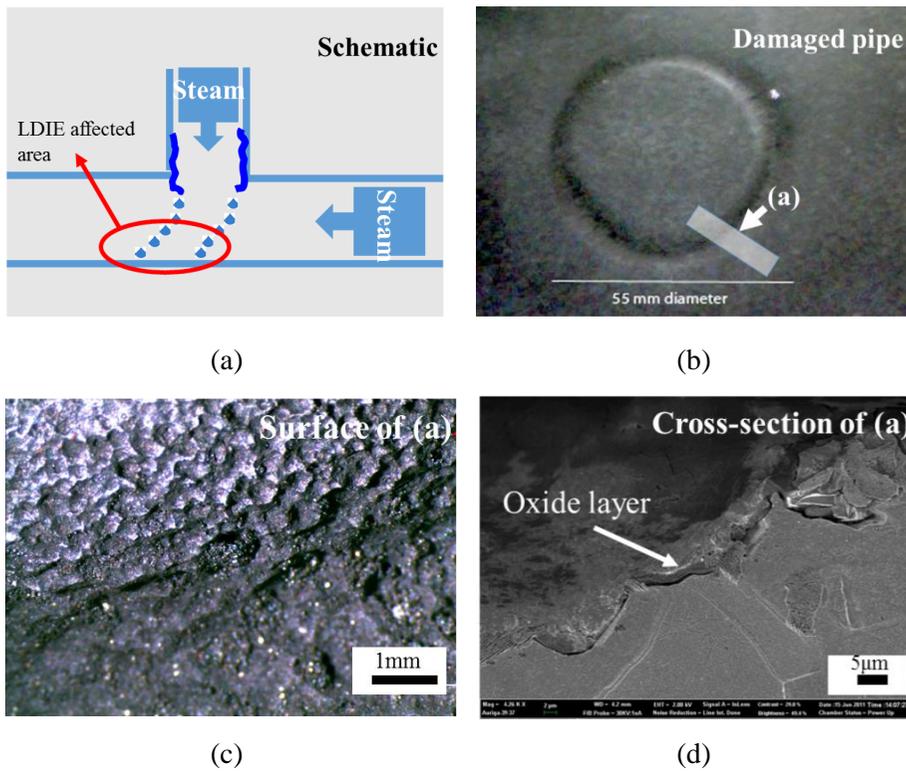
Figure 2.7 Field failure case-(a) schematic of damage scenario, (b) inner surface of damaged pipe, (c) microstructure of damaged surface, (d) cross-sectional image (A234 WPB, operated about 20 yr. at 138 °C)[4].

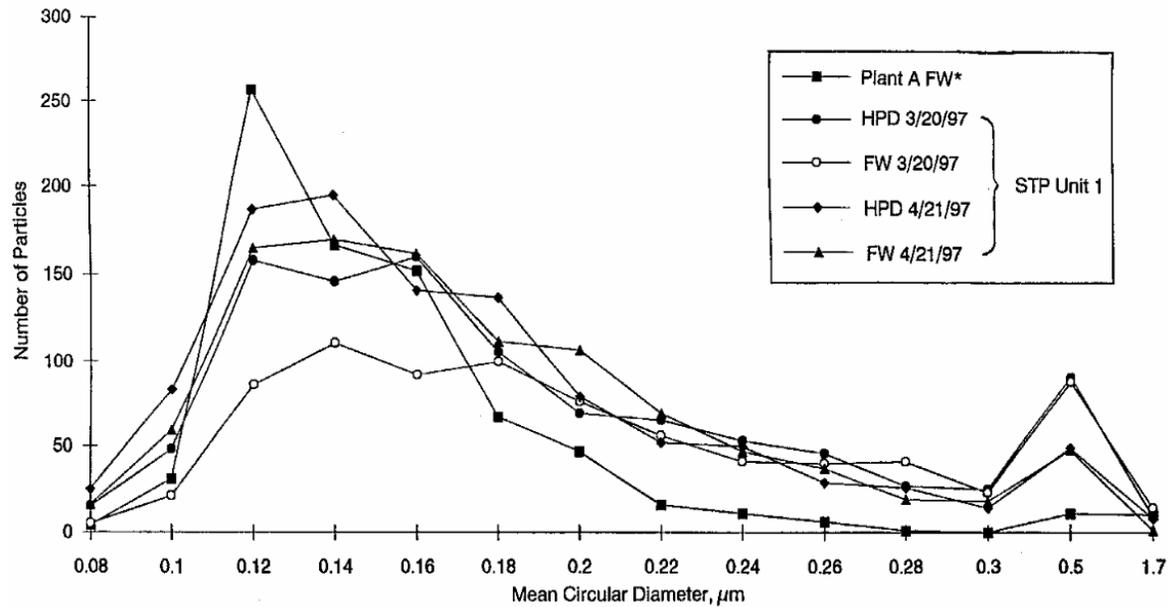
Figure 2.8 Corrosion product particle mean circular diameter distribution of high pressure drains and feedwater at South Texas Project Unit 1[61].

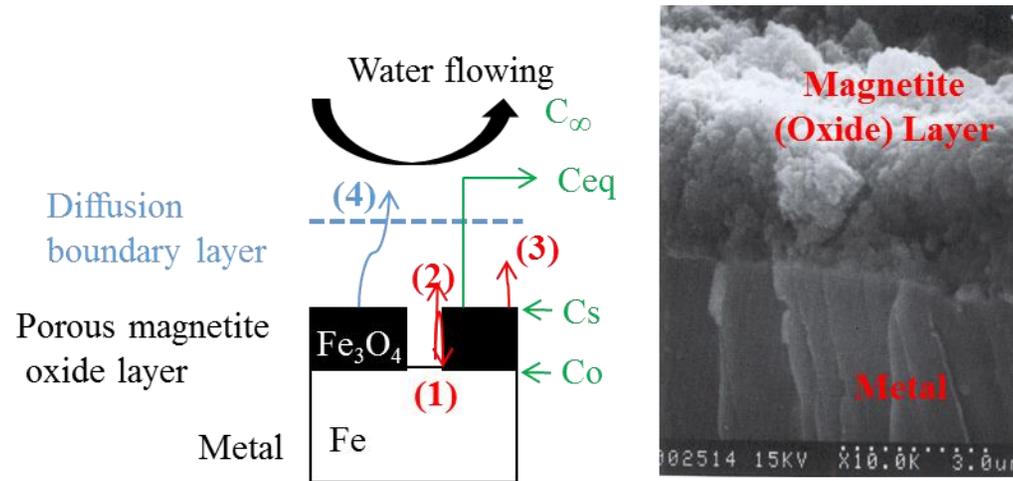
Figure 2.9 Flow accelerated corrosion model-(1) production of soluble ferrous ions at the iron/magnetite interface, (2) diffusion of soluble ferrous ions through porous oxide layer, (3) dissolution of magnetite at the oxide/water interface, (4) transfer of the ferrous ions into the bulk water across diffusion boundary[68].

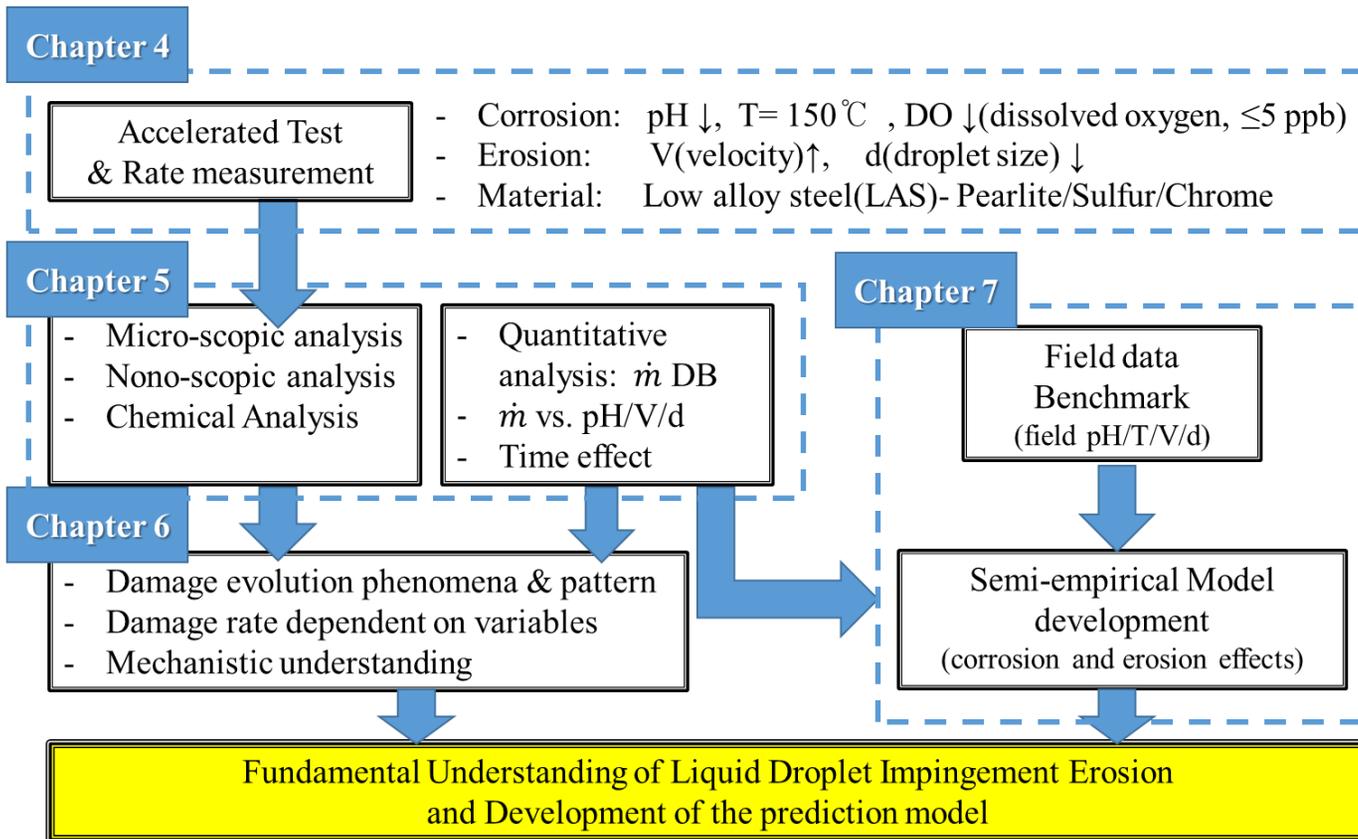
Figure 3.1 Diagram for LDIE mechanistic study

The thesis investigation approach is summarized in Figure 3.1. To pursue the main objective of this research, understanding of LDIE mechanism, it is necessary to analyze test materials under high resolution microscopy with adequate material selection. The analysis of the experimentally by produced damage are conducted by micro and nano-structural analysis as well as quantitative assessments. Mechanistic understanding from microscopic analysis can be confirmed by the relationship between effective factors and damage rates. A semi-empirical model on the damage rate can be developed based on damage mechanism. The model will be verified by field data using actual operation conditions.

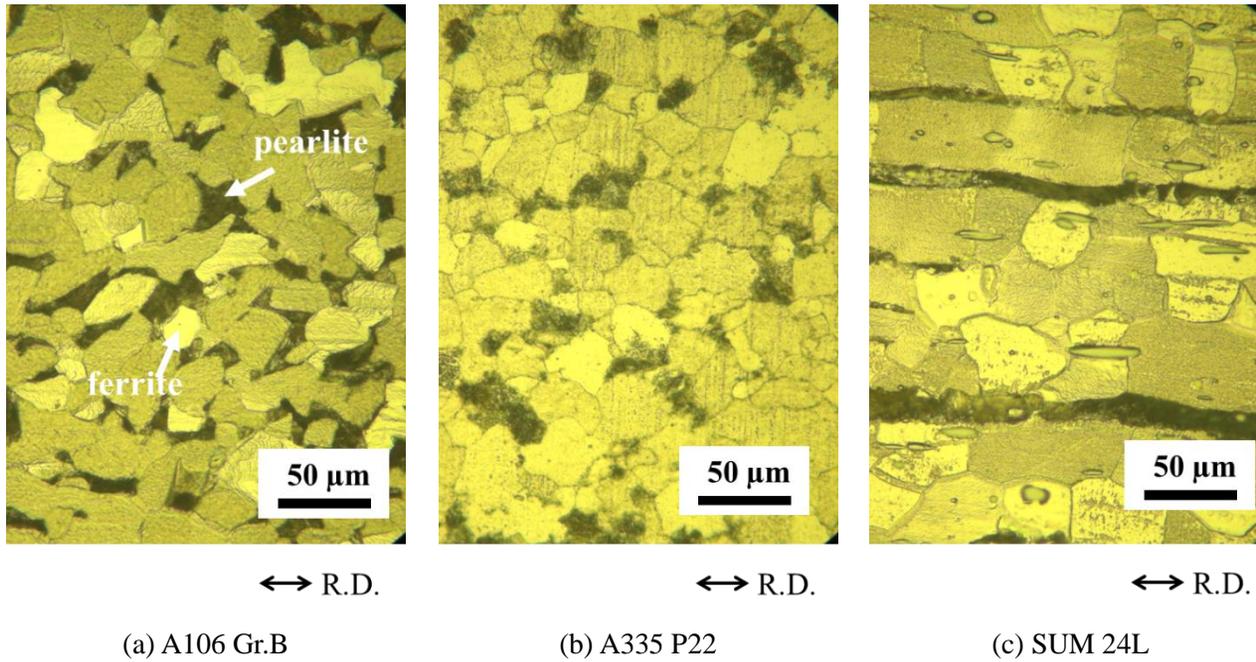
Figure 4.1 Photomicrographs of 2% nital etched test materials; (a) A106 Gr.B, (b) A334 P22, and (c) SUM24L.

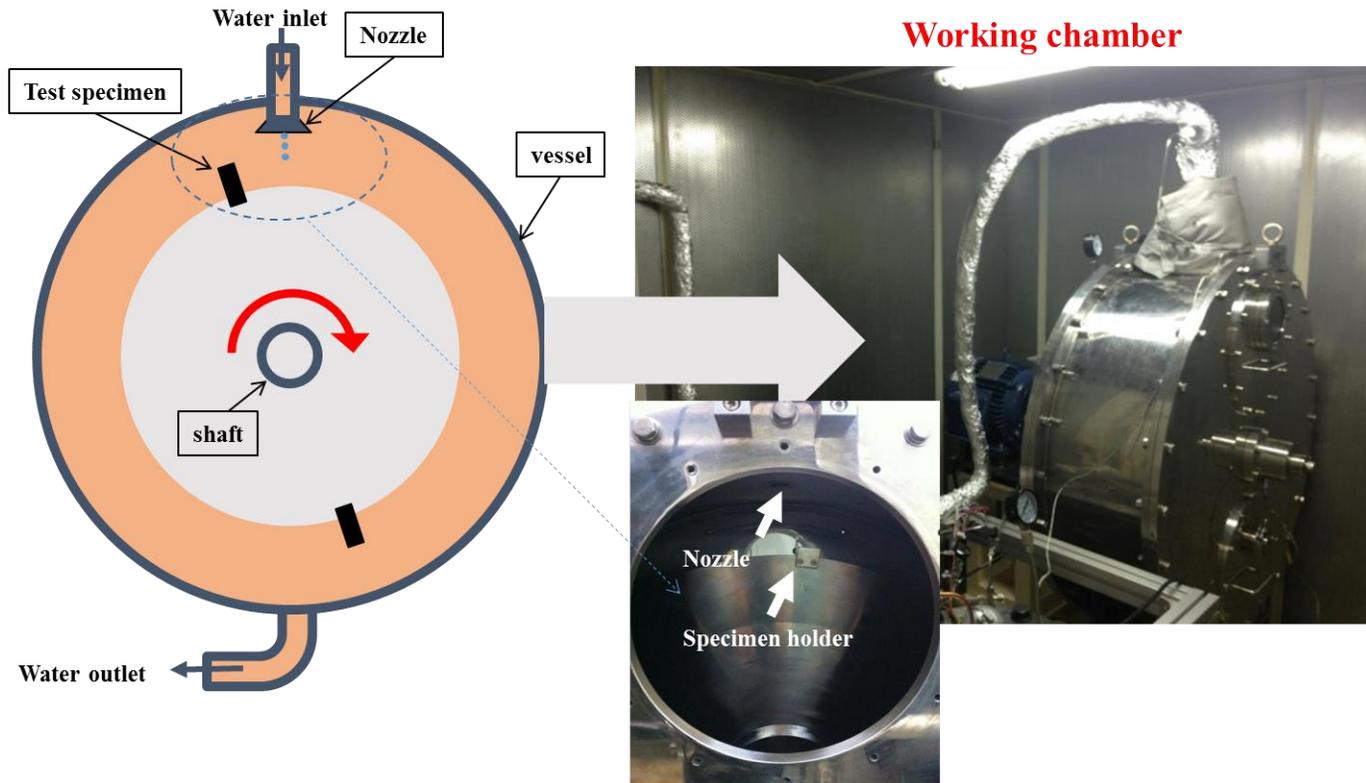
Figure 4.3 The schematic of LDIE test apparatus based on ASTM G73-10 standard method

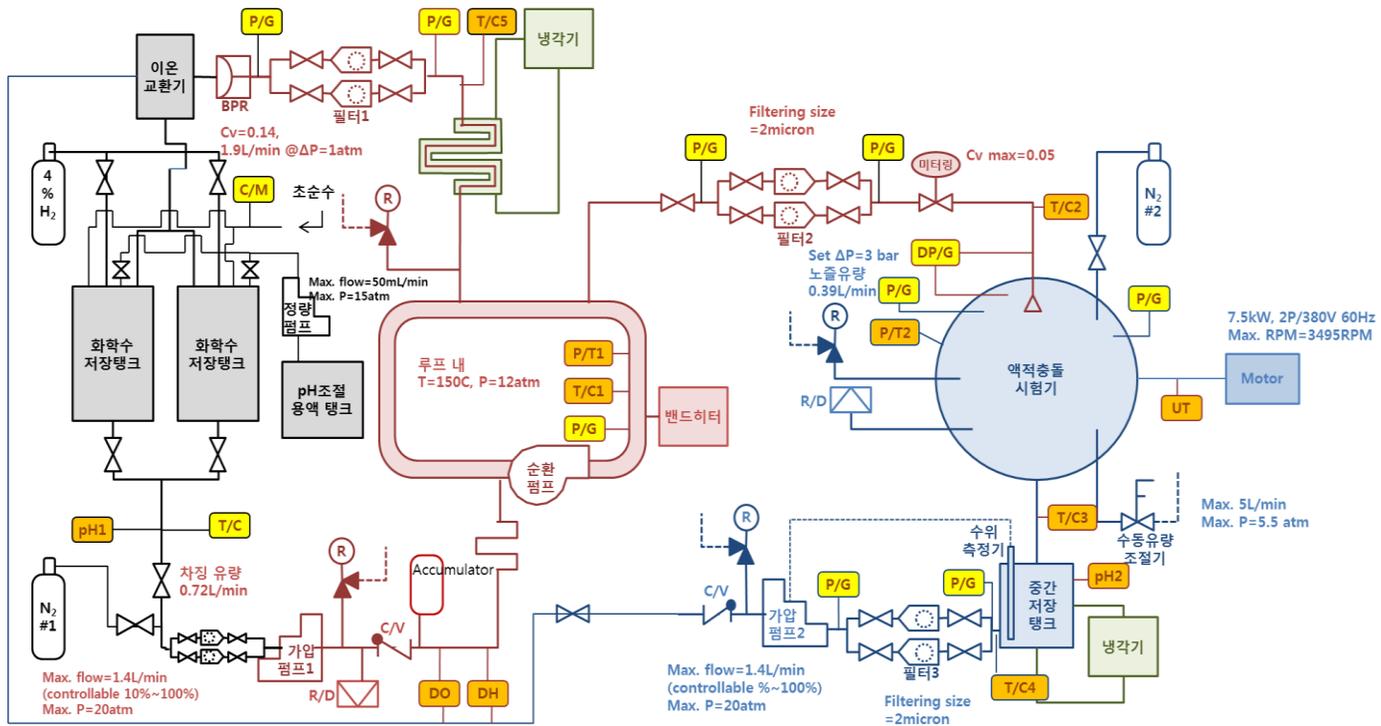
Figure 4.4 Piping and instrument diagram (P&ID) for balancing water chemistry and recirculation

chemical water tank that maintains the water chemistry. The chemical water in the tank is bubbled by 4% hydrogen gas, which makes nitric acid mixed with chemical water and removes dissolved oxygen in the water. The charging rate to the test loop is 720cc/min that is sufficient to fill the loss of a nozzle installed to impinge specimens. Chemical water is pressurized to 12 atm and is circulated by a circulation pump. Various parameters such as dissolved oxygen, dissolved hydrogen, temperature, and pH are continuously monitored and maintained at the designed test condition.

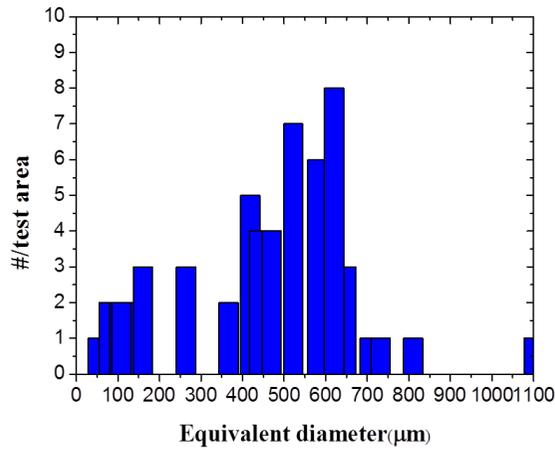
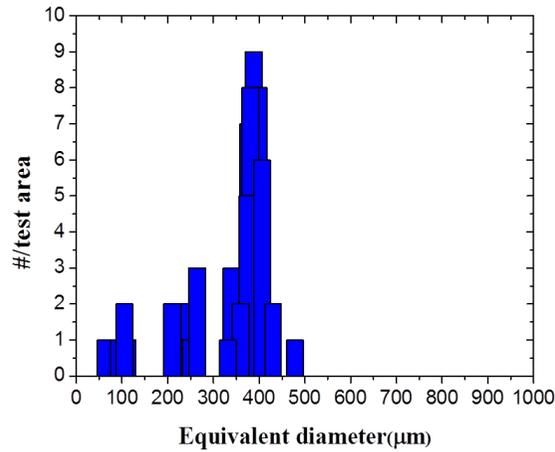
(a) SMD- 613 μ m (Nozzle size, 600 μ m)

(b) SMD-379 μ m (Nozzle size, 400 μ m)

Figure 4.6 Droplet diameter and distribution-(a) Sauter mean diameter(SMD) is 613 μ m for Nozzle size(600 μ m), (b) Sauter mean diameter(SMD) is 379 μ m for Nozzle size(600 μ m).

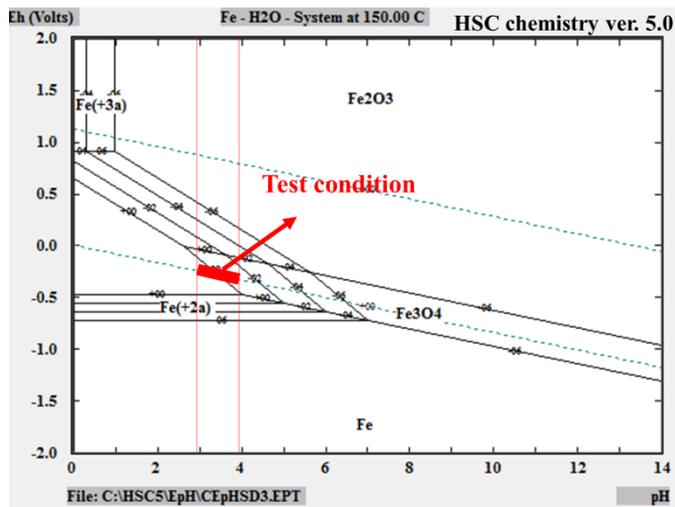
Figure 4.7 pH and electrochemical potential under test conditions calculated by HSC chemistry[70].

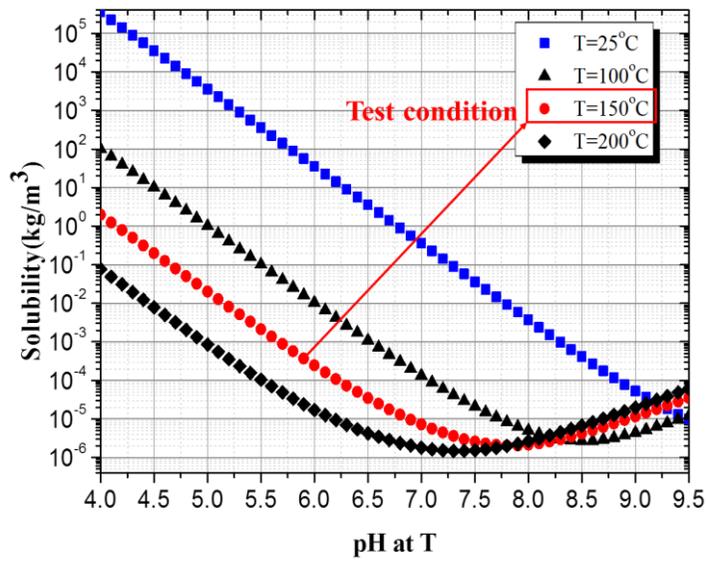
Figure 4.8 Magnetite solubility as functions of temperature and pH[69].

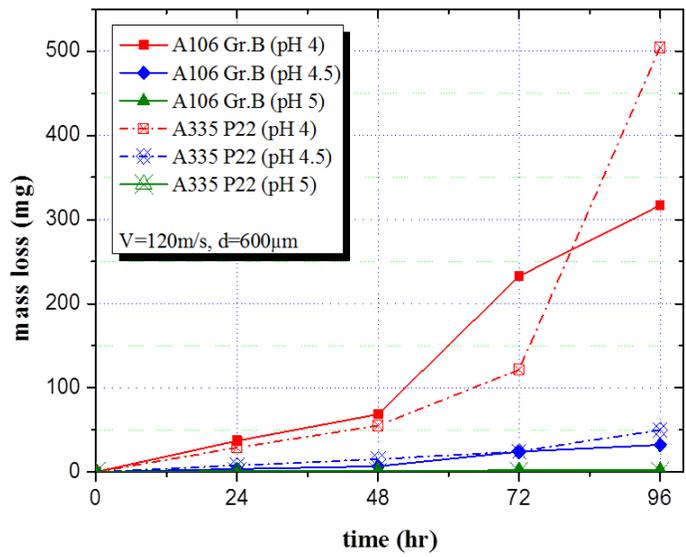
Figure 5.1 Mass loss of LAS as a function of pH.

It is noticed that there is transition period in which the LDIE rate is changed. To find the damage mechanism, it is important to understand the meaning of the transition phenomena which can be governed by different dominant mechanisms.

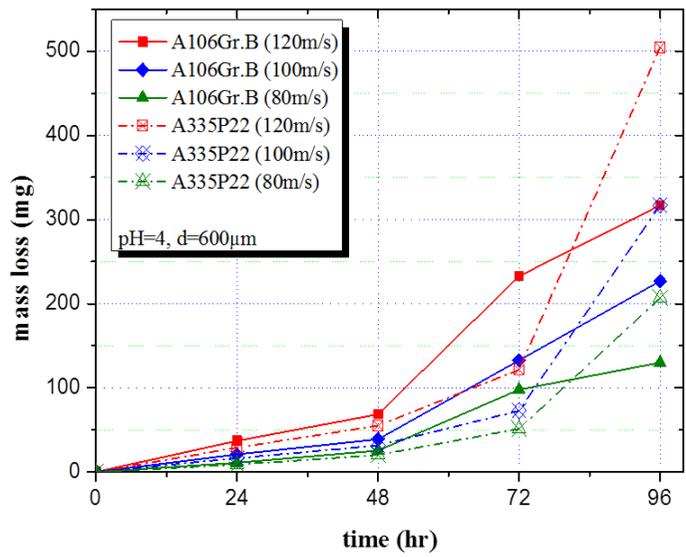
Figure 5.2 Mass loss of LAS as a function of droplet velocity.

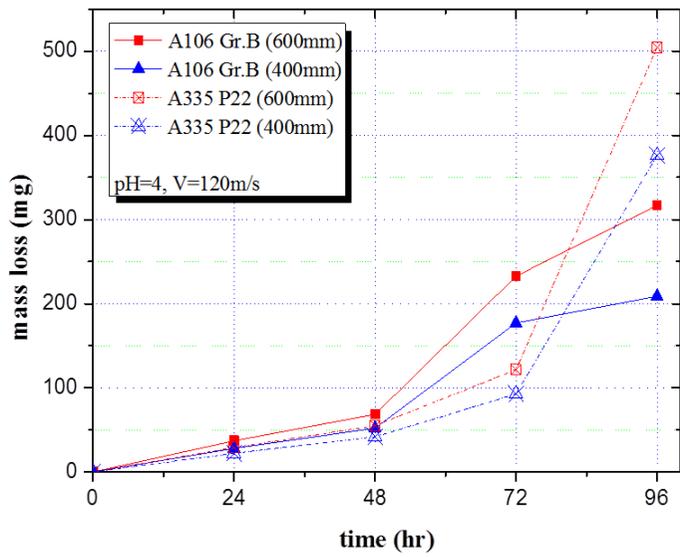
Figure 5.3 Mass loss of LAS as a function of droplet diameter.

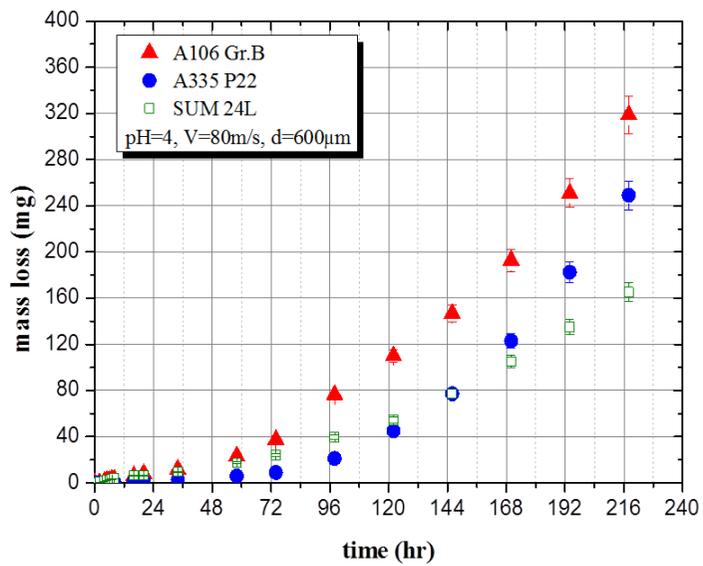
Figure 5.4 Long-term experiment for up to 200 hr.

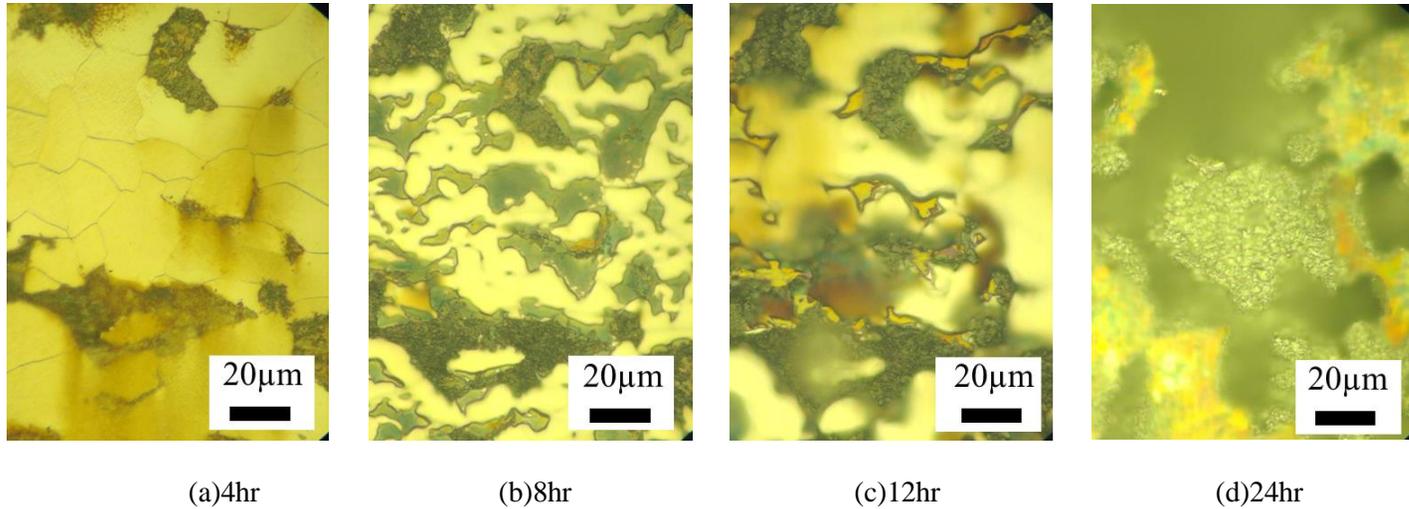
Figure 5.5 Time dependence of microstructures of A106 Gr.B (pH-4, V-80m/s, d-700µm, T-150°C, x1000 magnification)

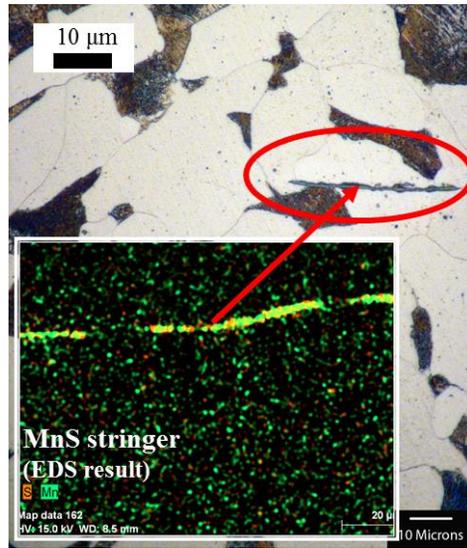
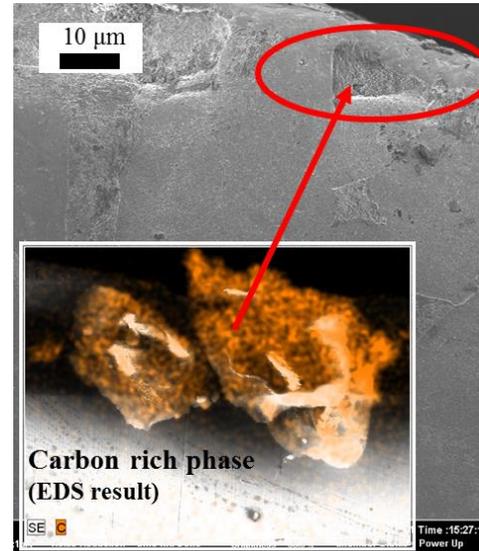
Figure 5.6 Cross-sectional microstructure of a field failure specimen –(a) MnS stringer in both optical microscope and EDS), (b) Carbon rich phase near damaged surface

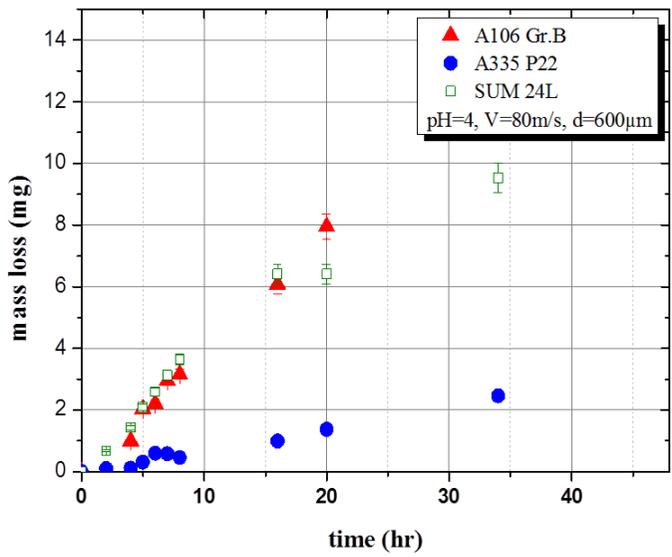
Figure 5.7 Initiation stage of LDIE damage-dependence of sulfur contents

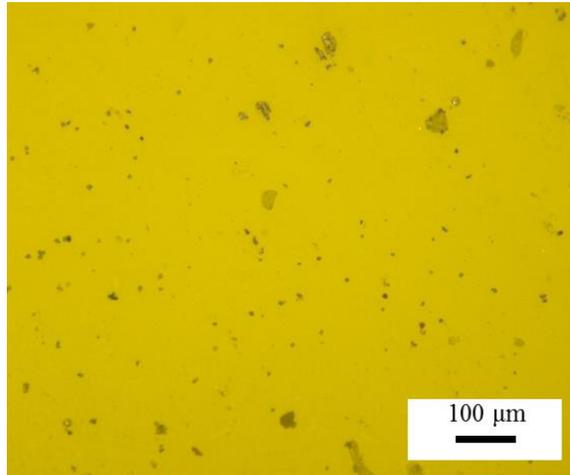
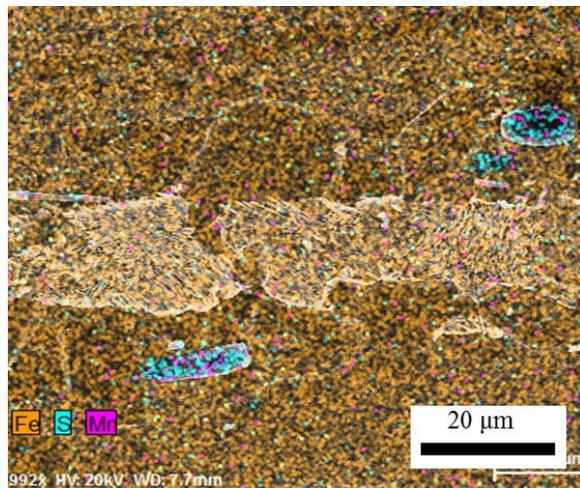
Figure 5.8 Sulfur rich area obtained by (a) sulfur print for A106 Gr.B, and (b) EDS for SUM24L.

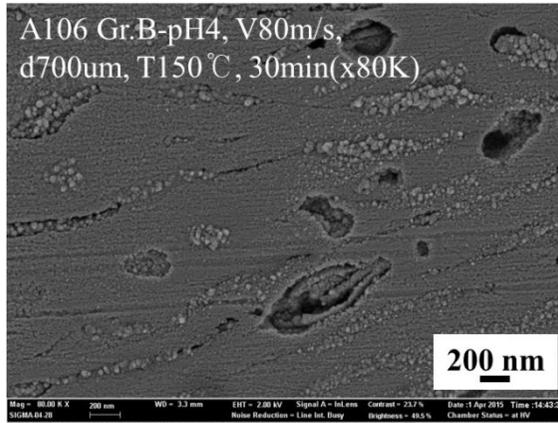
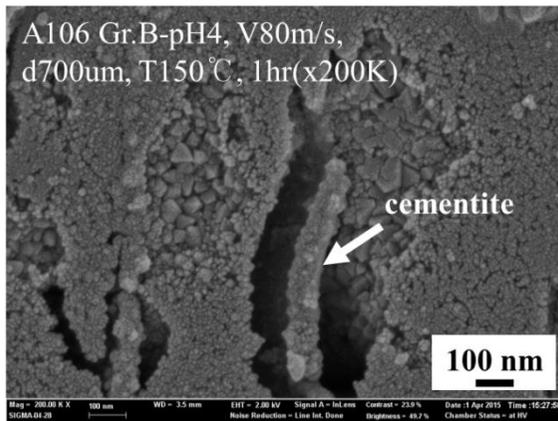
Figure 6.1 Initiation of LDIE damage(A106 Gr.B, pH 4, droplet velocity 80 m/s, droplet diameter 700 μm)-(a) cavities due to iron dissolution on pearlite, (b) the lamellar structure of cementite layers.

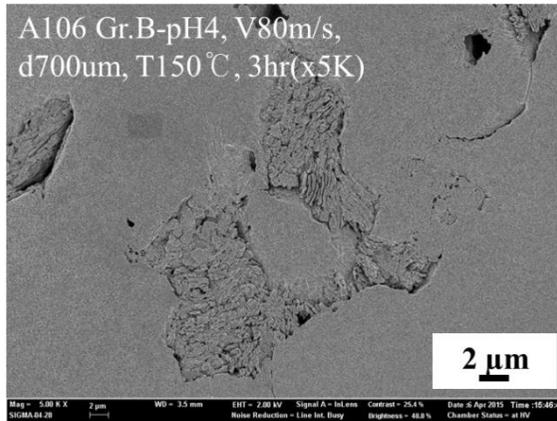
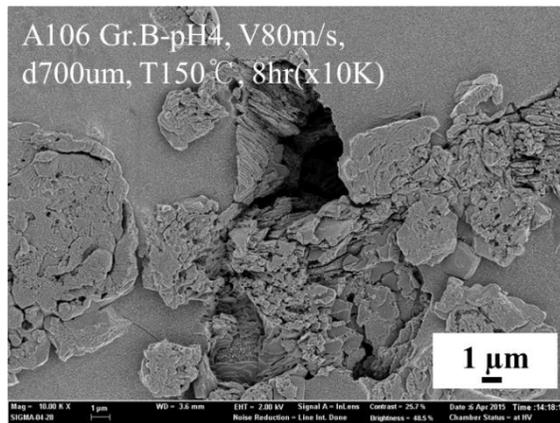
Figure 6.2 Initiation of damage(A106 Gr.B, pH 4, droplet velocity 80 m/s, droplet diameter 700 μm)-(a) pearlite corrosion and revealed grain boundary, (b) ferrite-pearlite grain boundary damage.

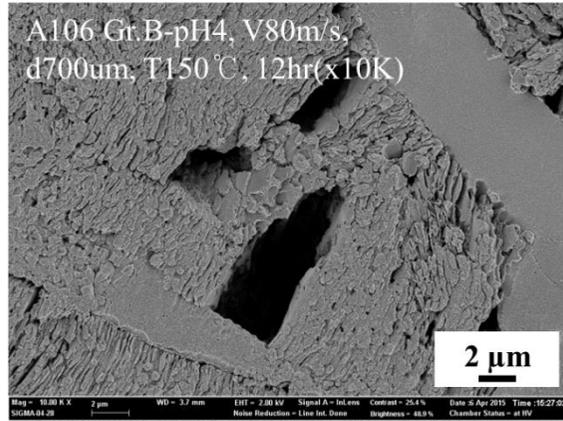
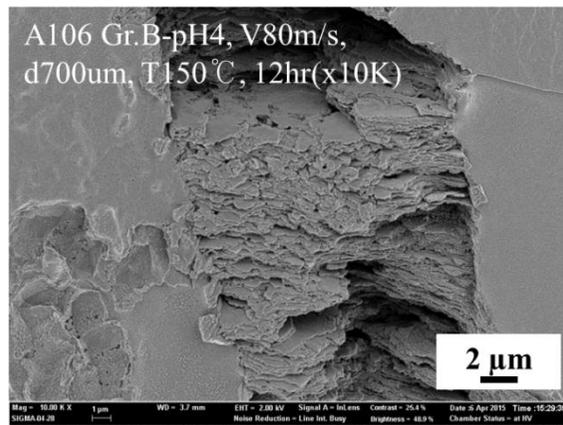
Figure 6.3 Local damage initiation(A106 Gr.B, pH 4, droplet velocity 80 m/s, droplet diameter 700 μ m)-(a) chunks of pearlite fell out of a pearlite region, (b) the lamellar structure teared by impinging droplets.

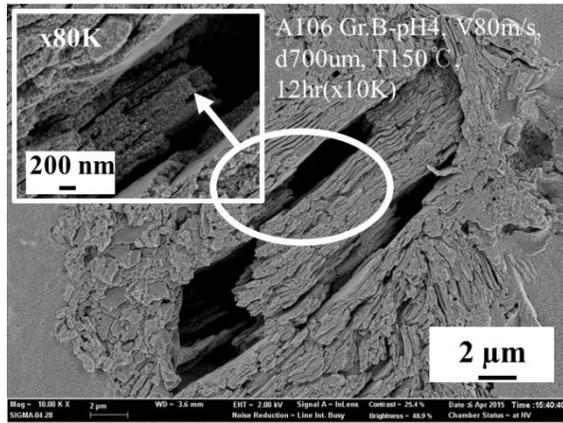
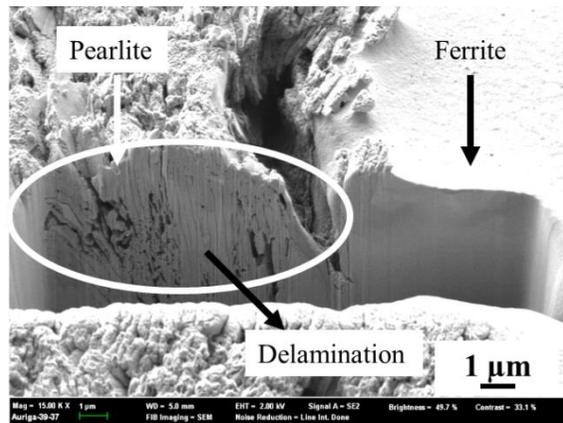
Figure 6.4 Local damage initiation(A106 Gr.B, pH 4, droplet velocity 80 m/s, droplet diameter 700 μm)-(a) damage path into the pearlite, (b) delamination of pearlite and ferrite-pearlite boundary damage (FIB).

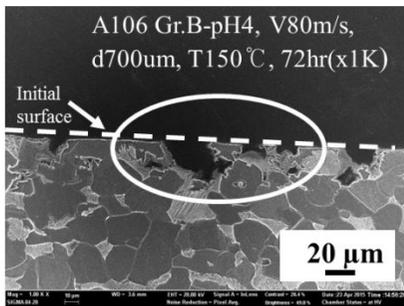
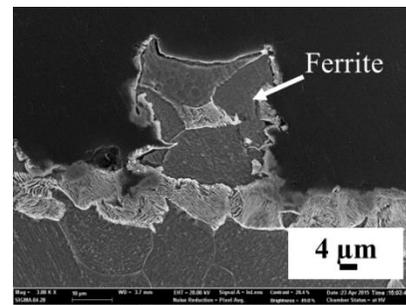
Figure 6.5 Cross-sectional investigation of the damaged specimen during transition period.

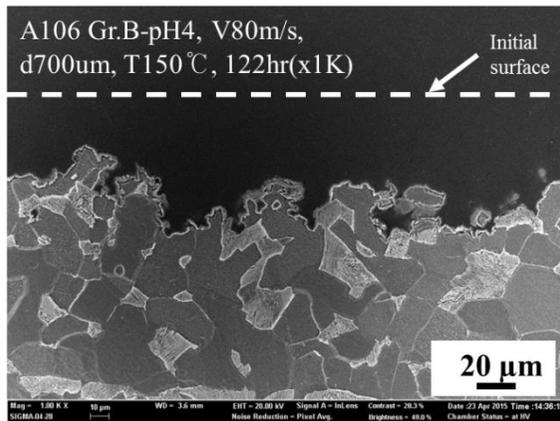
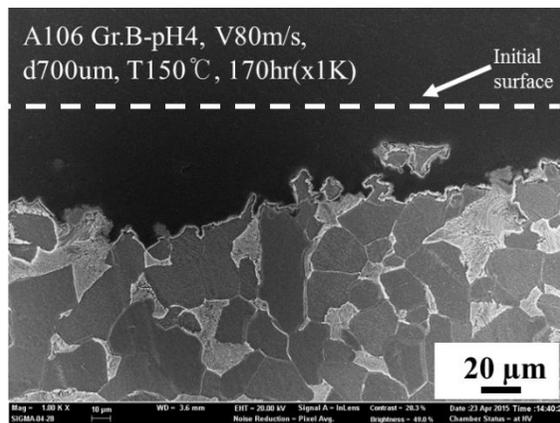
Figure 6.6 Cross-sectional investigation of the damaged specimen during stable-loss period.

When the original surface has been removed, the morphology can be shown as Figure 6.6. In this case, about 120 hours of exposure in LDIE test is sufficient to remove original surface grains and reveal rough surface by damages on the surface. The damaged surface was roughened and the evidence of removal process has been shown in the chips which are between the epoxy resin and the damaged surface. The chips are lumps of ferrite which can be easily removed by impinged droplets. In this stage, the material mass loss is drastically increases. It means the damage mechanism is governed by mechanical erosion process.

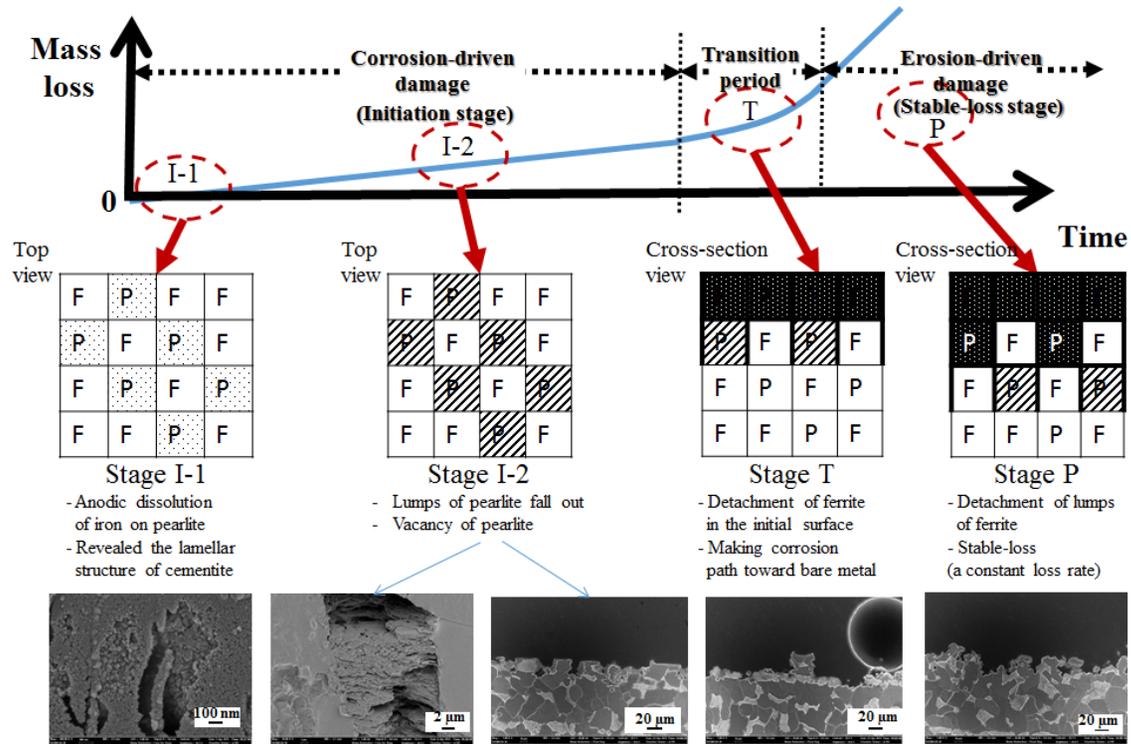
Figure 6.7 The schematic of sequence of events and damage mechanism.

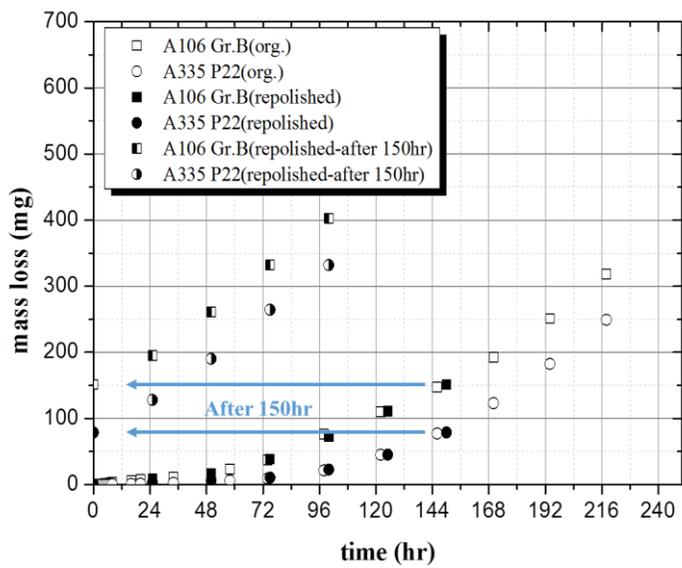
Figure 6.8 Reproducibility by a re-polish test.

To test the reproducibility of the LDIE damage mechanism and the mass loss rate, selected specimens that had undergone different stages were re-polished specimen and tested again at the same conditions as the original tests. Figure 6.8 shows the re-test results confirming the reproducibility and consistency of the damage process. Therefore, the suggested mechanism and the features of the mass loss rate are suggested as the fundamental nature of the LDIE damage process.

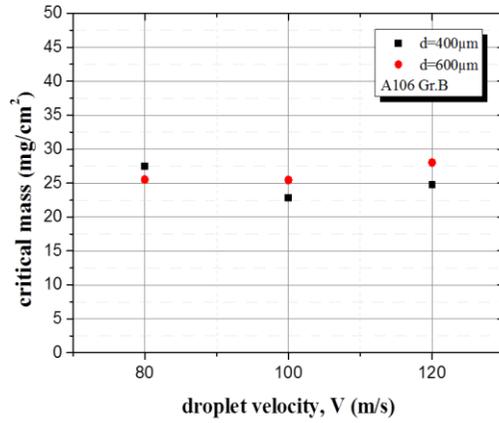
Figure 7.1 Critical mass loss-(a) critical mass for A106 Gr.B(black square for 400 micrometer-droplet size, red circle for 600 micrometer-droplet size), (b) critical mass for A335 P22(black square for 400 micrometer-droplet size, red circle for 600 micrometer-droplet size).
