공학박사 학위논문

**Liquid Droplet Impingement
Erosion Mechanism of Low-Alloy
Steels in the Secondary Side of
Pressurized Water Reactors**

서울대학교 대학원

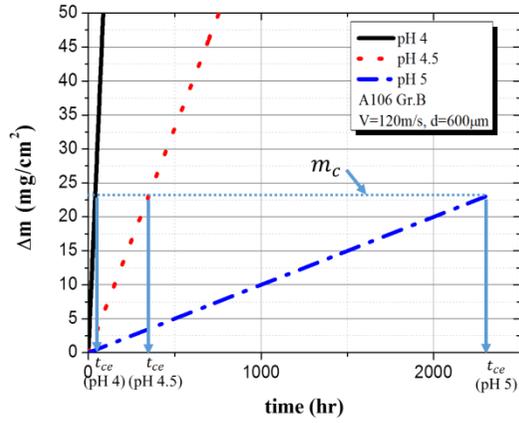
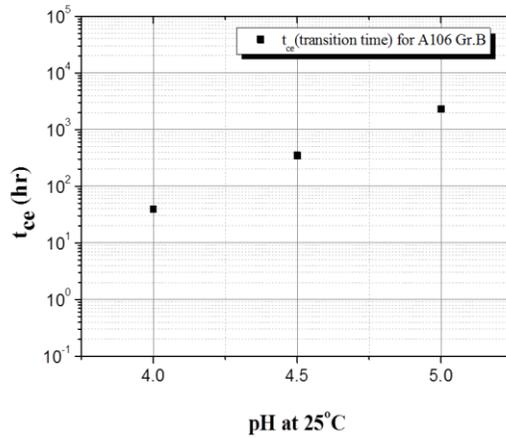
Figure 7.2 Calculated transition time-(a) transition time as determined by the critical mass, (b) transition time as a function of pH.

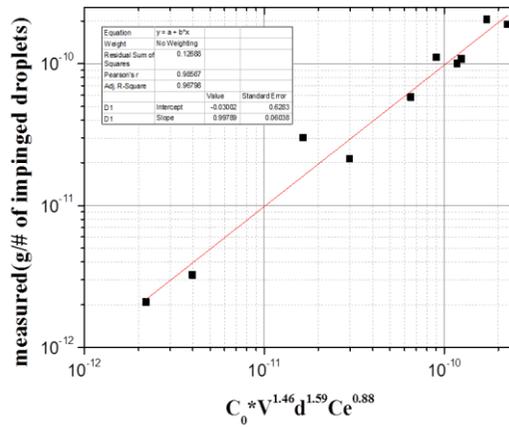
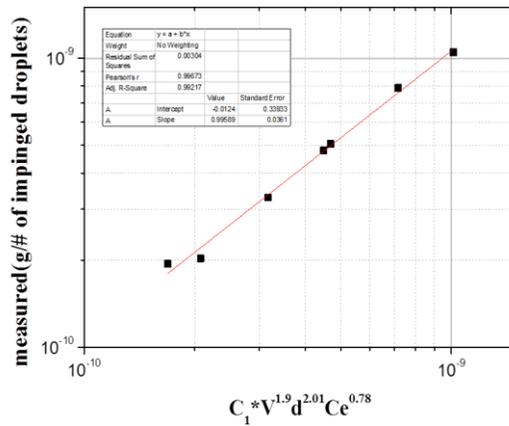
Figure 7.3 Regression results and relationship between the mass loss rate and the key LDIE factors including the magnetite solubility C_e , the droplet velocity, V and the droplet diameter, d -(a) initiation stage, (b) stable-loss stage(after transition time).

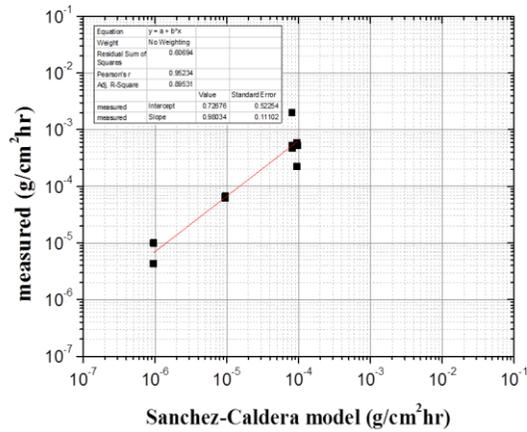
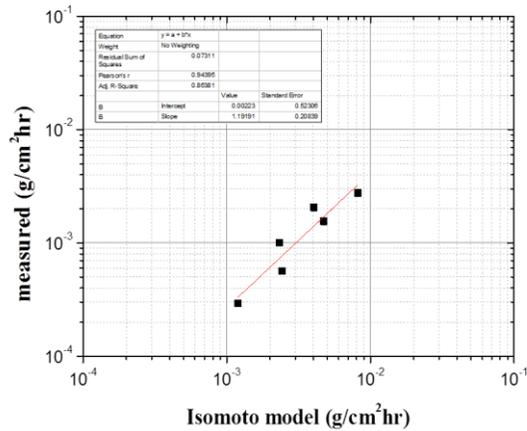
Figure 7.4 Comparison of measured data and the Sanchez-Caldera model(for A106 Gr.B)- (a) initiation stage, (b) stable-loss stage(after transition time).

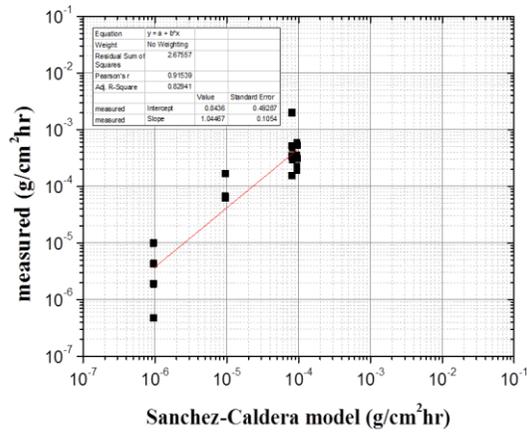
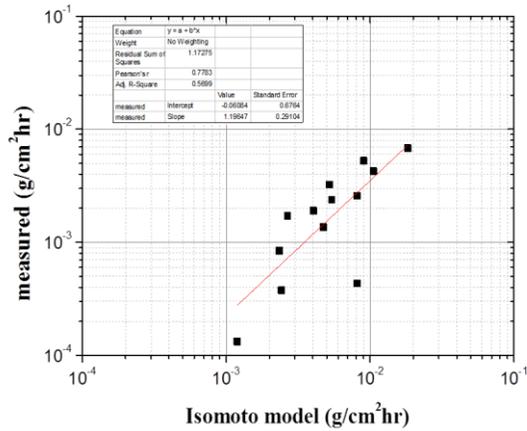
Figure 7.5 Comparison of measured data and the Sanchez-Caldera model for all test materials including A106 Gr.B, A335P22, and SUM24L -(a) initiation stage, (b) stable-loss stage(after transition time).

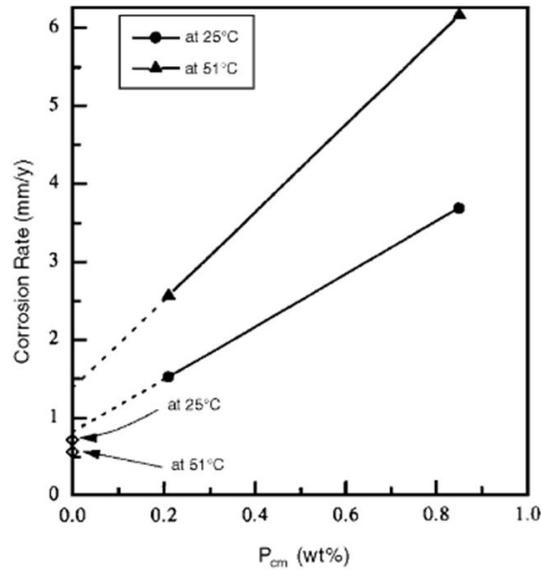
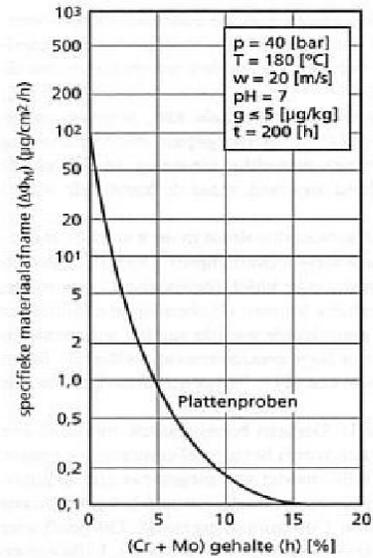
Figure 7.6 Material dependence of corrosion rate-(a) corrosion rate as a function of carbon content in steels[74], (b) Influence of Cr+Mo content on erosion-corrosion according to the experiments of KWU[43].

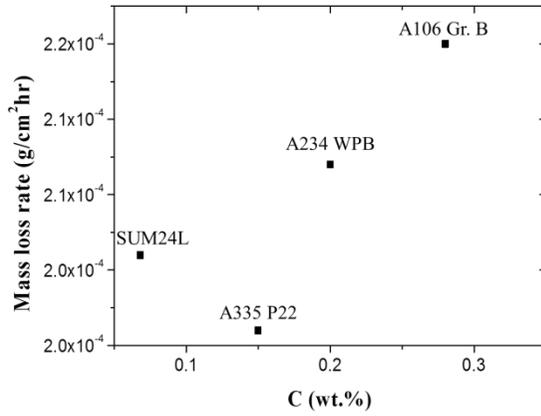
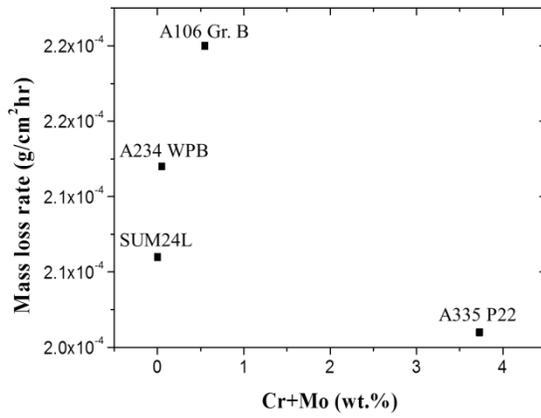
Figure 7.7 Mass loss rate of LAS as a function of alloying contents-(a) carbon contents, (b) Cr and Mo contents.

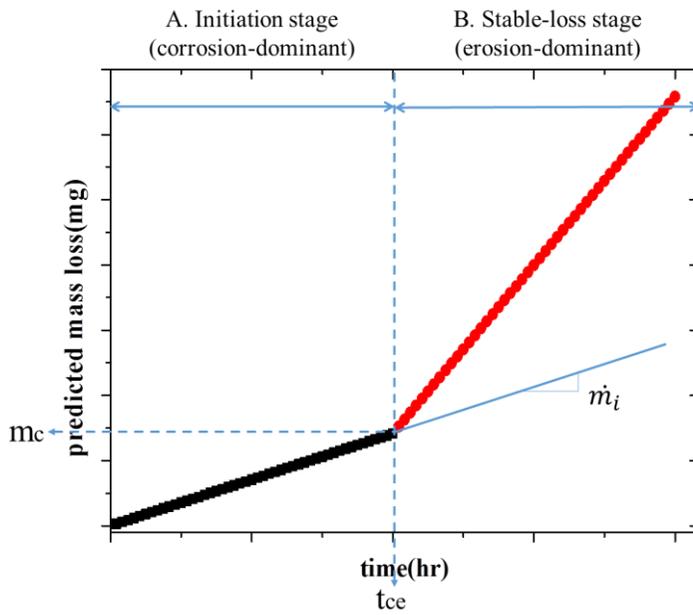
Figure 7.8 The schematic of developed model which is a bi-linear model including the corrosion-dominant initiation stage and the erosion-dominant stable-loss stage.

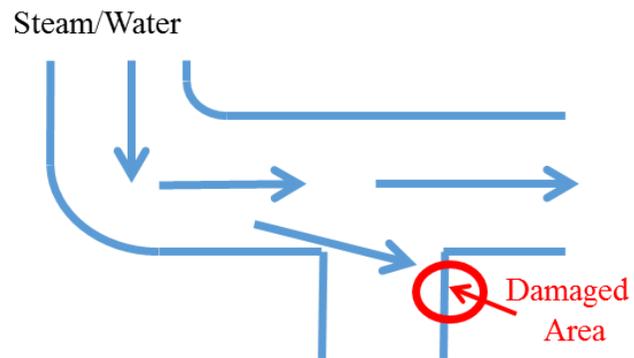
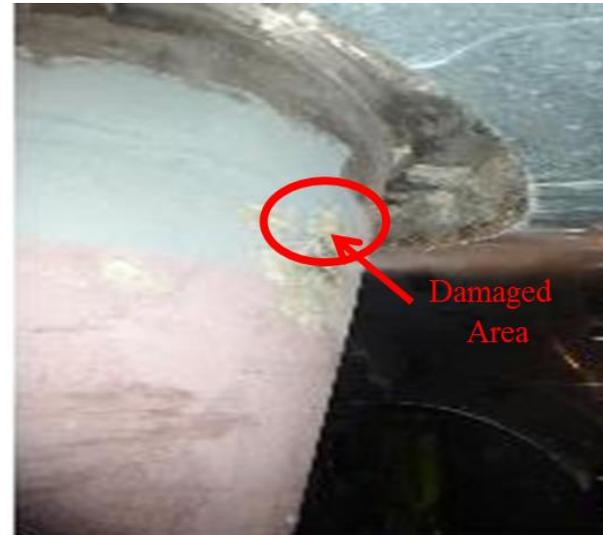
Damaged section: a line from HP turbine to MSR (48" pipe to 20" pipe)

Figure 7.9 Field failure case-(a) schematic of the damaged section, (b) photograph of the damaged area[4].

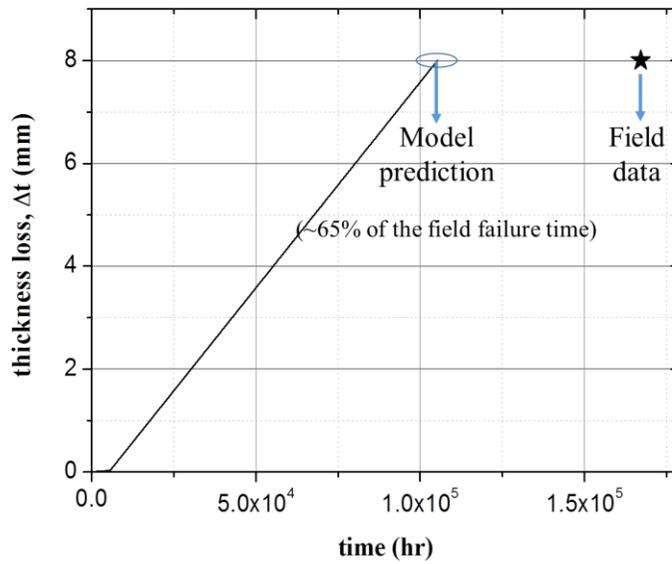
Figure 7.10 Comparison of the failure time and the model prediction result that is equal to 65%(about 12 yrs.) of the field failure time.

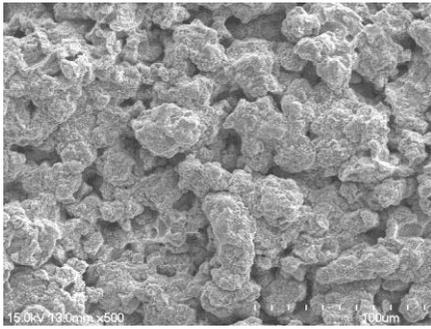
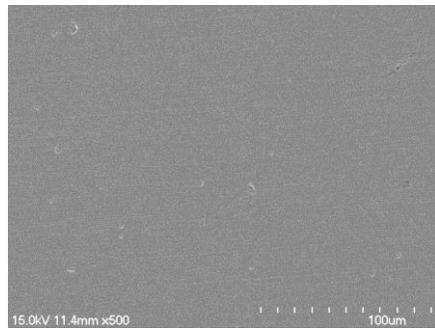
Figure A2. 1 SEM images for damaged specimens(Ex.1,2,3).

To investigate damage mechanism of LDIE, micro- and nano-structural analysis has been examined. Optical microscope, Normal SEM, FE-SEM, and FIB were adopted to clarify the details of damage mechanisms. The key factors influencing the LDIE damage rate have been identified as pH, droplet velocity, and droplet size. As shown in Table 4.2, the LDIE tests have been examined. From Figure A2.1 and Figure A2.2, it has been shown that the LDIE damage can be deepened in relatively lower pH conditions.

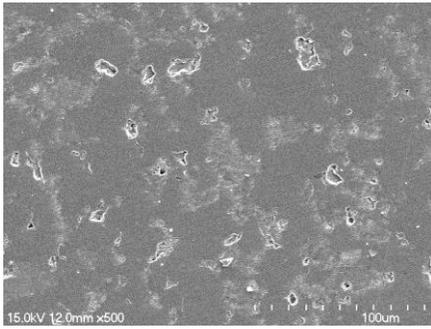
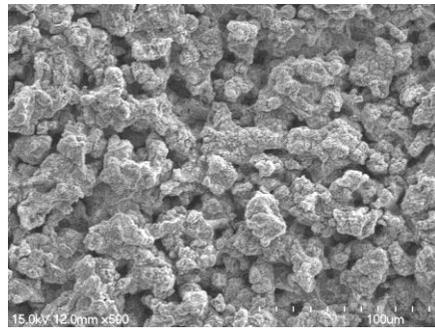
Figure A2. 2 SEM images for damaged specimens(Ex-4,6,10).
