공학석사 학위논문

RC Column Retrofit with Ultra High Performance Concrete

초고성능 콘크리트를 이용한 기둥 보강 연구

서울대학교 대학원

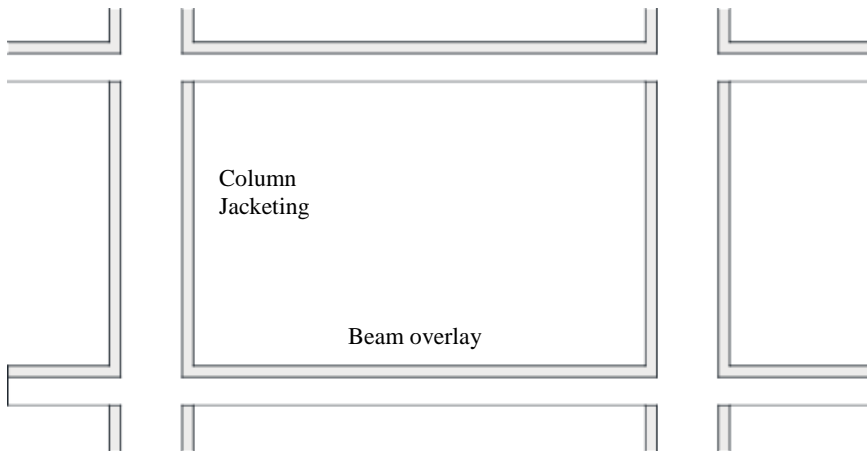
Fig. 1-1 Prototype of UHPC retrofit for an existing RC frame

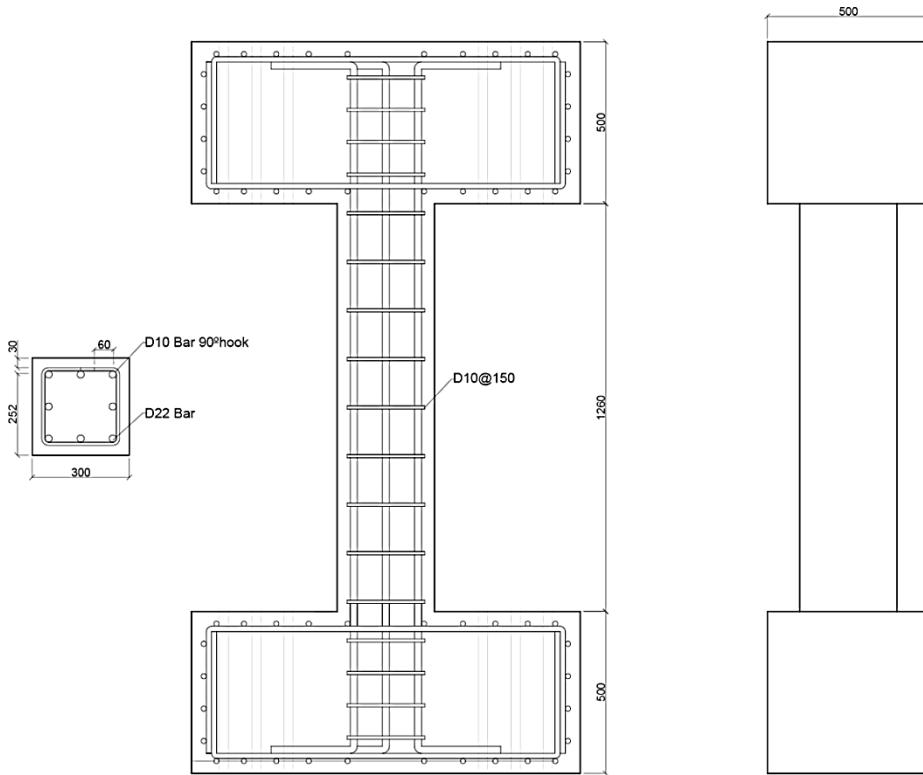
Fig. 3-1 Geometry of RC column

Four identical RC column specimens were manufactured in half scale. The dimensions adopted for the column cross section and height were 300×300mm and 1260mm, respectively. The corresponding span to depth ratio is 4.15. The longitudinal reinforcement consisted of eight 22mm diameter bars and corresponding reinforcement ratio is 3.44%. These relatively small span to depth ratio and large reinforcement ratio were intended to make a shear failure mode both in before and after retrofitting, in order to make it clear to define shear strength of specimens. The transverse reinforcement comprised of 10mm diameter stirrups with 150mm spacing.

The column has 500×500mm foundations at both upper and lower stubs to have double curvature experiment. Detail geometres and material properites of the RC column are described in Fig. 3-1 and Table 3-1.

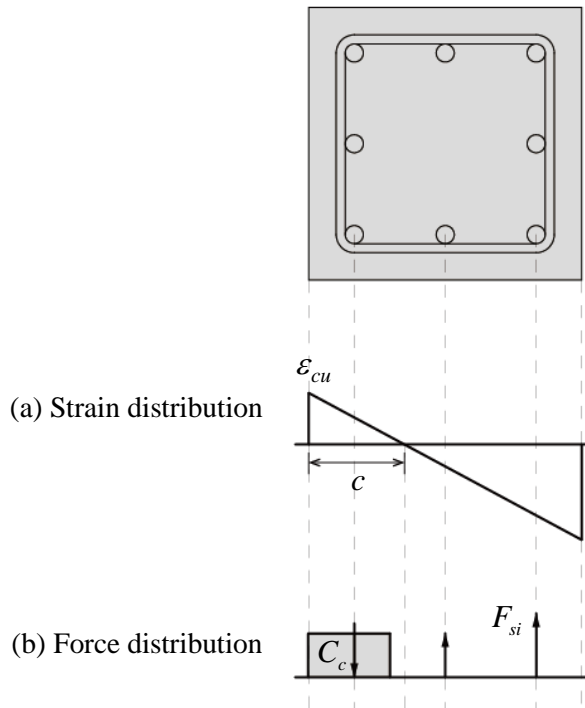
The nominal moment capacity of the target column can be estimated using strain compatibility solution. This process starts with assuming linear strain distribution among the whole section and setting the value of the strain of extreme compressive fiber, $\epsilon_{cu} = 0.003$. With a stress-strain relationship of materials, the stress distribution and corresponding net normal force and moment can be calculated. The process is briefly described in Fig. 3-2. The iteration of this process while varying the neutral axis location, gives the P-M interation diagram. Fig. 3-3 shows the resultant P-M interation diagram for this RC section. Herein, any strength reduction factor was not considered.

Fig. 3-2 Strain compatibility solution

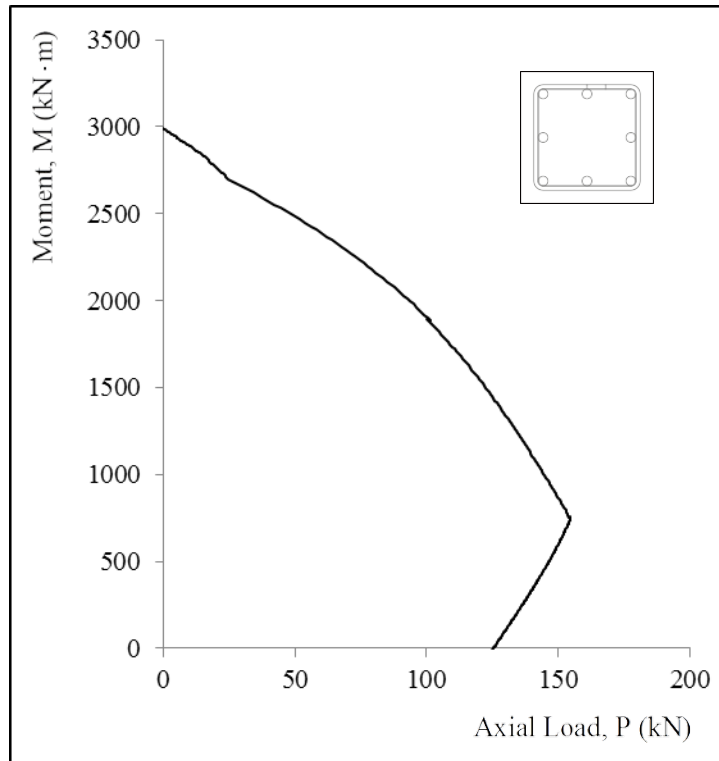
Fig. 3-3 P-M interaction diagram for the target RC column

From the equation (22), the P-M interaction diagram of Fig. 3-3 can be transformed to P-V interaction diagram, as shown in solid line of Fig. 3-4.

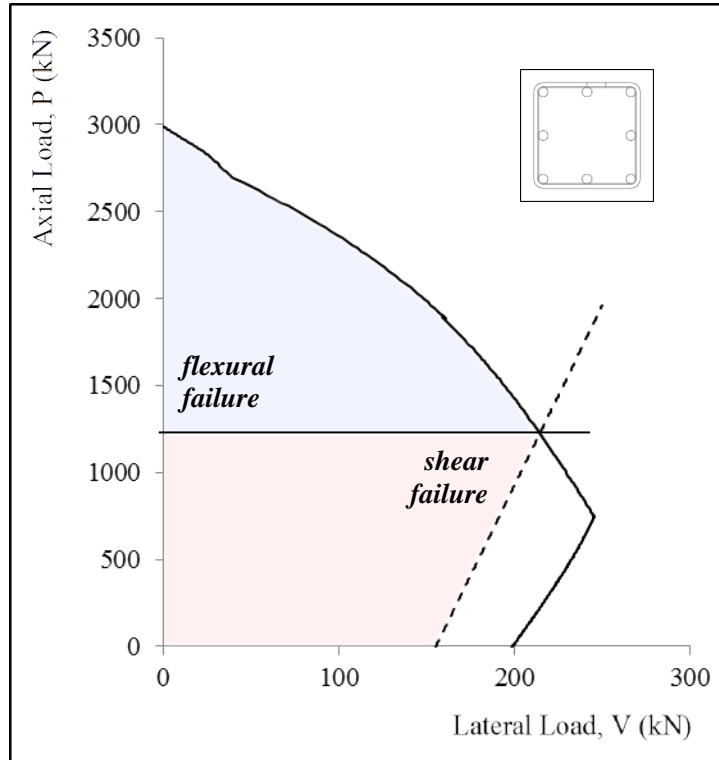
The resultant shear strength with respect to axial load, P is plotted with dotted line in Fig. 3-4. This graph shows that the column would be governed by shear failure at lower axial load and by flexural failure at higher axial load. The axial load in this experiment was $0.3A_g f'_c$ so that the target column would fail in flexural failure.

Fig. 3-4 P-V interaction diagram for the target RC column

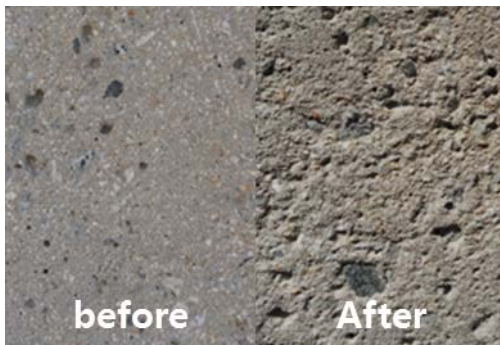
Fig. 3-5 Surface before/after sandblast

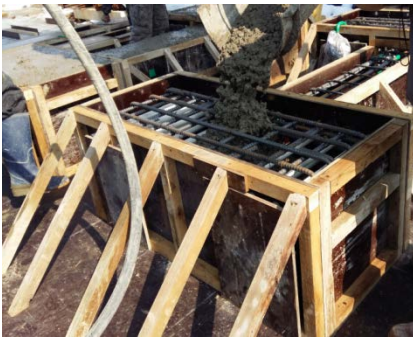
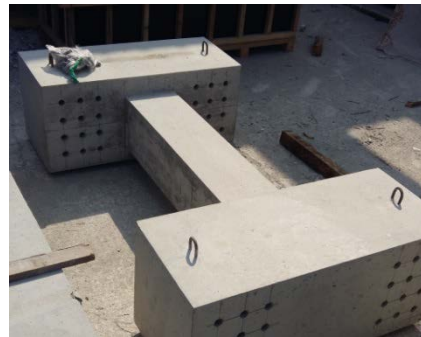
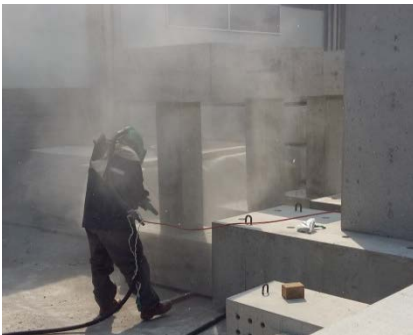
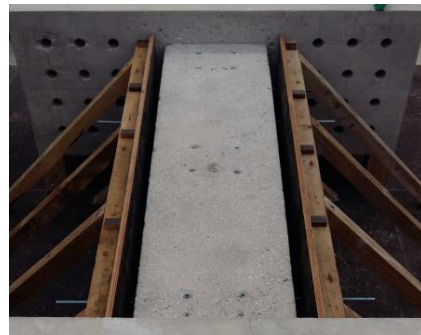
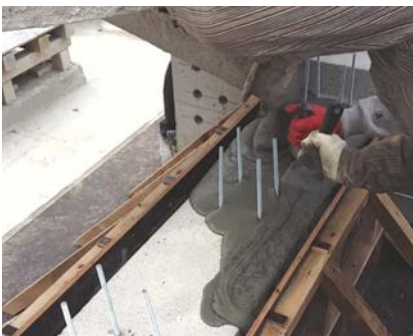
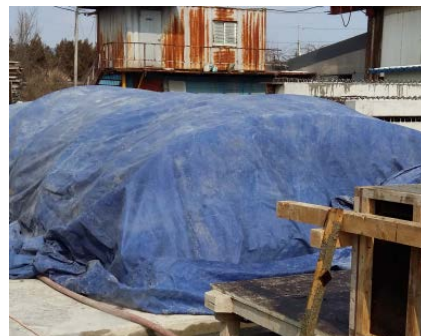
(c) Concrete placing

(d) Disassemble formwork

(e) sandblasting

(f) jacking formwork

(g) placing UHPC

(h) steam curing

Fig. 3-7 Manufacturing process of test specimens

Then, the jacketing forms were installed for R-30 and R-50. For the convenience in UHPC pouring, the formwork were made lied down(Fig. 3-7 (f)). UHPC was mixed on the place and poured onto core column (Fig. 3-7 (g)). Fig. 3-7 shows that the slump test result of the UHPC was about 600mm, which shows high fluidity of the UHPC. After pouring, UHPC was cured in hot steams about 90°C for 72 hours(Fig. 3-7 (h)).

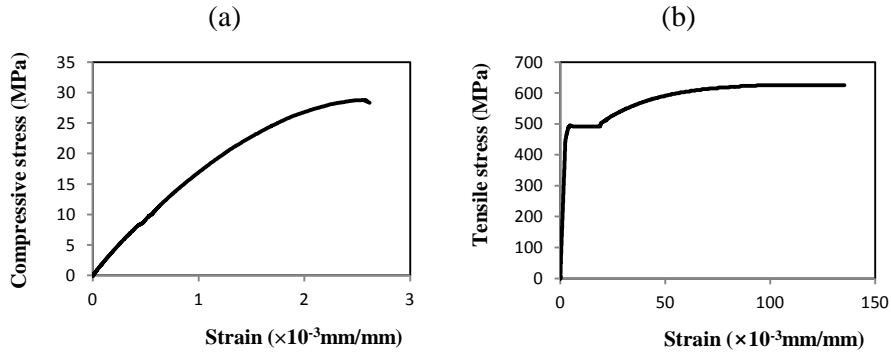
Fig. 3-8 Material properties of RC columns and additional reinforcements
a) Compressive stress-strain curve of concrete, b) Tensile stress-strain curve of SD400 D22

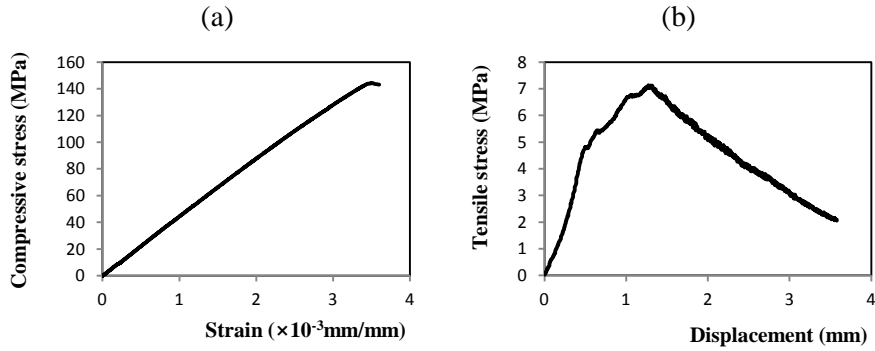
Fig. 3-9 UHPC material test results:

a) Compressive stress-strain curve, b) Tensile stress-displacement curve.

Compression test for UHPC was carried out in the same way for normal concrete. Its compressive strength came out to be 144MPa and maximum strain was about 0.004. The tensile strength was estimated to be 6.4MPa and tensile cracking strength was 4.9MPa.

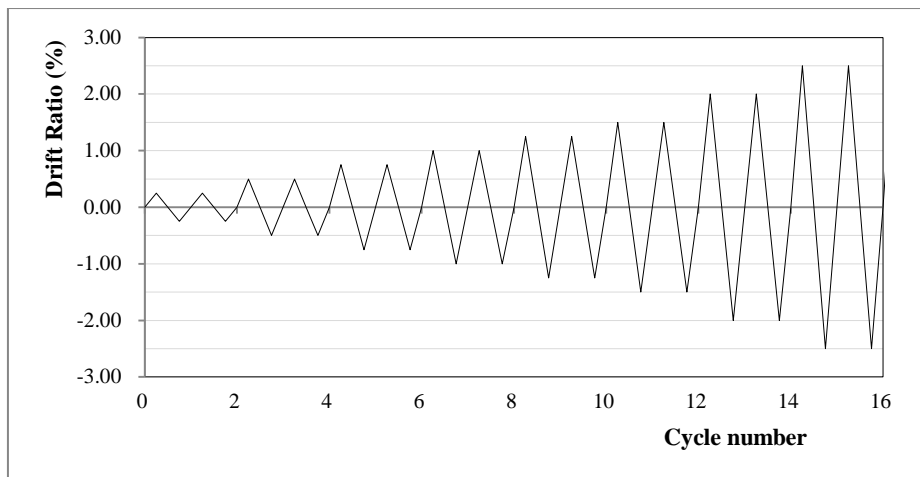
Fig. 3-10 Lateral loading protocol

The four tests were conducted in the same set-up as presented in Fig. 3-11. Initial constant axial load of $P = 0.3f'_c A_g$ was applied to column by two 100ton oil jacks and then, displacement controlled horizontal cyclic load V was applied by a 200ton actuator. The amplitude of imposed displacement of the first cycle was 3mm and increased by 3mm for every additional cycle up to 15mm, and thereafter increased by 6mm.

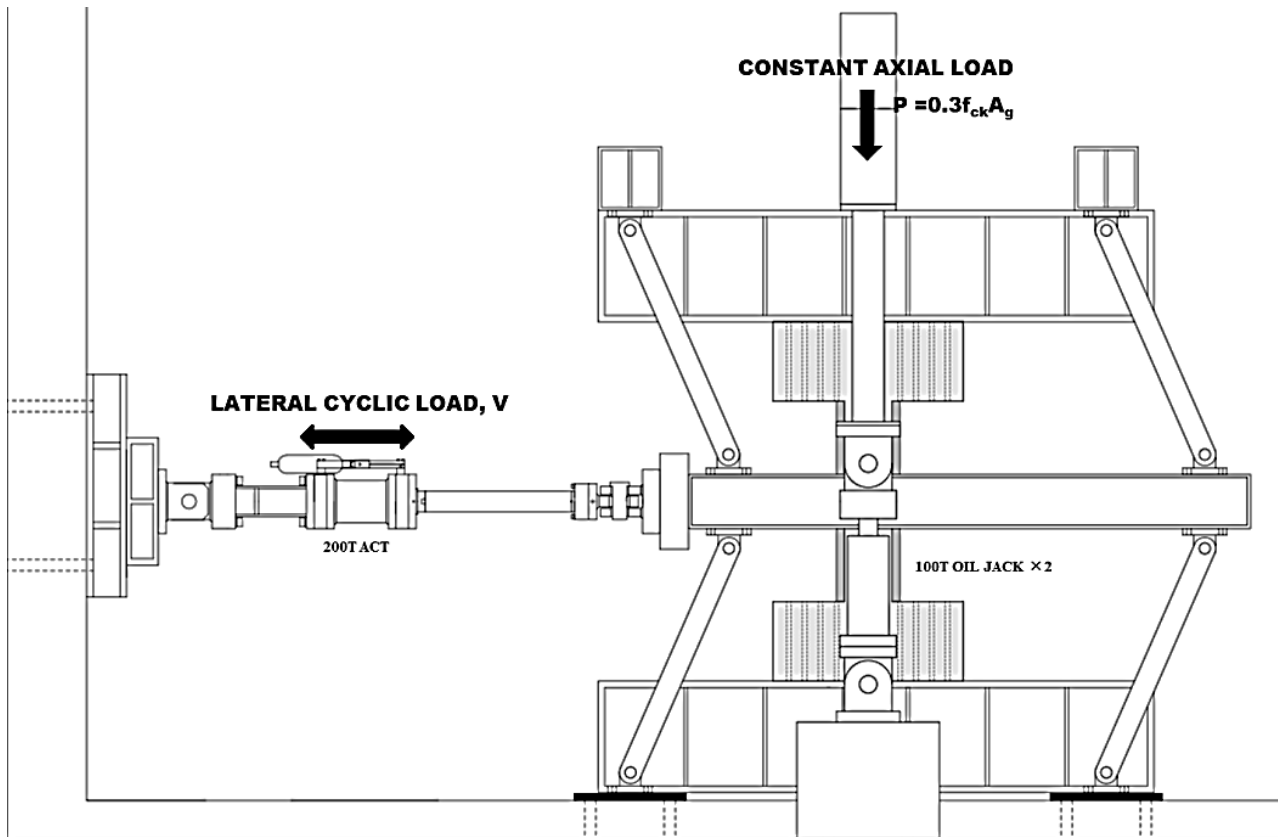
Fig. 3-11 Test set-up

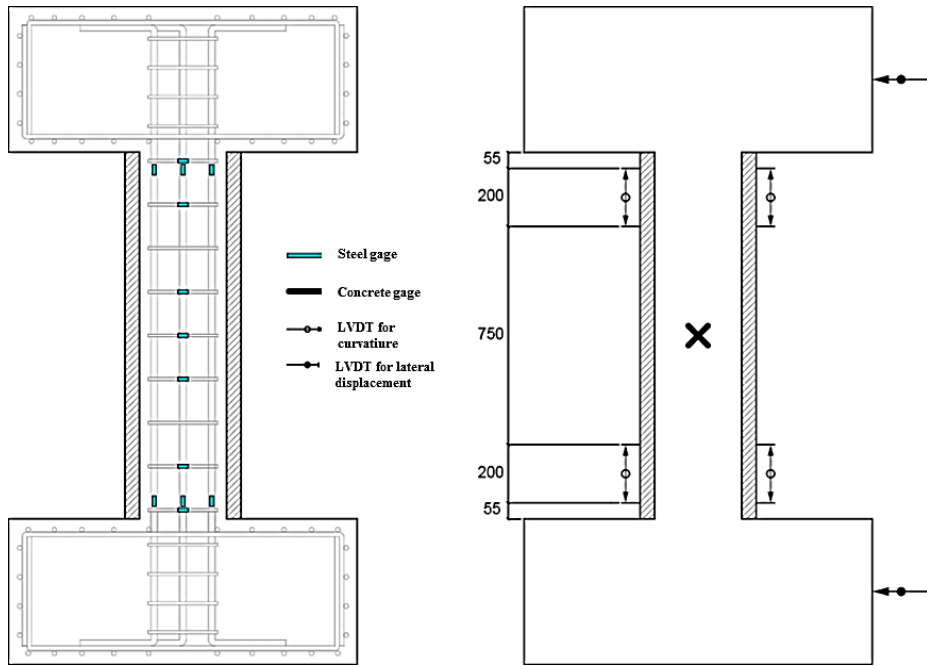
Fig. 3-12 Measurement set-up

Steel gauges were attached to the main longitudinal bars at both ends of the columns to measure the flexural curvature and yield point of the members. Steel gauges for stirrup bars were attached at the points where shear failure is expected. The shear deformation of the center part of the column was measured by attaching the concrete gauge in X shape. LVDT was installed in order to measure the flexural curvature of the end portion of the member where maximum flexural deformation is expected.

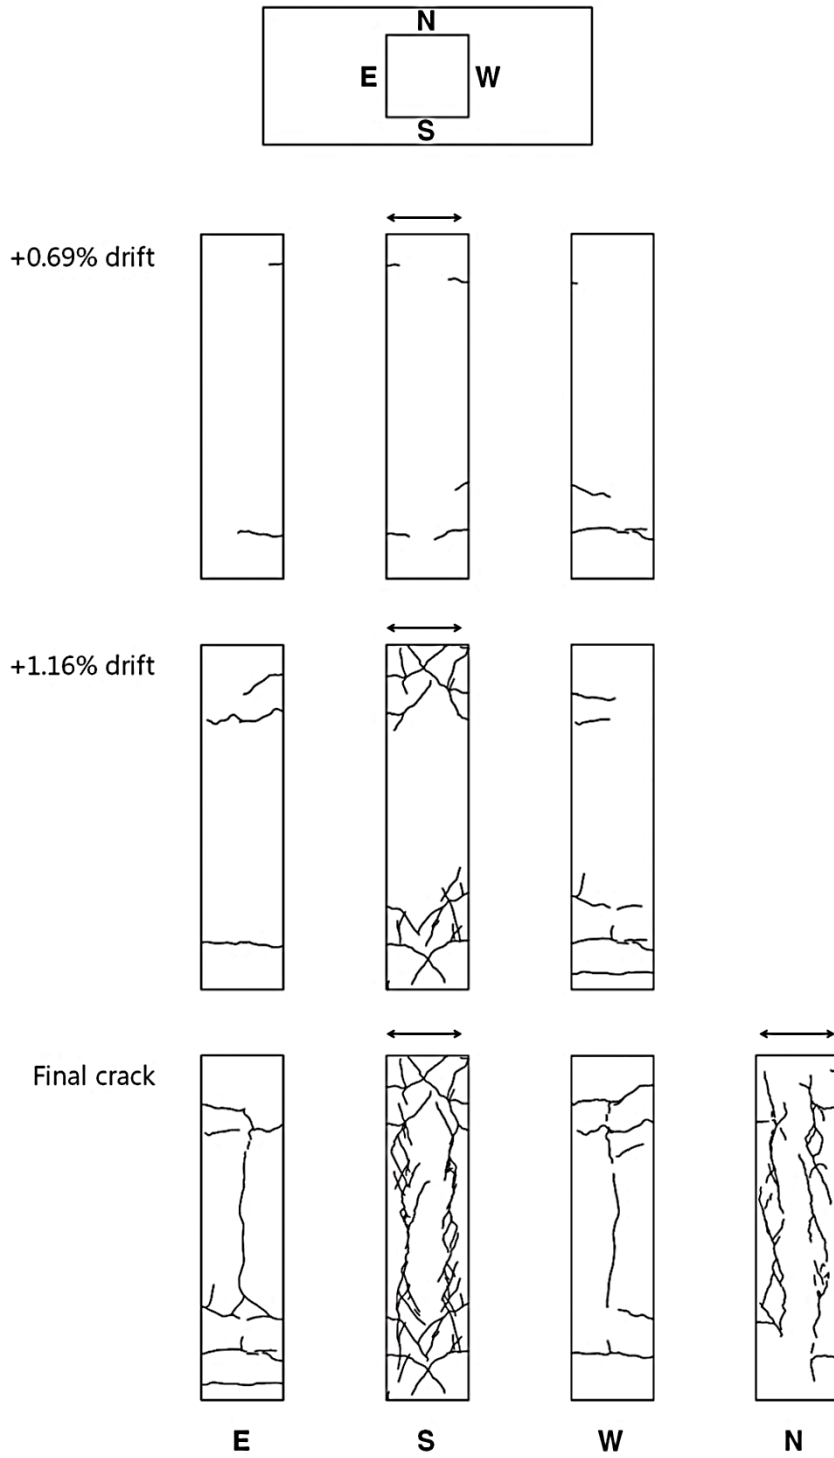
The crack patterns of the unretrofitted reference specimen R-0 during and after test are as shown in Fig. 3-13. The initial cracks occurred around the end of the column as flexural cracks at 0.46% drift ratio. These cracks spread as flexural - shear cracks until 0.92%. However, when the displacement reached 1.16%, vertical cracks occurred rather than flexural - shear cracks, which were dominant until the previous stage. Afterwards, the strength had dropped abruptly. The vertical cracks almost coincide with the position and direction of the longitudinal reinforcements. Therefore, it can be seen that the failure mode was a bond failure due to the separation between the rebars and concrete. This is not the originally intended shear failure mode. It is inferred that due to the excessive amount of longitudinal rebars in small cross section had led to this unexpected bond failure. Also, tight loading cycles might have influenced on the result.

Fig. 3-13 Crack pattern (R-0)

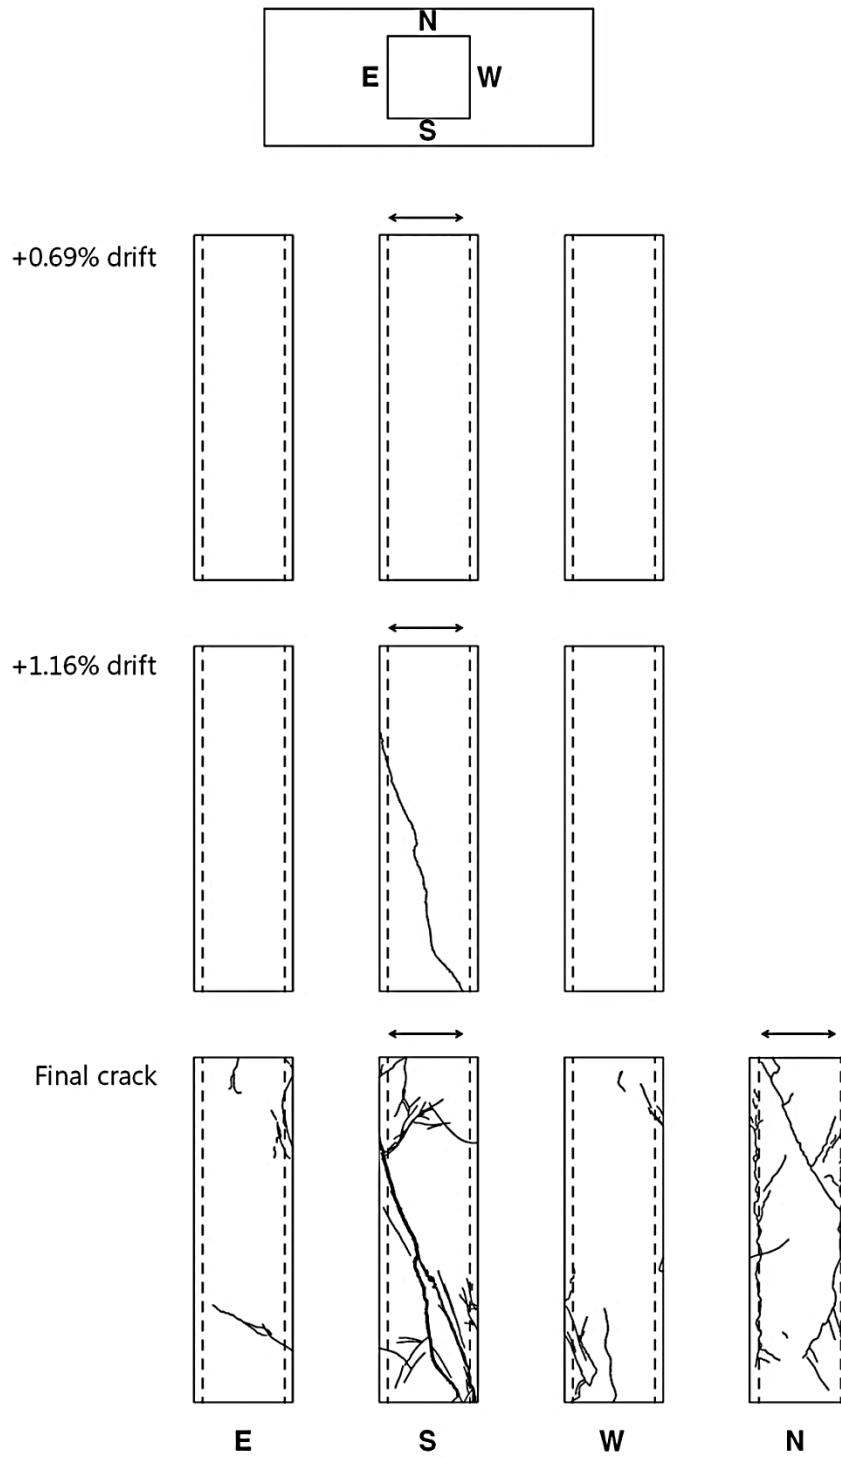
The crack patterns of the R3 specimen reinforced with UHPC of 30mm is described in Fig. 3-14. Owing to the crack control capability of the steel fiber, any cracks in the column surface did not occur until the drift ratio reaches 0.90%, except for the separation between UHPC jacket and end stubs. When the displacement increased to 1.16%, there occurred a large diagonal crack starting at column center. The strength was not immediately reduced right after the occurrence of the cracks. However, as following load was applied, the diagonal cracks were spread over while other small cracks occurred simultaneously. As the massive crack reaches around the pull-out length of the steel fiber, the UHPC jacket does not function and the strength decreased drastically.

Fig. 3-14 Crack pattern (R-30)

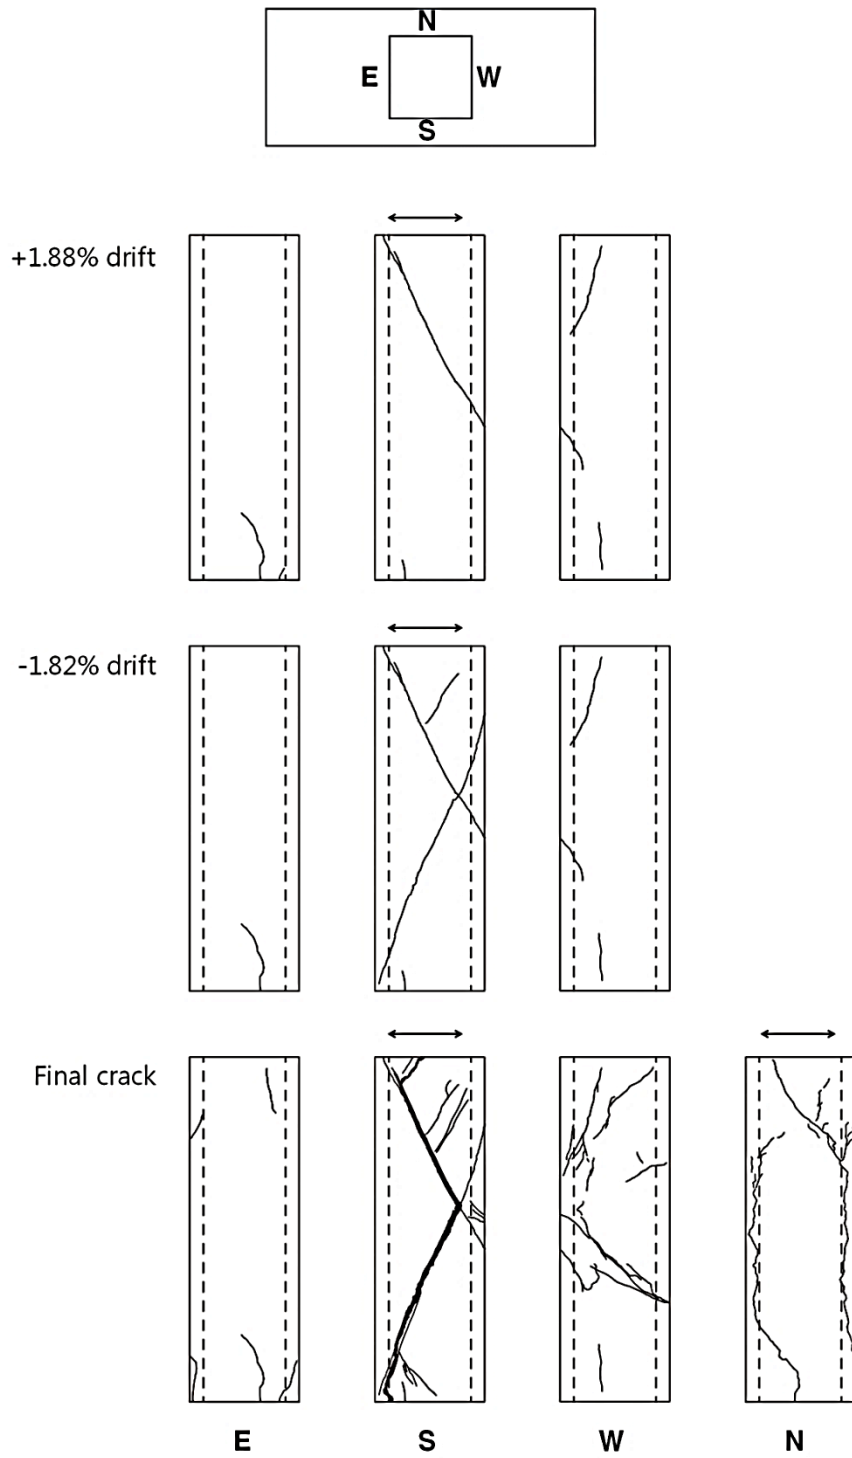
For R-50 specimens retrofitted with 50mm UHPC jacket, cracks patterns and the failure mode appeared similar to those of R-30. At the drift ratio of 1.78%, some vertical cracks occurred in the compression zone. Thereafter, when the drift increased up to 2.20%, large diagonal cracks occurred at the upper part of the column. In contrast to R-30, diagonal cracks occurred in both positive and negative directions. As the cracks of the diagonal cracks gradually spread, the steel fibers were observed to be pulled out or cut off from the UHPC matrices. It resulted in a sudden drop in lateral load capacity. It seems that when massive diagonal cracks opened, the UHPC jacket and the core column did not act as a unified section any more.

Fig. 3-15 Crack pattern (R-50)

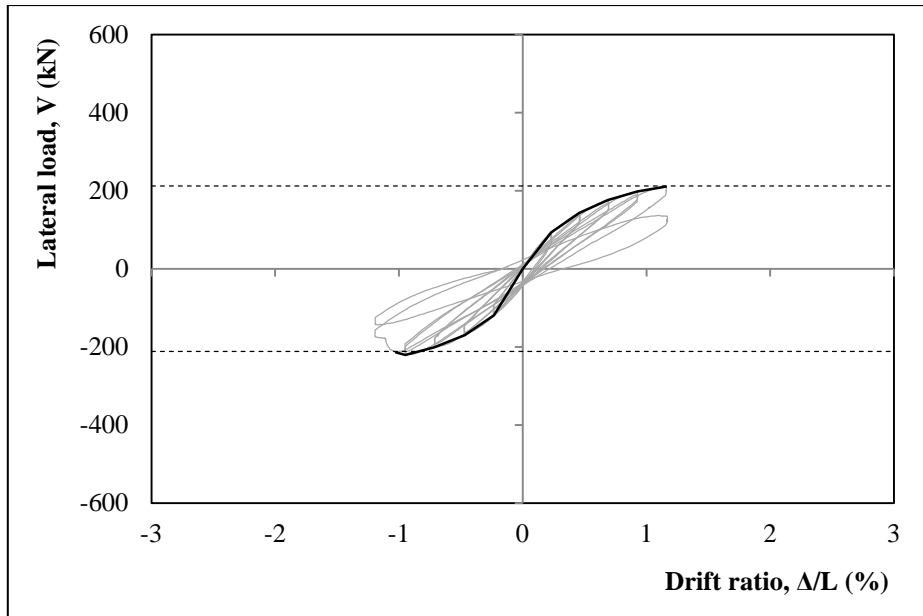
During the test, any rebars didn't reach the yield point. The maximum lateral load came out to be 210.4 kN and the maximum displacement was 1.16%. The resultant load-displacement curve is shown in Fig. 3-16

Fig. 3-16 Load-displacement curve (R-0)

By the process explained above, nominal shear strength of test specimens can be calculated. In Fig. 3-16 to Fig. 3-18, the dotted lines represent the theoretical nominal shear strength. The calculated nominal strengths, V_d were found to be a little bit higher than maximum experimental results. However, the differences are small and considering the strength reduction factor, they are within allowable levels.

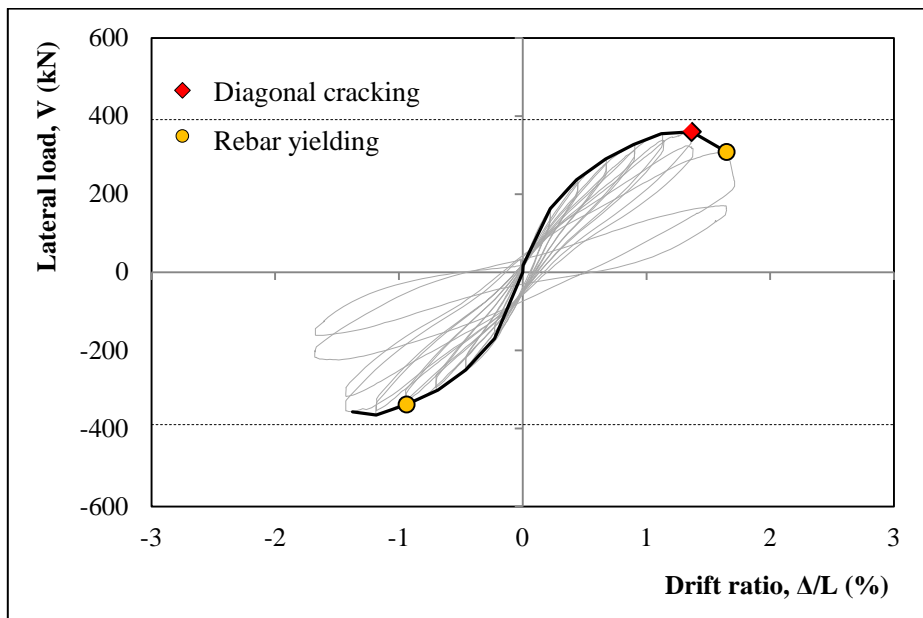
Fig. 3-17 Load-displacement curve (R-30)

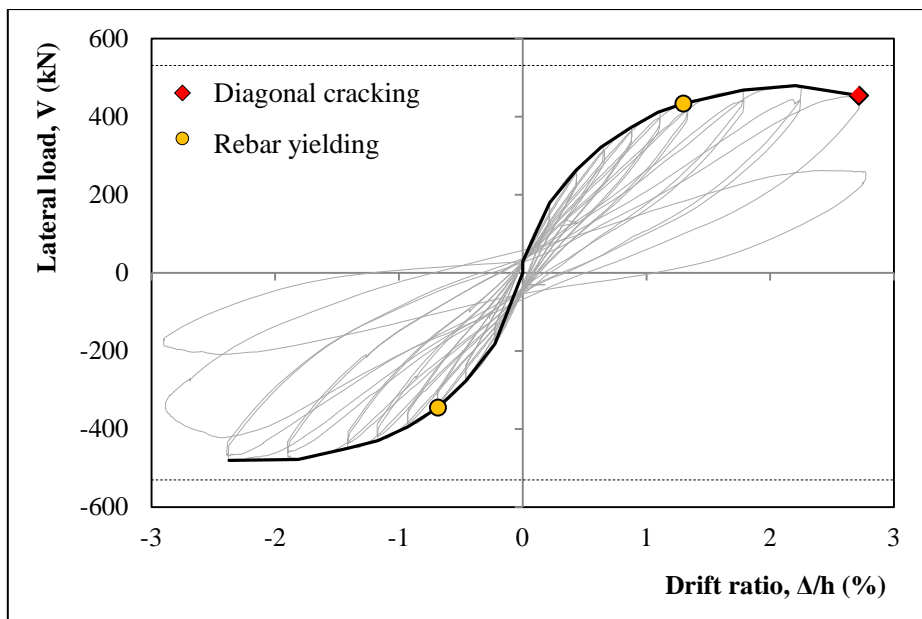
Fig. 3-18 Load-displacement curve (R-50)

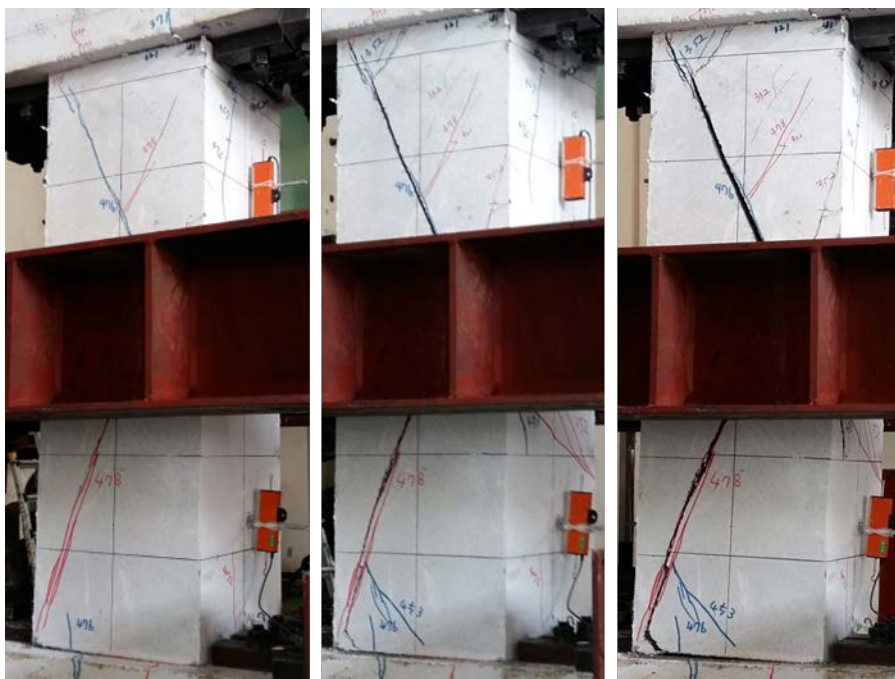
Fig. 3-19 Crack opening process

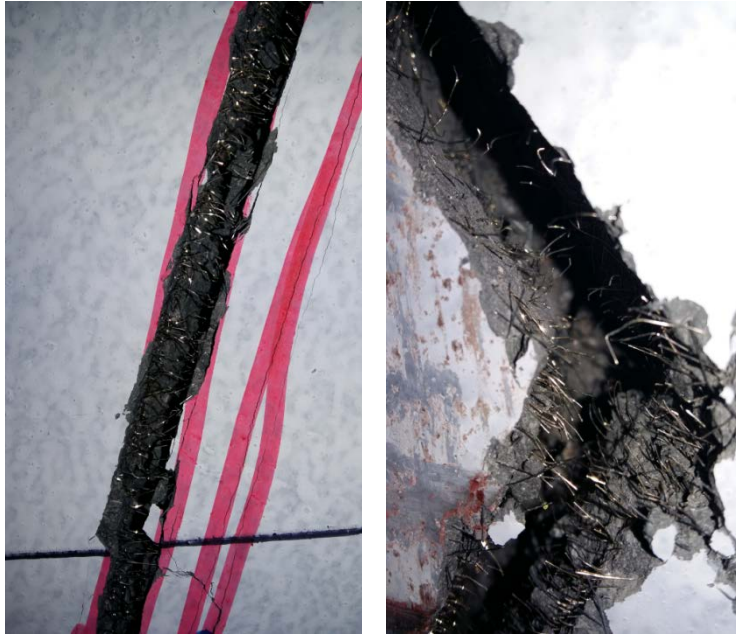
Fig. 3-20 extended image of diagonal crack

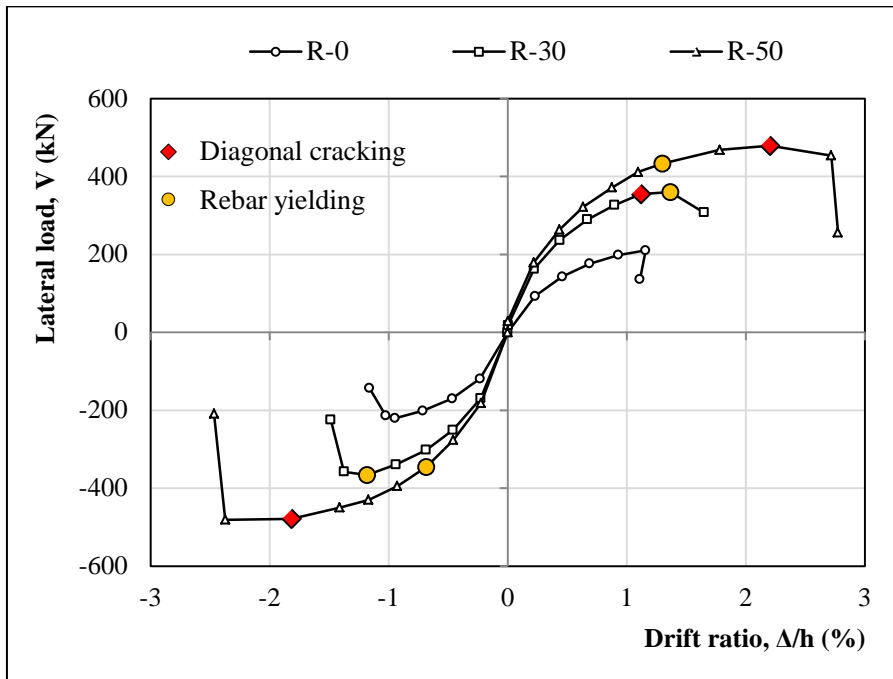
Compared with the R-0 specimen, the maximum load capacities of R-30 and R-50 increased about 71% and 128%, respectively. The maximum strain increased about 42% and 134%, respectively. Considering that the column area increased 44% and 78%, the increase in strength was almost proportional to the increase in area. However, the maximum displacement of R-50 was superior to that of R-30. This is because in R-50, the rebars has reached the yield points and R-30 has been fractured before yielding.

Fig. 3-21 Load-drift curve envelop

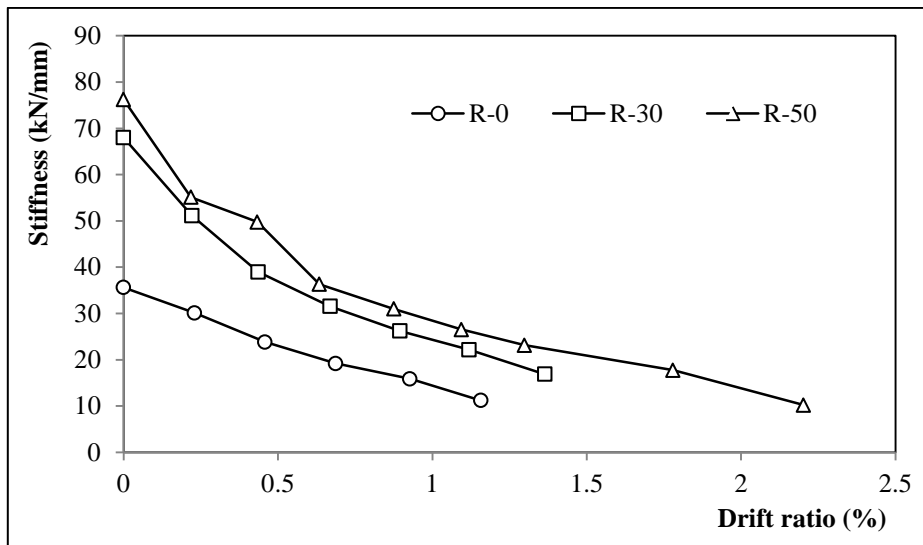
The initial stiffness of unreinforced specimen R0 was 35.6kN, R3 was 68.0 kN / mm, and R5 was 76.2 kN / mm. It was confirmed that the stiffness increased by 91% and 114%, respectively. The decrease of the stiffness due to the displacement was linearly decreased in the R0 case, but in the case of the reinforced specimen, the decrease width was relatively large at the initial stage and then decreased linearly thereafter. This is due to the fact that unlike R0, the reinforced specimens show prominent lifting at the joints. After the initial rapid decline, stiffness reduction was observed to be similar to R0. At this time, the stiffness of R3 and R5 increased by 69% and 100%, respectively.

Fig. 3-22 Stiffness against displacement envelopes

For each cycle, the point corresponding to 75% of the maximum value / additional force maximum strength is connected, and the stiffness is calculated from the drift by the slope, and the result is shown in Fig. 3-22.

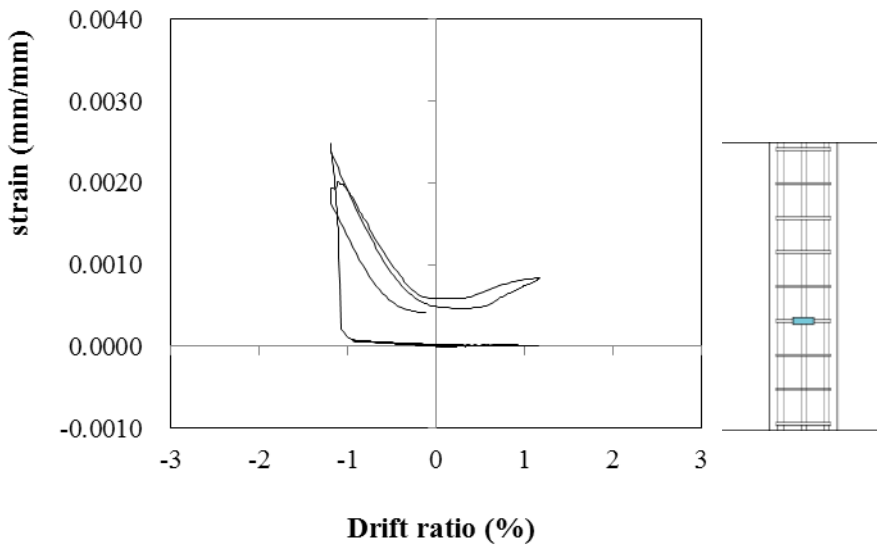
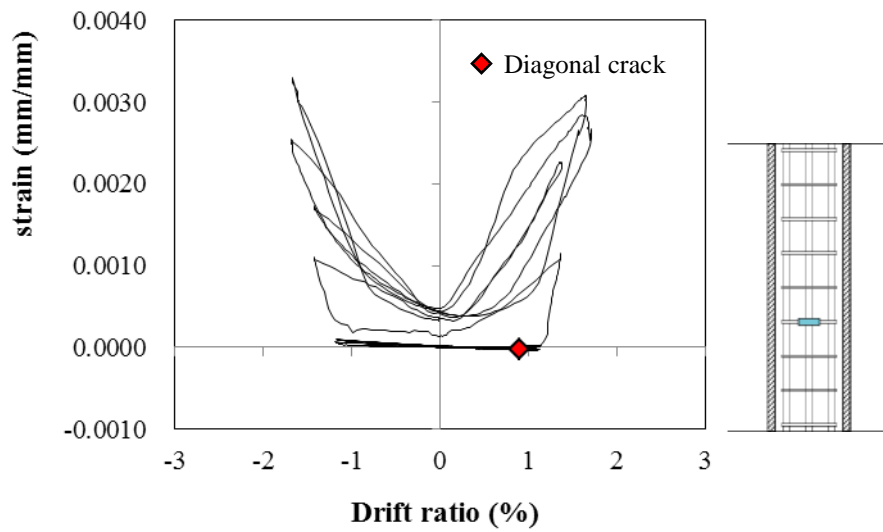
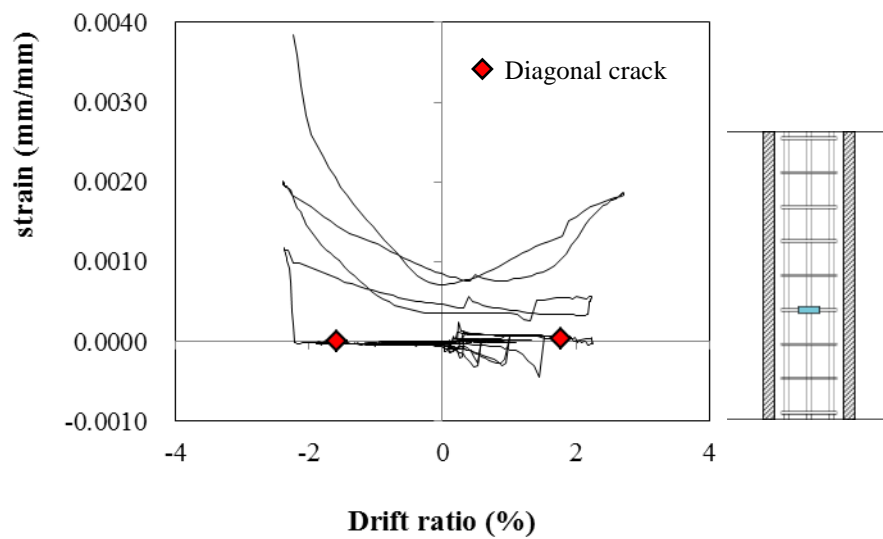
Fig. 3-23 (a), (b) and (c) show strains of stirrup bars that are located fourth from the bottom stub for R-0, R-30 and R-50, respectively. In R-0 specimen, the strain has kept in linear elastic state and suddenly went up at last cycle. This indicates that the column failed in very brittle manner. For R-30 and R-50 specimens, they showed similar behaviors. Before diagonal crack occurred, the strains have kept in linear elastic state, which means that there were not notable cracks in core concrete and diagonal crack has just occurred in UHPC jacket. Even after diagonal cracks occurred in jacket, the graphs show continuous linear state. However, after a few cycles, the strains rose up abruptly. It seems that as the diagonal cracks expanded the confinement effect from the jacket lost and sudden cracks must have occurred in core column.

Fig. 3-23 Strain of tie bars in core column

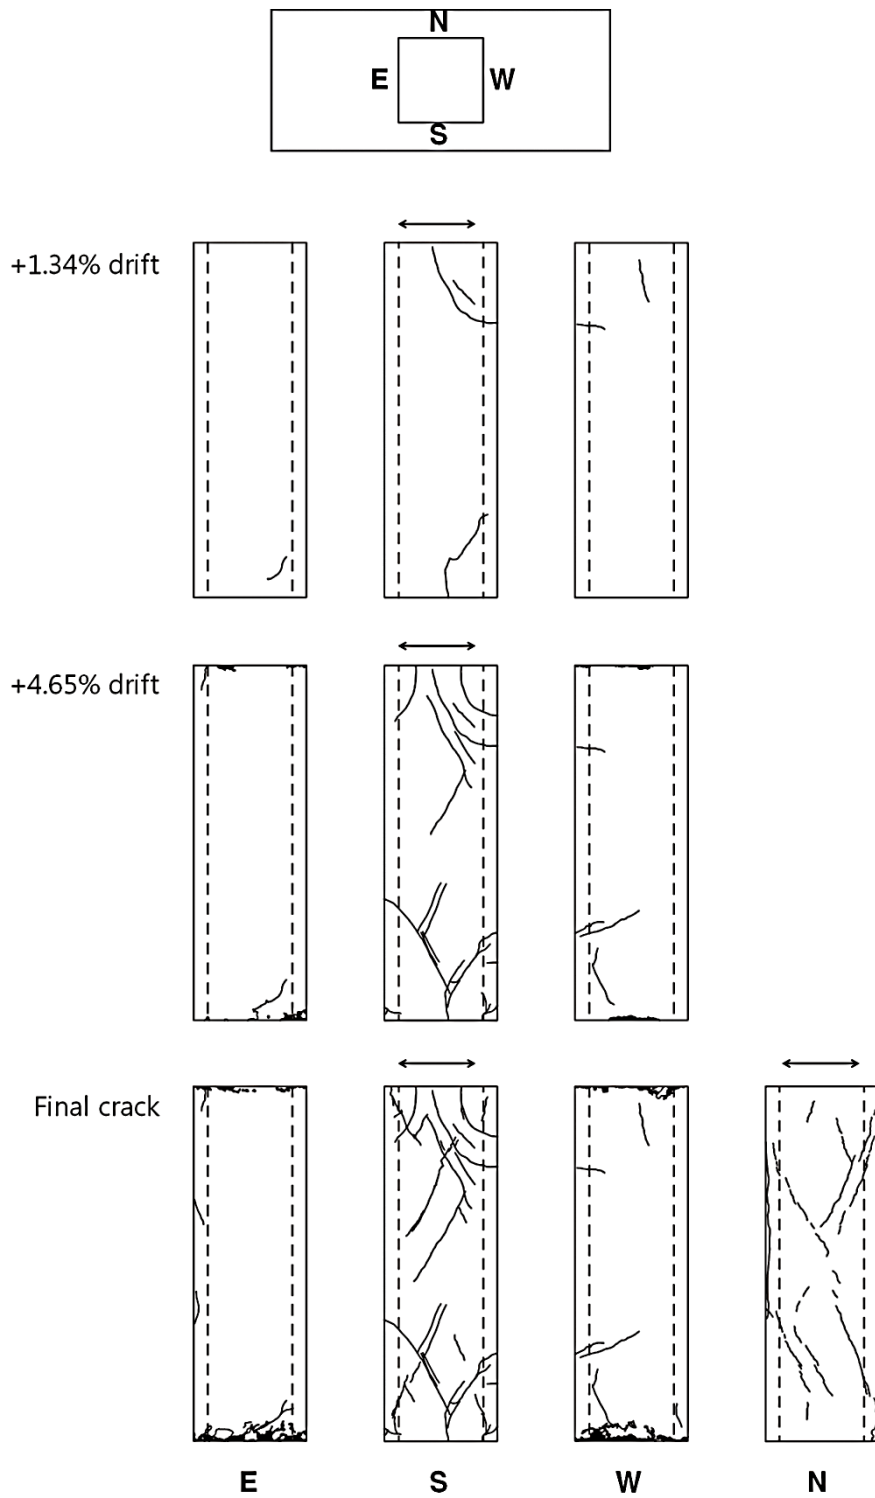
The load-displacement curves and the cracks of R-50S reinforced with shear reinforcement (D10 @ 150) in addition to UHPC of 50mm are shown in Fig. 3-25. At a glance, it shows a clear difference from previous specimens. While R3 and R5 specimens failed by massive diagonal crack, in R5S specimen, although the diagonal crack occurred, it did not grow up to massive scale. The shear cracks generated at the early stage seems to be sustained by shear reinforcement so that cracks could not extend. As the jacket kept surrounding the core column and making it as a unified section, columns could be prohibited from shear failure and very ductile behavior was observed.

Fig. 3-24 Crack pattern (R-50S)

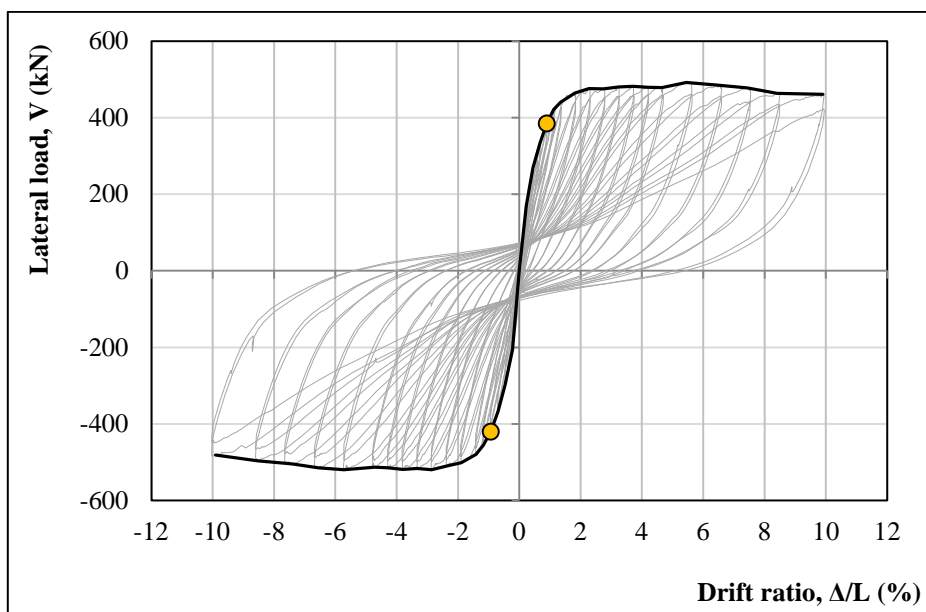
The maximum lateral load was 480kN, which is slightly larger than that of R5 specimen. This satisfied the fact that both columns reached yield points and the flexural moments of both columns were same.

Fig. 3-25 Load-displacement curve (R-50)

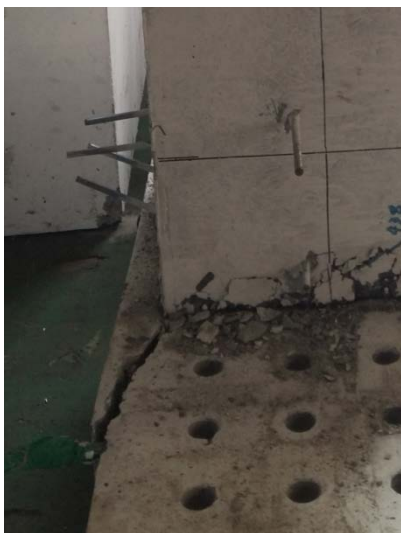
Fig. 3-26 Base crack after experiment

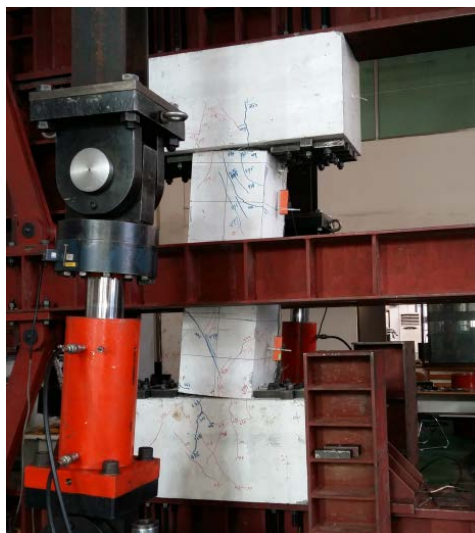
Fig. 3-27 Rocking state of R-50S

It was confirmed that the column height increased from 1260mm to 1270mm by 10mm after the experiment. In the case of the general column lateral force test, the displacement after the flexural yielding should increase, and the tensile fracture of the reinforcing bar due to the compression of the concrete at the compression zone or the tensile failure at the tension zone should occur. However, the compressive strength of the UHPC is only marginal, It was judged that the maximum strain was not reached even at 10% drift due to occurrence of many slip in the repeated force.

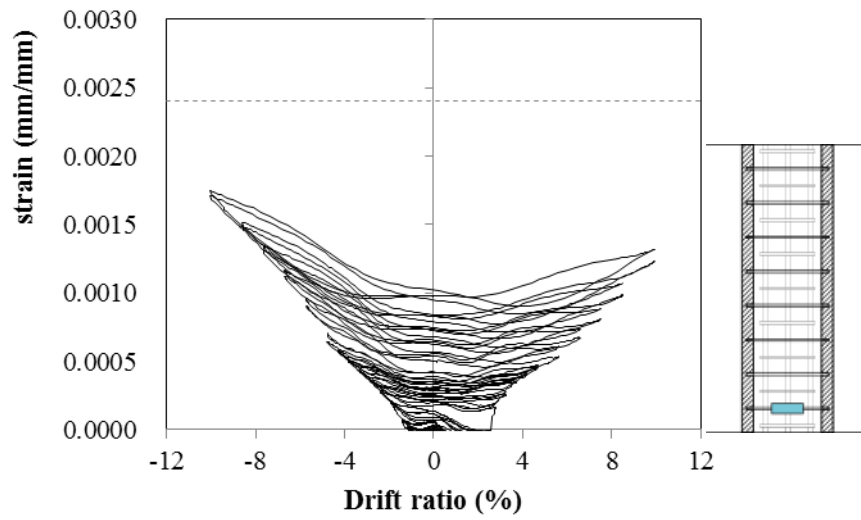
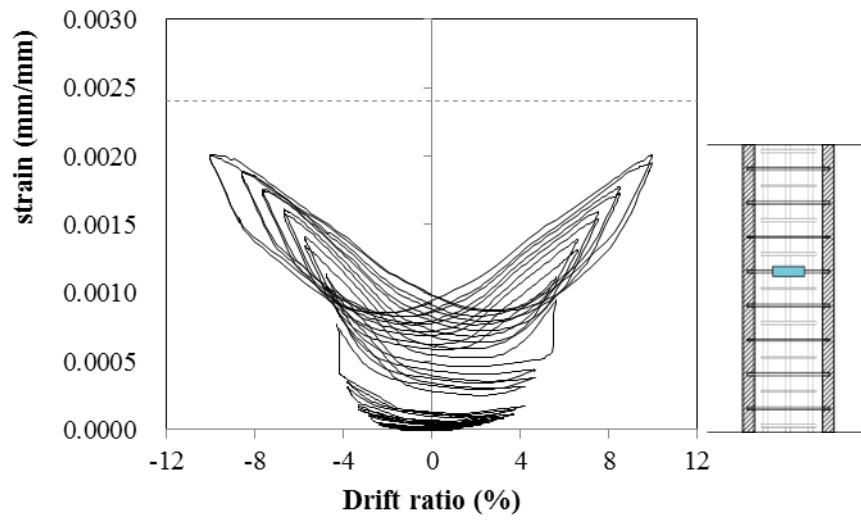
Fig. 3-28 shows the strain of tie bars inserted in UHPC jacket. The graphs show obvious tendency that the strain was increasing linearly with drift ratio after a certain point. At 10% drift ratio, the maximum strain of RS-5 bar came out to be about 0.002mm/mm, which is a little bit lower than yield strain of reinforcement. This means that if the test had kept proceeding, the RS-5 tie bar would have yielded within a few cycles. While the strain graph of RS-5 which is located at around mid-height shows very symmetric shape, the strain of RS-1 that is put in near the stub shows unsymmetric tendency.
