공학석사 학위논문

RC Column Retrofit with Ultra High Performance Concrete

초고성능 콘크리트를 이용한 기둥 보강 연구

서울대학교 대학원

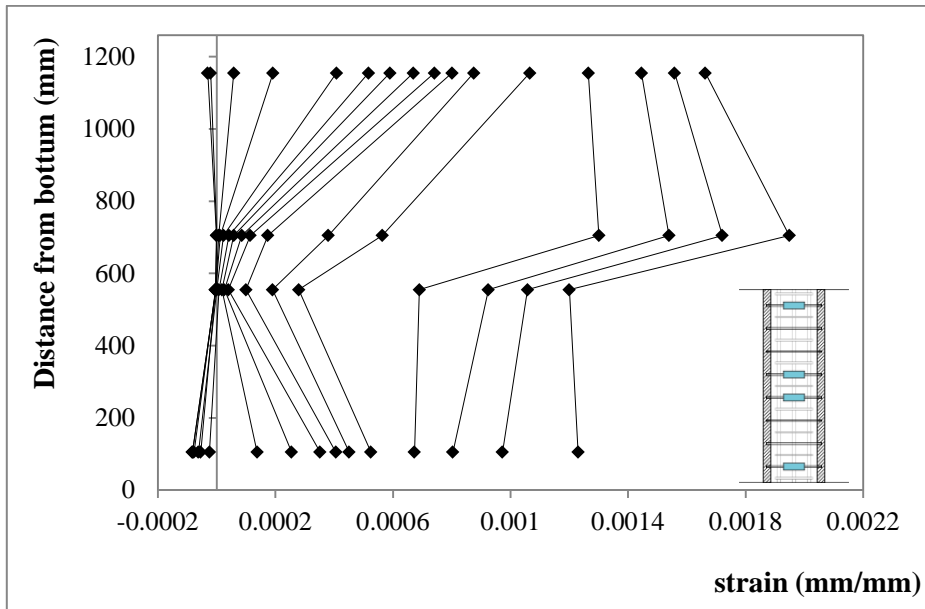
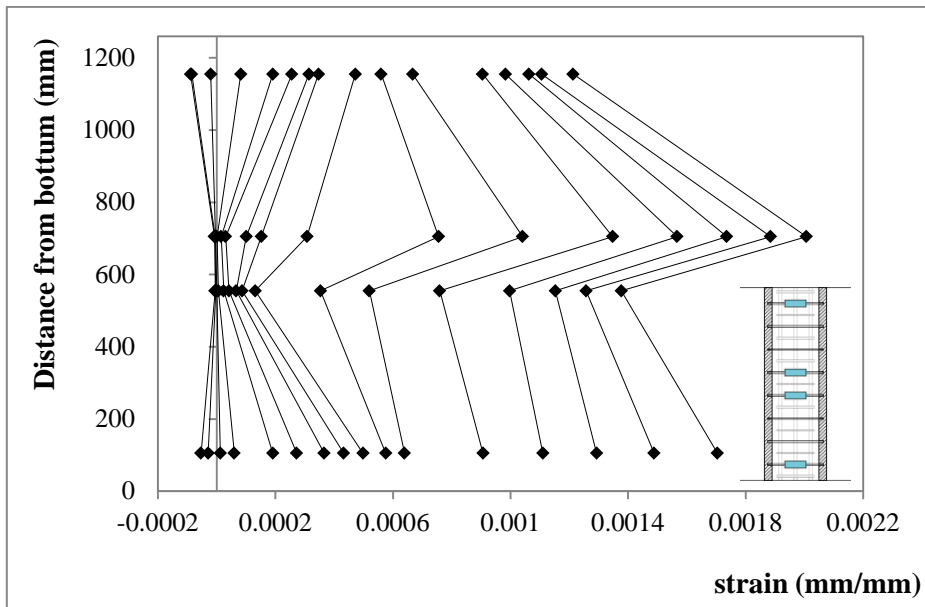
Second, there are obvious tendency that as drift ratio increases, strains of JS-1, JS-8 increase much faster than JS-4 and JS-5, which are located at inner part. And when drift ratio got very high, strains of inner tie bars became larger than boundary stirrups. This indicates that when lateral load is applied to this column, shear deformations are first concentratated near the end stubs and then gradually expand to inner parts as the drift ratio get futher higher. It is required to design shear stirrups of UHPC jacket depending on design seismic load. If the column is expected to get mid-range seismic deformation, strengthening end parts are more important. And if the column is expected to get severe seismic deformation, strengthening mid-parts would be more important.

(a) positive direction (drift ratio : 0.5%~9.0%)

(b) negative direction (drift ratio : 0.5%~9.0%)

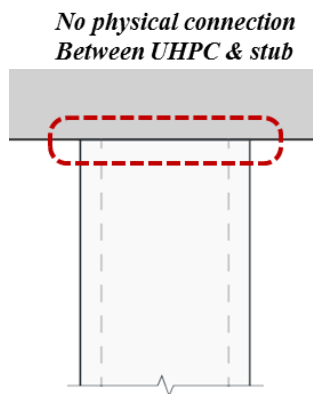
Normally, jacketing method causes confinement effect to core column. However, in this case UHPC jacket contributes for strengthening the column mainly by supporting the external loads directly. Strengthening effect by confinement would be relatively very small compared to direct supports of the jacket. Moreover, confinement effect of the jacket in rectangular section is very difficult to estimate. Thus, most researches on confinement effect depend on experiments focusing on confinement effect, which is not the case. Therefore, Confinement effect was not considered in this study.

Fig. 4-1 Jacket connection to stub

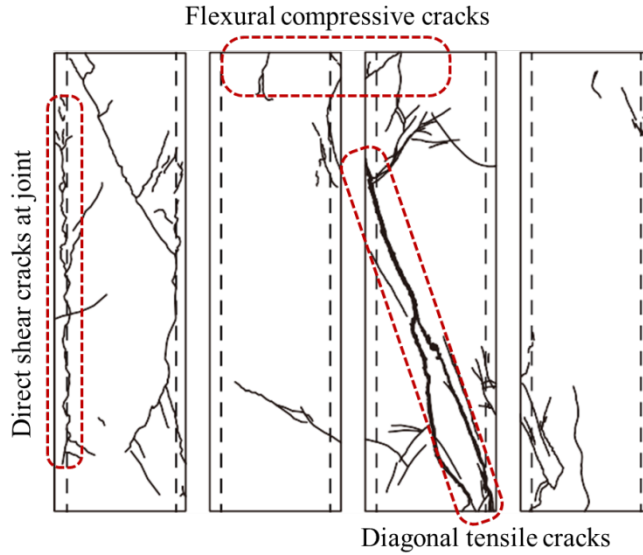
Fig. 4-2 Crack types of experiment result (R-30)

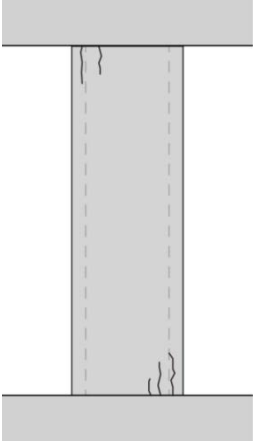
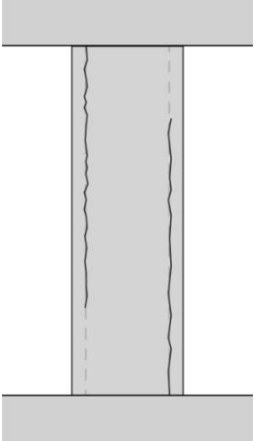
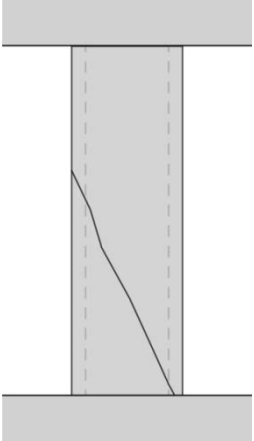
Mode ①	Mode ②	Mode ③
Failure mode	Compressive failure of UHPC	Direct shear failure between web-flange	Diagonal tension failure in web plane
Crack patterns

Failure criteria	$\varepsilon_{cm} = \varepsilon_{uu}$	$\tau_{jt} = \tau_{u,allow}$	$\sigma_1 = f_{u,t}$

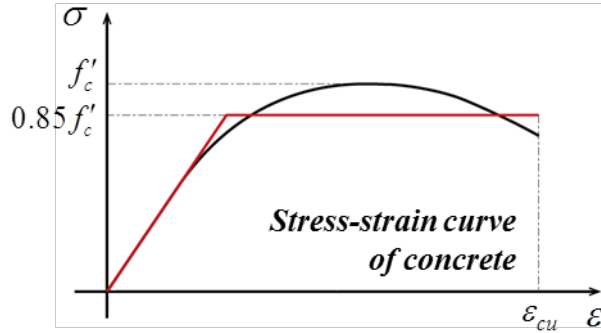
concrete is not always $\varepsilon_{cu} = 0.003$, the equivalent stress block method cannot be applied. Thus, the stress-strain curve of concrete was assumed as a double-linear curve described in Fig. 4-3. The maximum compressive strength and the initial stiffness were based on material experimental result.

Fig. 4-3 Assumed stress-strain curve of concrete

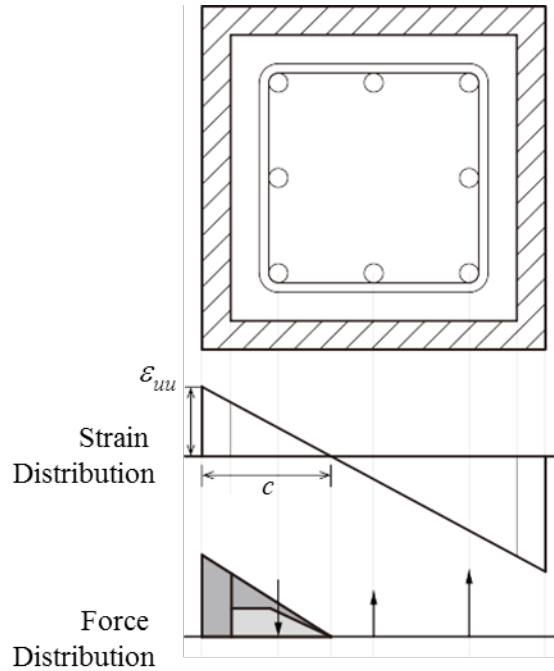
Fig. 4-4 Strain compatibility solution for composite section

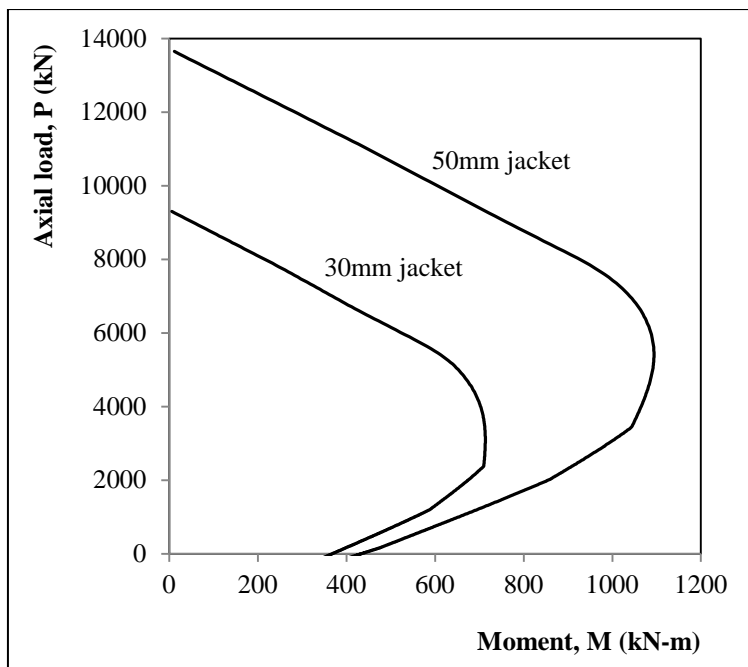
Fig. 4-5 P-M interaction diagram for jacketed section

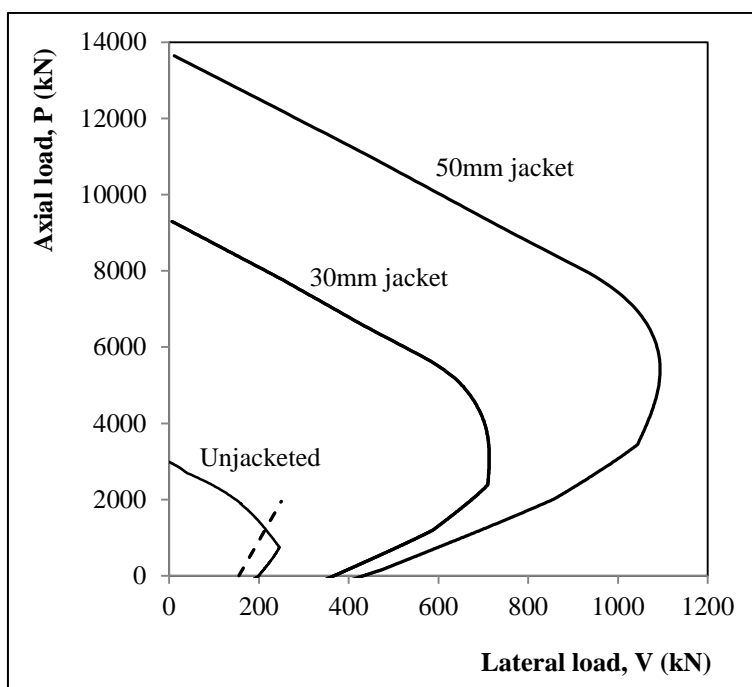
Fig. 4-6 shows the failure curves of flexural failure mode for the jacketed columns including for the unjacketed section. The lateral load capacity increased about two times at zero axial load and the axial load capacities are calculated to increase about 2.5 to 4 times depending on the jacket thickness.

Fig. 4-6 P-V interaction diagram (failure mode 1)

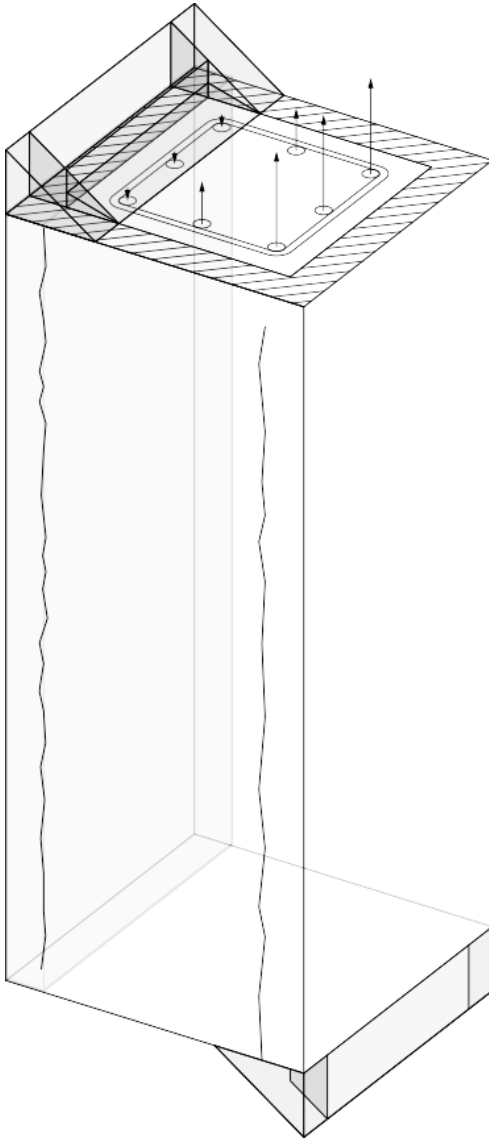
Fig. 4-7 crack patterns of mode 2 and normal stress distribution at end

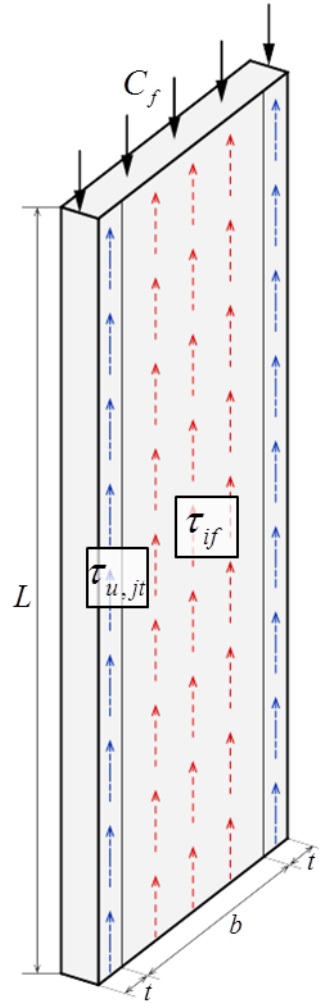
Fig. 4-8 vertical stress distribution in flange

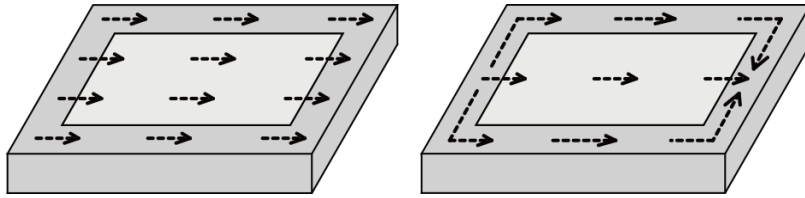
Interface shear strength should be considered to analyze this failure mode. If interface shear strength is sufficiently large (case (a)), the shear flow caused by C_f could be directly transferred aligned with the direction of shear force (Fig. 4-9. (a)). In this case the shear stress among the interface could be regarded same (equation (27)). However, if interface shear strength is not sufficient (case (b)), the shear stress in flange should be transferred to web to fill the insufficient amount (Fig. 4-9. (b)). This additional shear stress will increase the shear stress in web and hasten this shear failure mode.

Fig. 4-9 shear flow in column section:

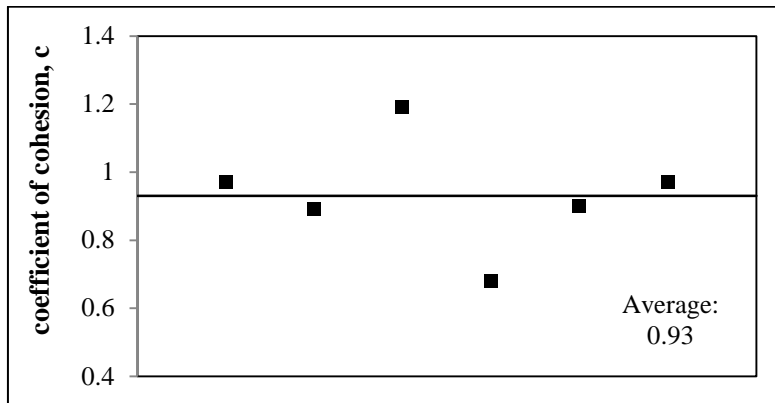
As the values used for equation (16) have relatively large deviations, the interface shear strength was assumed conservatively as $\tau_{if,allow} = 2 \text{MPa}$

Fig. 4-10 Cohesion coefficient for sandblasted surface (Santos et al, 2014)

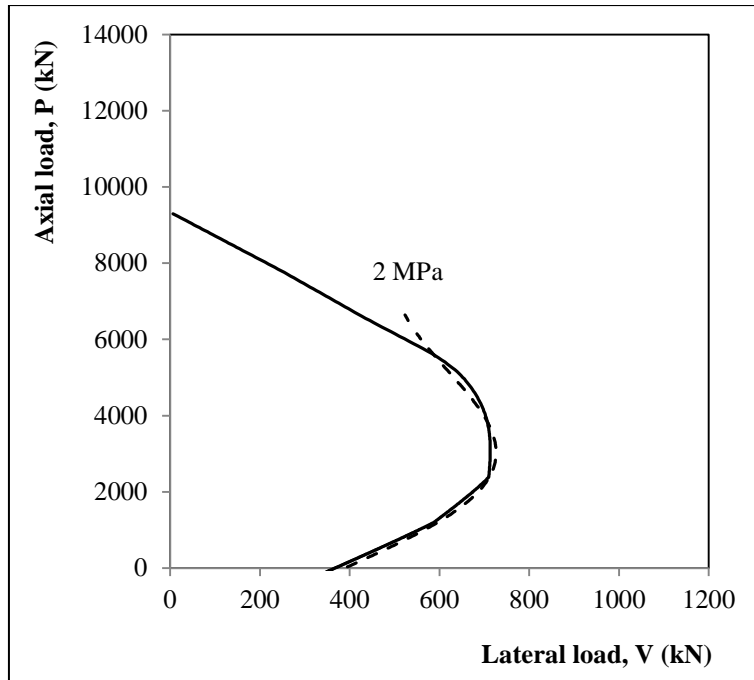
Using the algorithm of Fig. 4-13, it is possible to get failure curve of mode 2. The resultant P-V interaction diagram for R-30 and R-50 sections are plotted in Fig. 4-11 and Fig. 4-12. For the interface shear strength of assumed 2MPa, it is shown that the failure curve for mode 2 in R-30 is almost same with mode 1 curve. In the case of R-50 section, failure curve for mode 2 is much lower than mode 1, which means that the column is apt to fail in mode 2 rather than mode 1.

Fig. 4-11 P-V interaction diagram (30mm, mode 2)

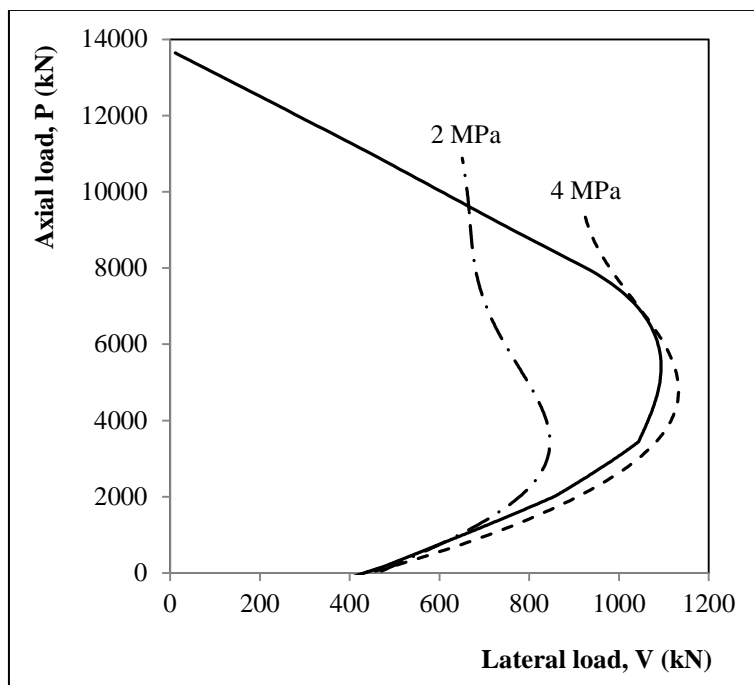
Fig. 4-12 P-V interaction diagram (50mm, mode 2)

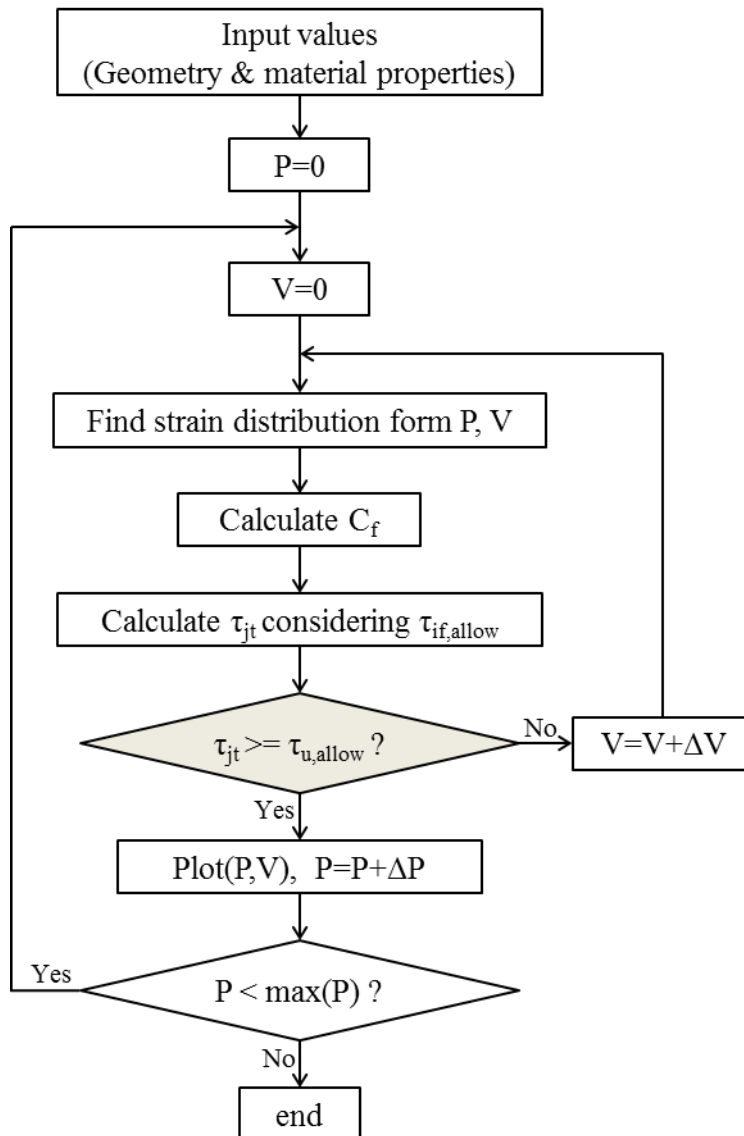
Fig. 4-13 Analysis method for failure mode 2

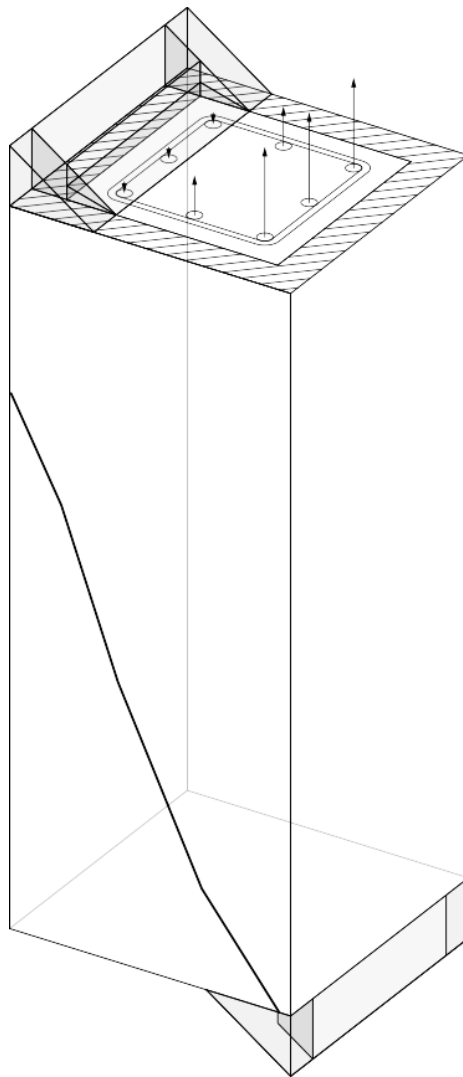
The third failure mode is a diagonal tension failure, which was the experimental result. Fig. 4-14 shows the crack patterns of this failure mode. This failure mode could occur when the maximum principal tensile stress in UHPC web is higher than tensile strength of UHPC, which may not be high enough.

Fig. 4-14 Crack patterns of mode 3

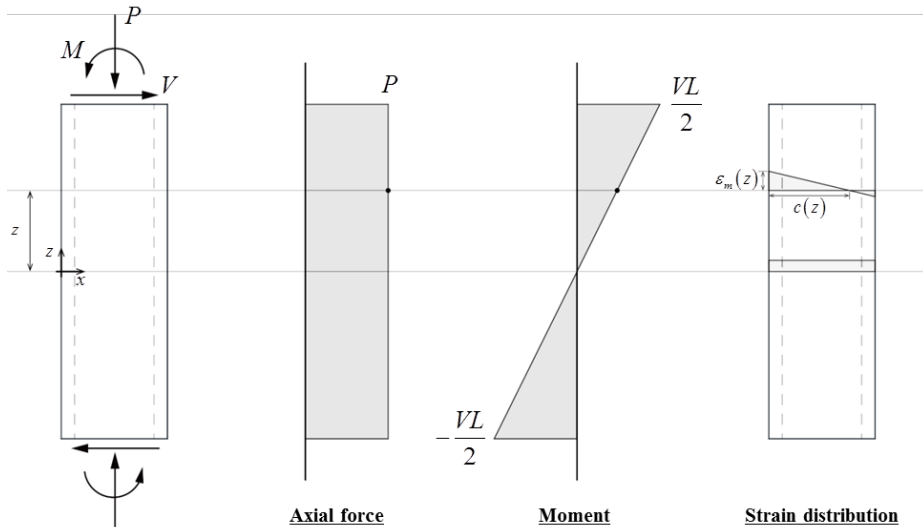
As the strain distribution at height z , defined by $\varepsilon_m(z)$ and $c(z)$, is given, the normal stress can be easily found out by multiplying elastic modulus of UHPC to strain distributions. As assumed in 4.1.3, the tensile stress is not considered. Thus, the negative value in the vertical stress should be just zero.

Fig. 4-15 Strain distribution at height z

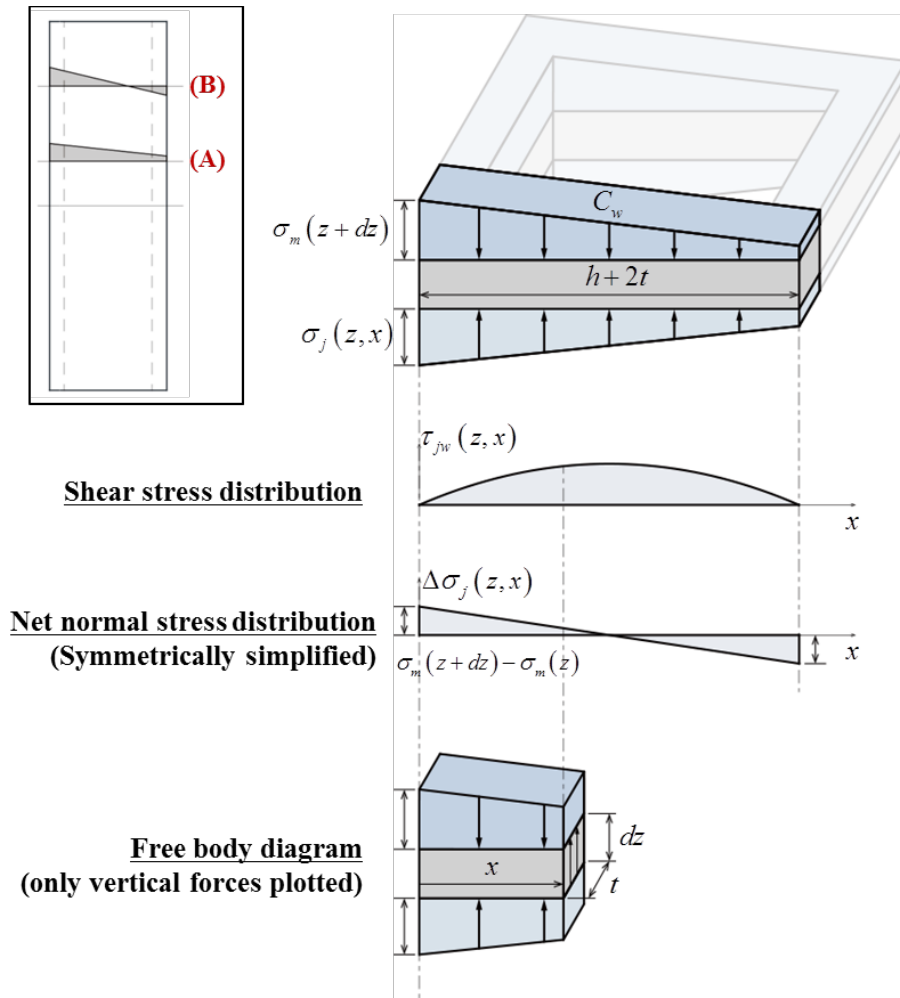
Fig. 4-16 Normal stress distribution by C_w in web at (A)

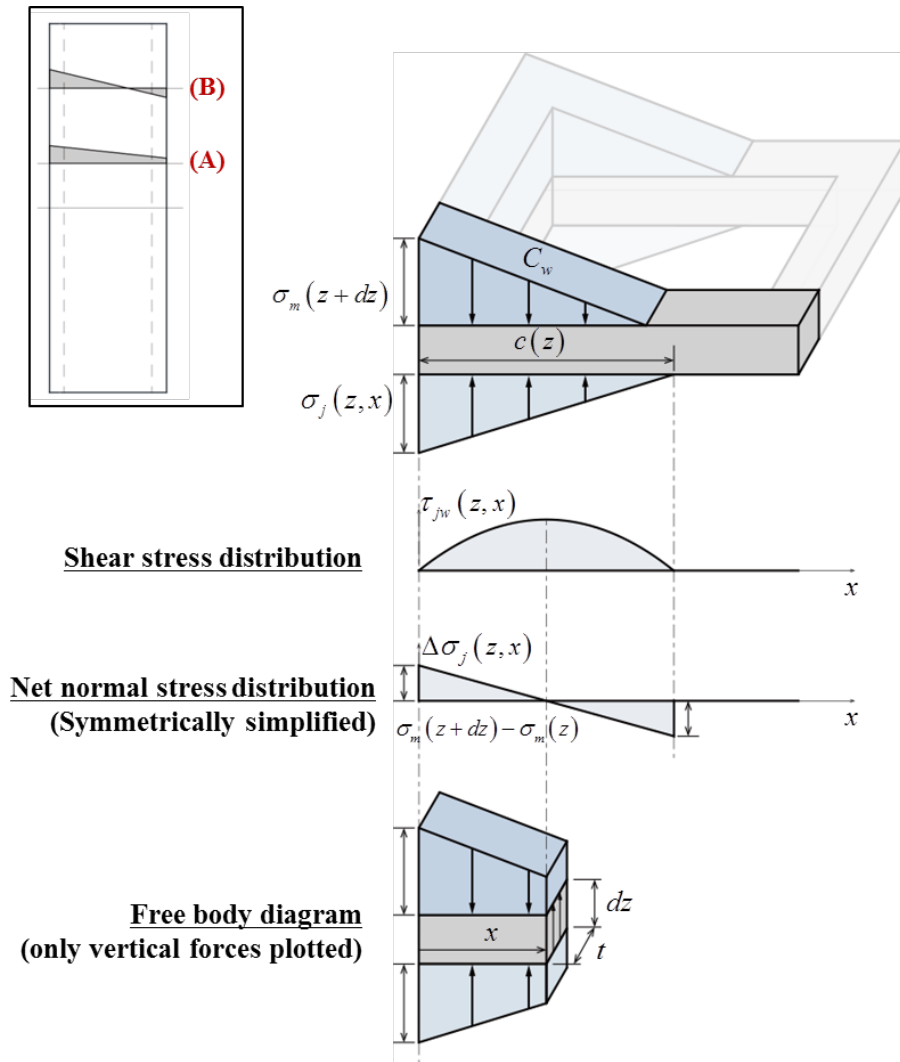
Fig. 4-16 shows the normal stress distribution at (B) which indicates the location where only part of the section gets normal compressive strain. The shear stress by normal force should start with zero at left side and end with zero at the point where normal stress becomes zero. Assuming shear stress distribution as symmetric, then, from the vertical force equilibrium in the free body diagram of Fig. 4-17, equation (21) and (22) can be built.

Fig. 4-17 Normal stress distribution by C_w in web at (B)

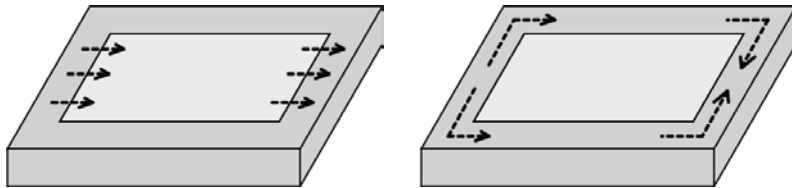
Fig. 4-18 shear flow of flange in column section:

a) if $\tau_{if,allow}$ is large enough, b) if $\tau_{if,allow}$ is not sufficient

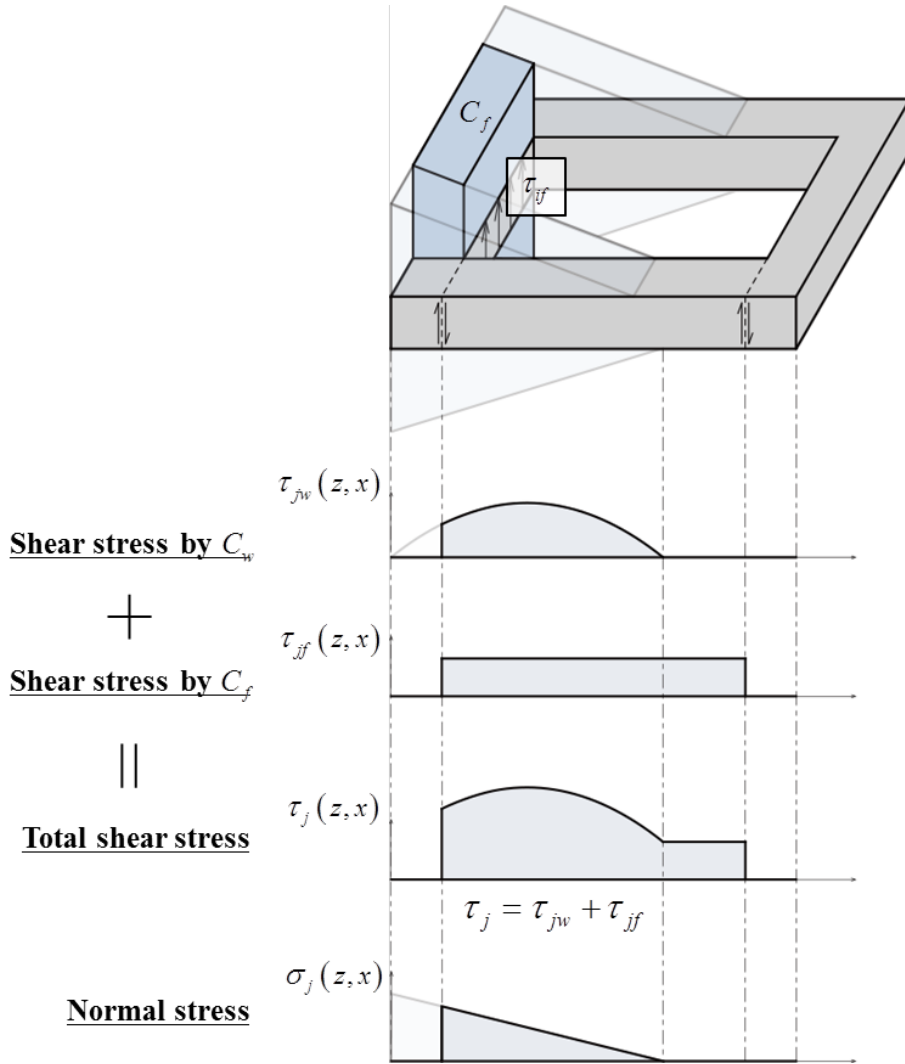
Fig. 4-19 Normal stress distribution by C_t in web

The total shear stress can be found by just adding τ_{jw} and τ_{jf} , as shown in Fig. 4-19. Then, as the shear stress and normal stress at any location in the web of jacket, the principal stress can be found out from the equation (27), which can be built from the Mohr's circle that is described in Fig. 4-20.

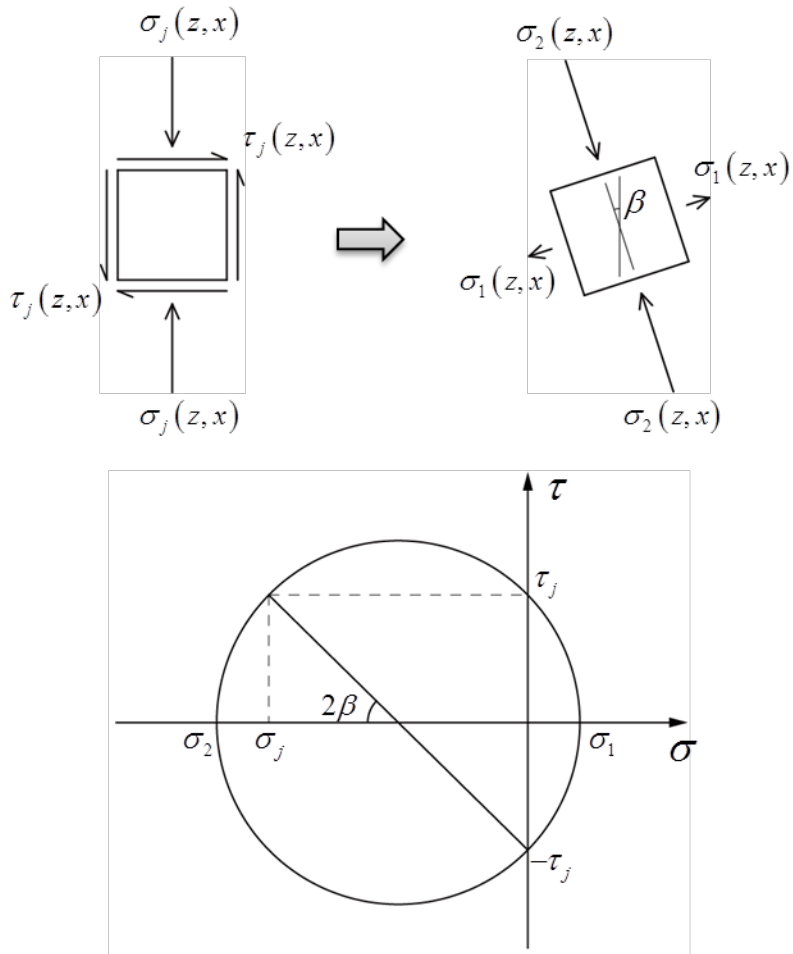
Fig. 4-20 Mohr's circle

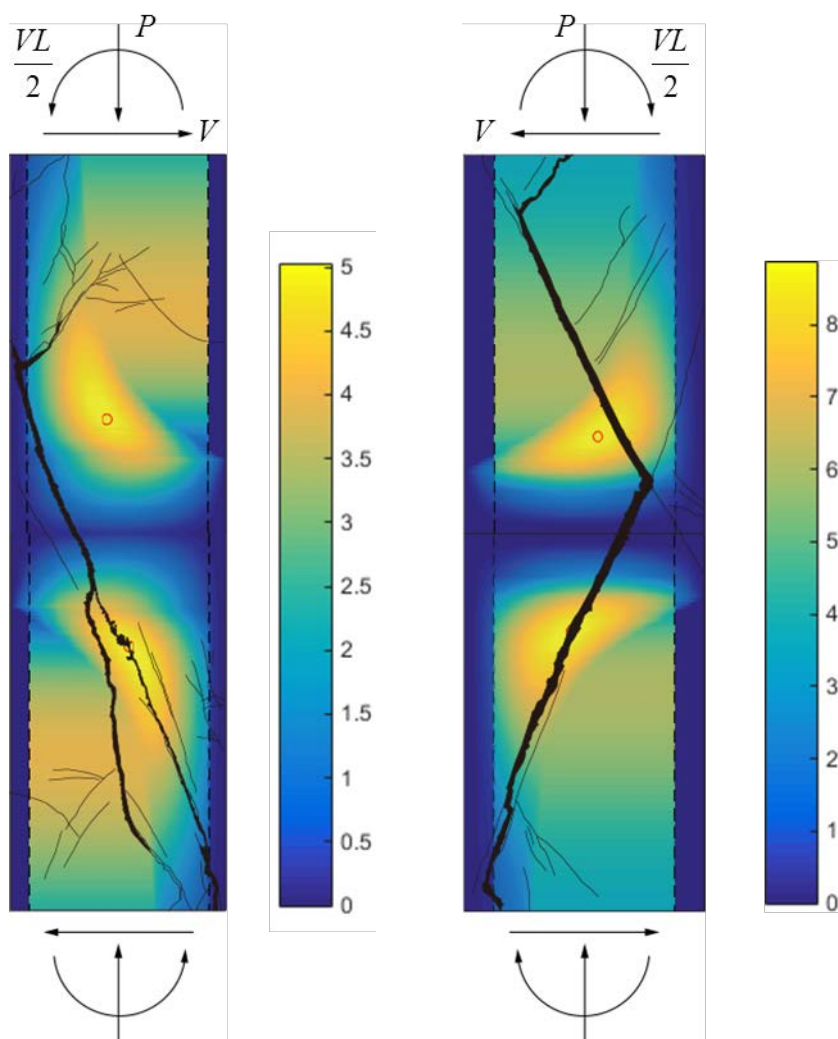
**Fig. 4-21 Principal stress distribution at the cracking load
a) for R-30, b) for R-50**

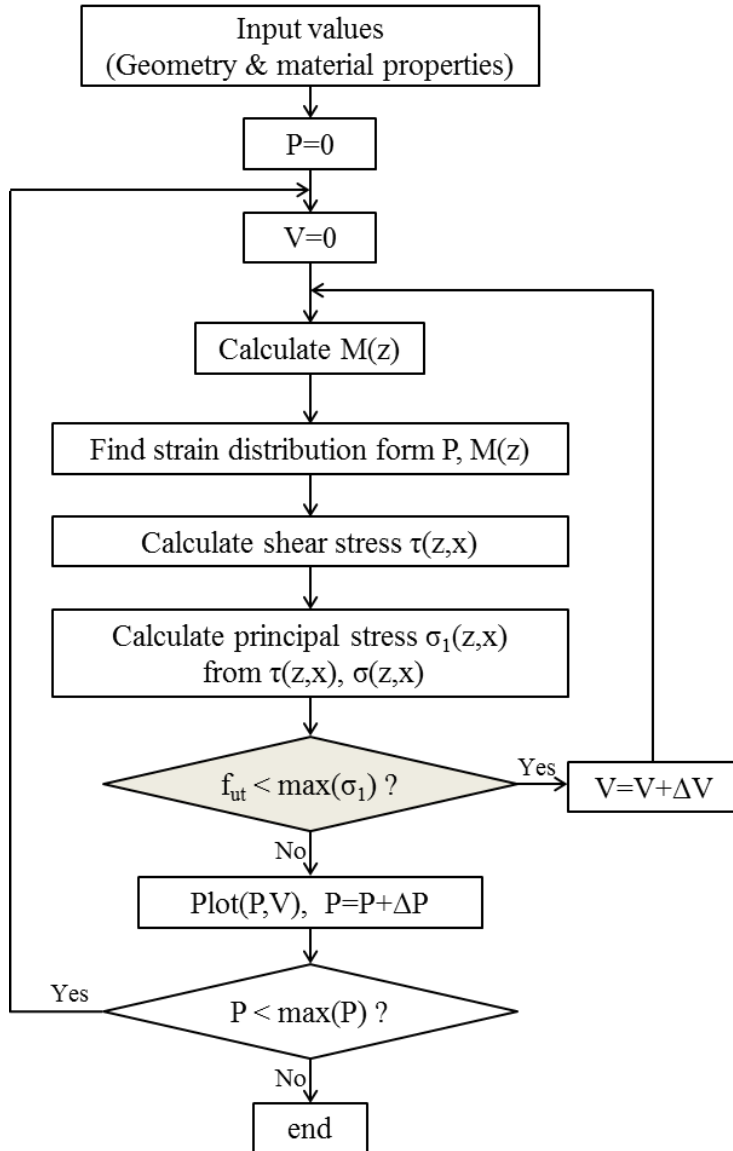
Fig. 4-22 Analysis method for failure mode 3

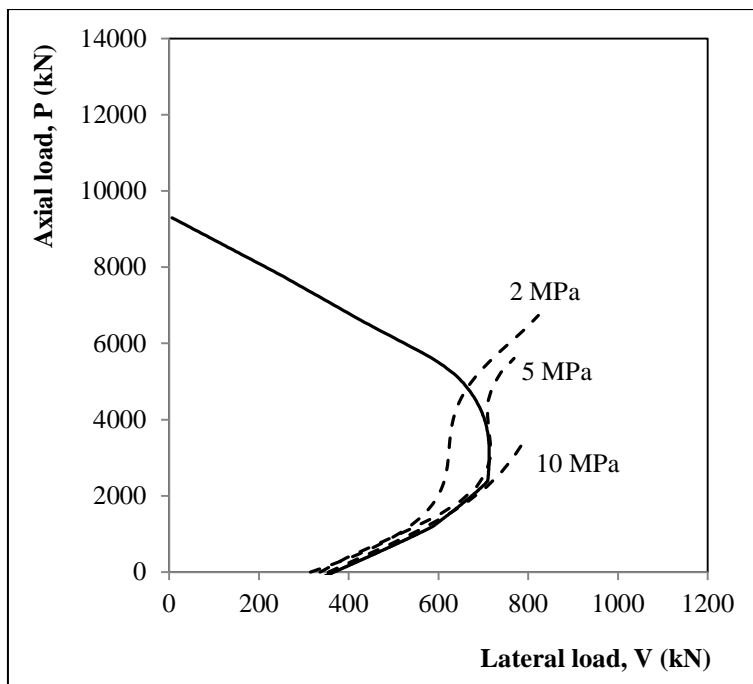
Fig. 4-23 P-V interaction diagram (30mm, mode 3)

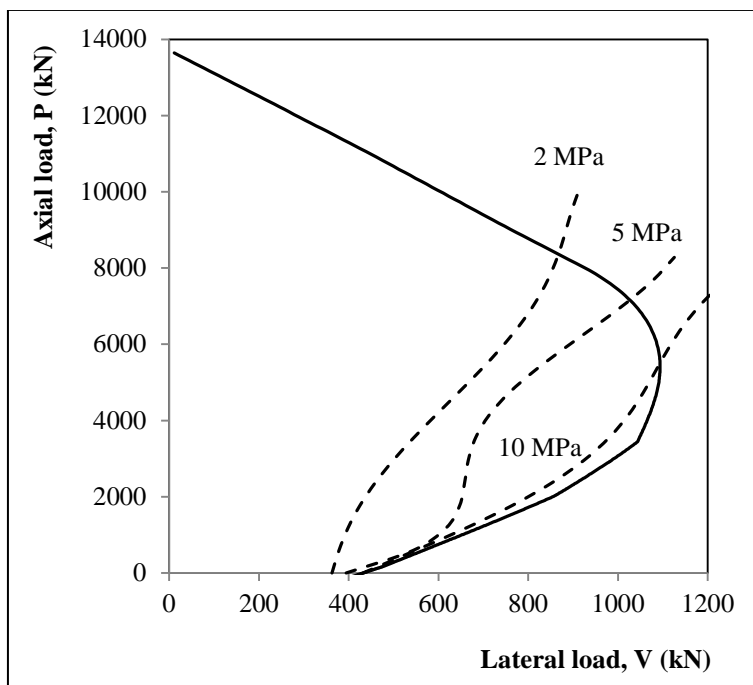
Fig. 4-24 P-V interaction diagram (50mm, mode 3)

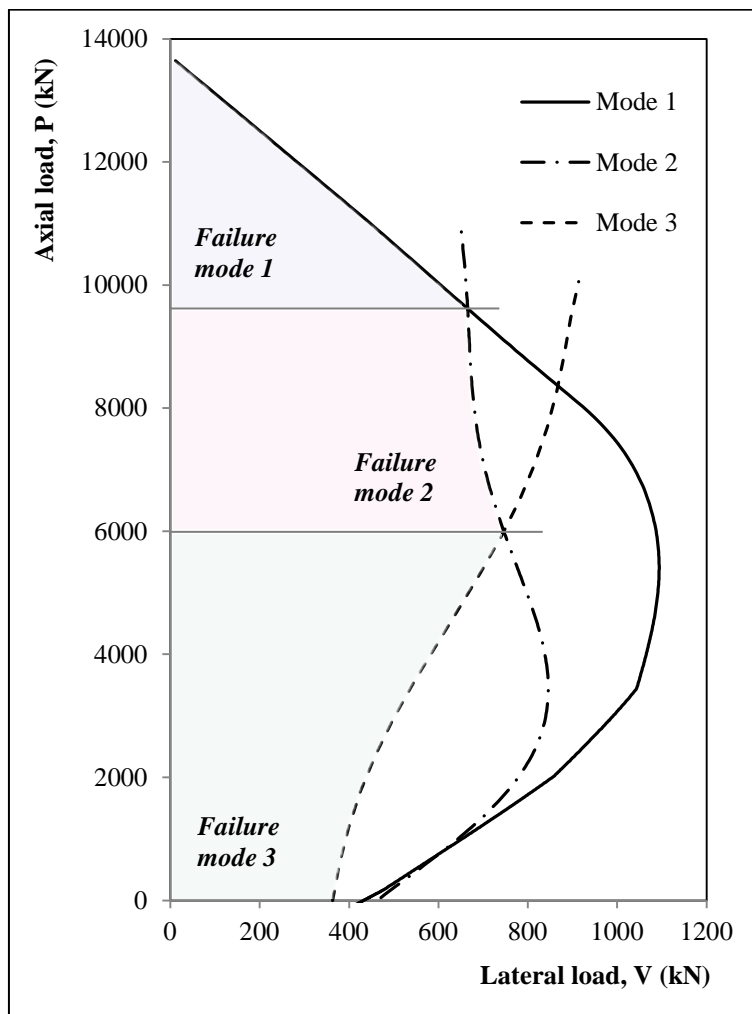
Fig. 4-25 shows the final P-V interaction diagram including mode 1,2 and 3 for R-50. The interface shear strength was assumed to be 2MPa. It appeared that for normal axial force region, about less than 6000kN, the column would fail in mode 3. The column is prone to fail in mode 2 for higher axial force region and fail in mode 3 for the highest region.

Fig. 4-25 Final P-V interaction diagram (R-50)

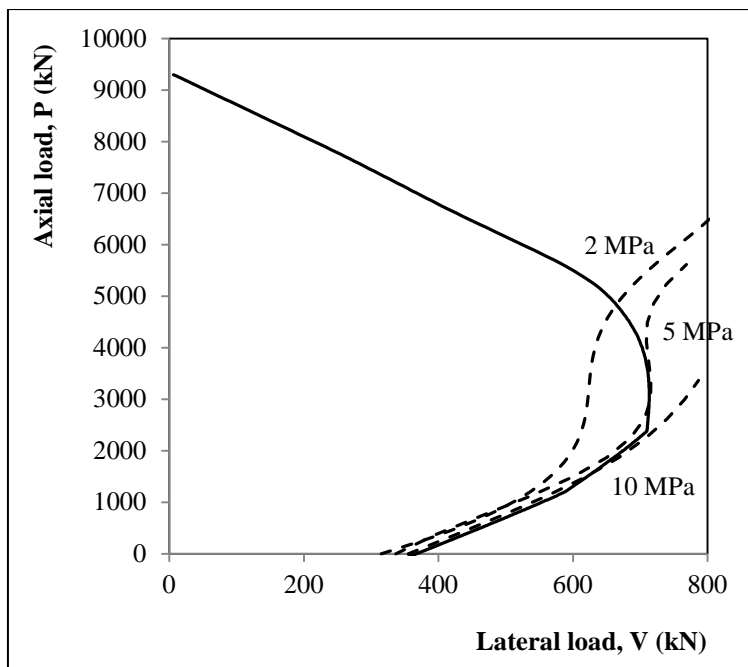
Fig. 4-26 P-V diagram ($b=300\text{mm}$, $\rho=2.1$)

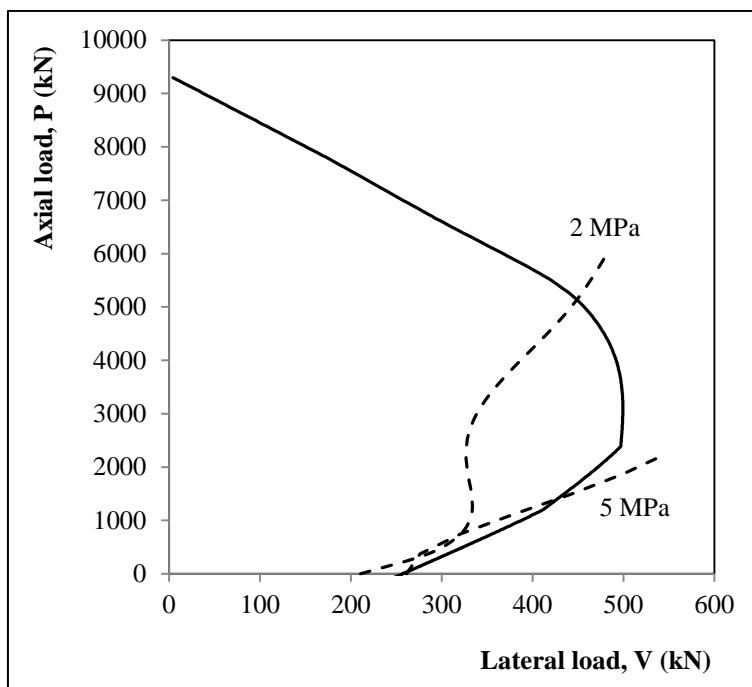
Fig. 4-27 P-V diagram ($b=300\text{mm}$, $\rho=3.0$)

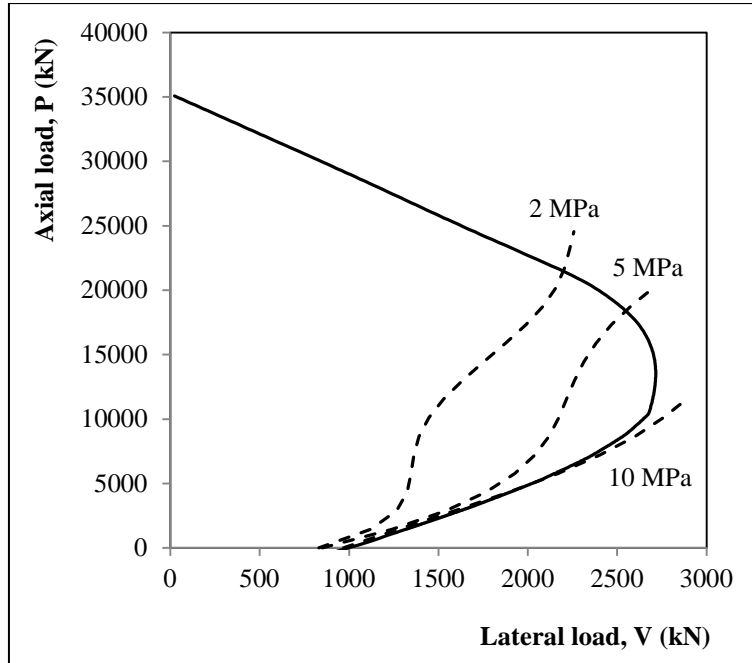
Fig. 4-28 P-V diagram ($b=600\text{mm}$, $\rho=2.1$)

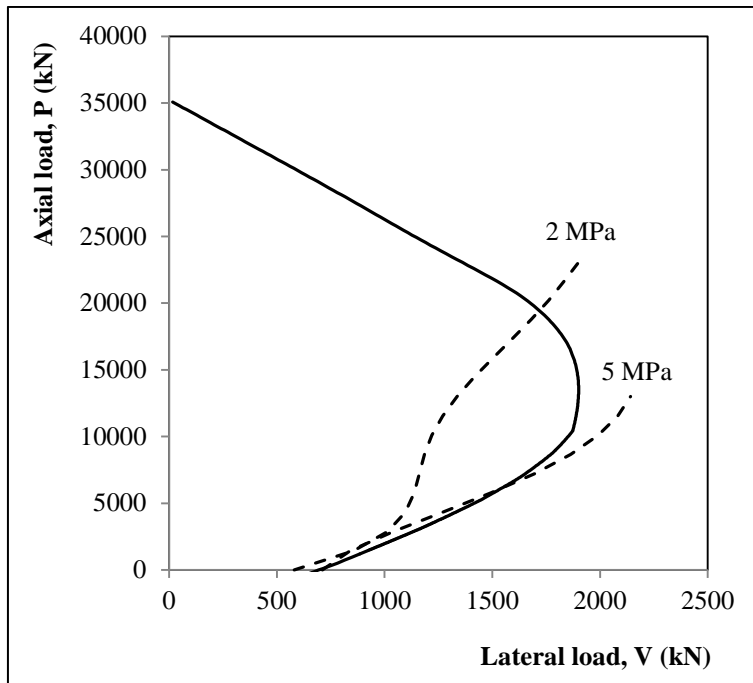
Fig. 4-29 P-V diagram ($b=600\text{mm}$, $\rho=3.0$)
