**Ph.D Dissertation**

**Development of Stability Evaluation  
Indicators on Revegetated Cut-slopes of  
Mountainous Terrain of Korea**

**Seoul National University**

**Landscape Architecture Major**

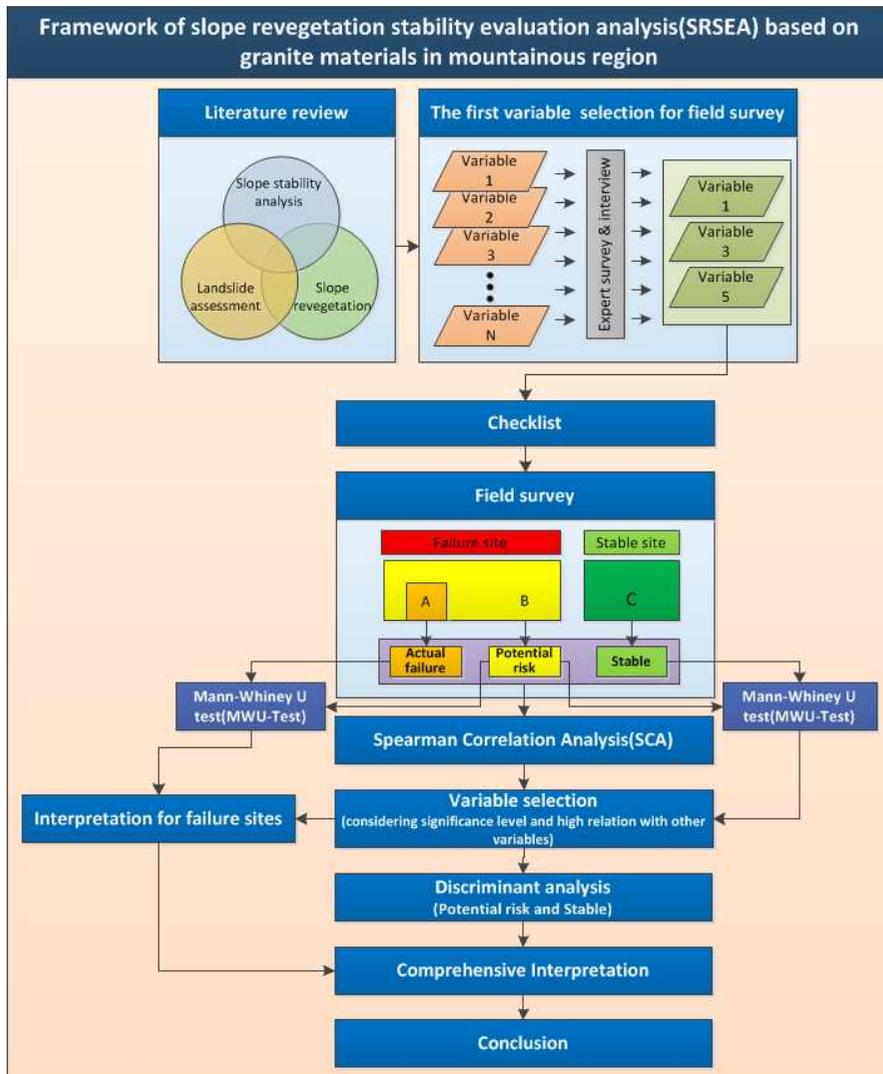
Figure 12. Framework of this study.

5) Discriminant analysis used major variables selected by correlation analysis and non-parametric testing. A nominal-scale indicator of surveyed data was excluded in the discriminant analysis. However, the nominal-scale indicator was compared with discriminant score extracted by the discriminant analysis. Finally, slope revegetation stability evaluation analysis (SRSEA) using the final indicators was suggested.

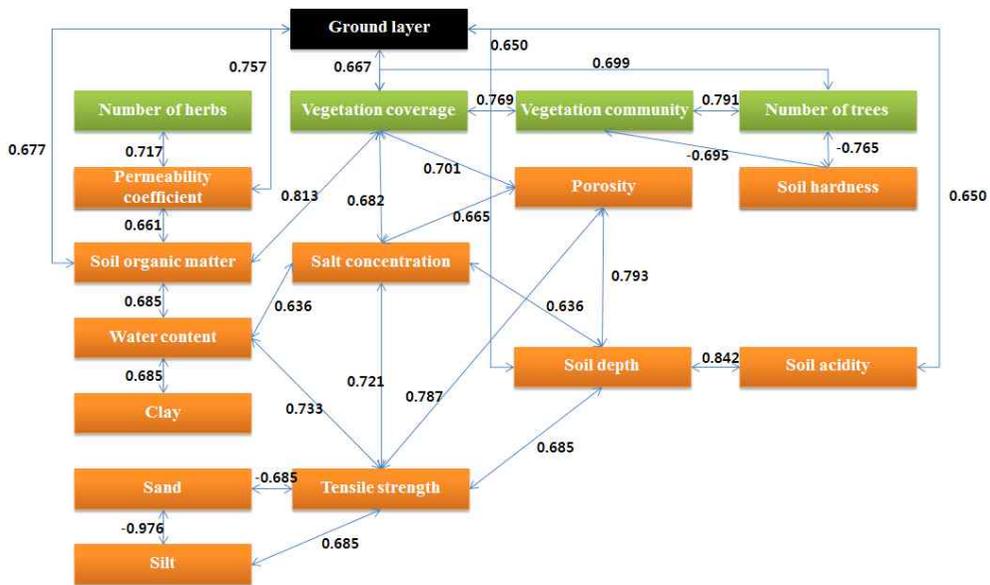
Figure 13. Correlation between variables.

The porosity positively correlated with tensile strength, soil depth, salt concentration, and vegetation coverage. All sites of this study had a salt concentration of less than 0.1%<sup>35)</sup> and therefore had no negative effect on vegetation, although stable sites had a relatively higher salt concentration compared with failure sites.

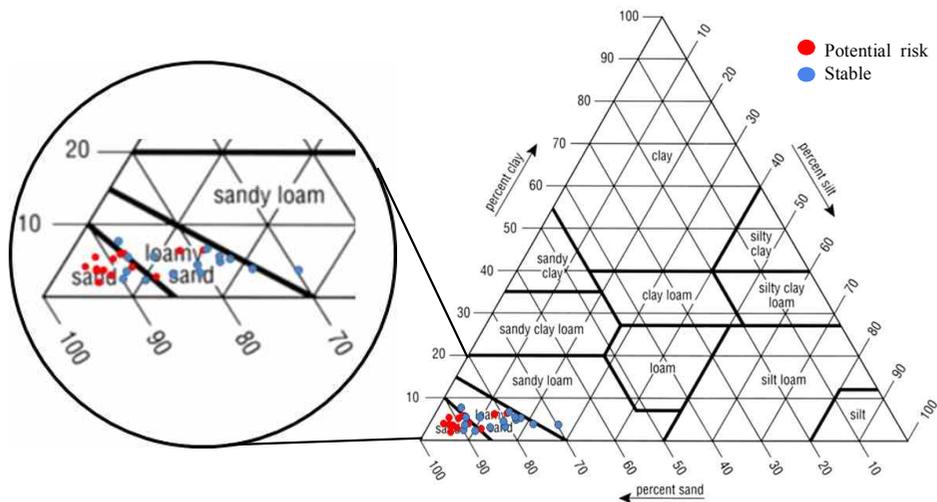
Figure 14. Soil texture triangle of potential risk and stable sites.

Soil texture can be determined by the USDA soil texture triangle. For example, the potential risk sites fell in the “sand” class (88.77% sand, 6.80% silt, and 4.42% clay). The stable sites fell in the “loamy sand” class (82.13% sand, 13.51% silt, and 4.35% clay). Thus, the soil texture of the potential risk sites had a highest percentage of sand while having the lowest percentage of silt than the stable sites had. The high percentage of sand means low soil organic matter as well as porosity in the soil (Brady and Weil, 2009).

In the Mann-Whitney U test,  $p=0.001$  for sand and  $p=0.001$  for silt, both of which indicating a significant difference between the groups due to sand and silt soil textures. For clay,  $p=0.771$ , indicating an insignificant difference between the groups due to it. The percentage of sand in the potential risk sites was higher than that of the stable sites, whereas the percentage of silt in the potential risk sites was lower than that of the stable sites.

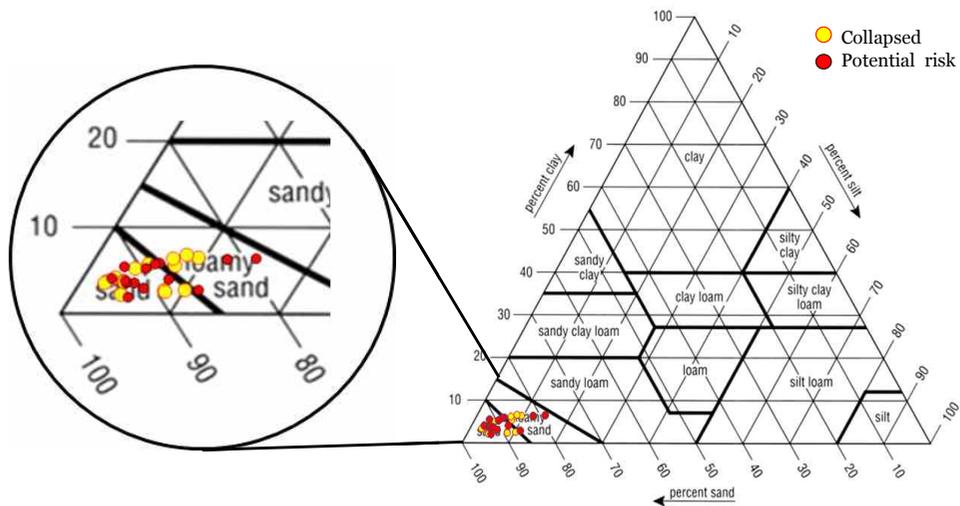
Figure 15. Soil texture triangle of collapsed and potential risk sites.

In the Mann-Whitney U test, the differences between the groups were insignificant ( $p=0.455$  for sand;  $p=0.534$  for silt; and  $p=0.575$  for clay). Furthermore, the ratio of soil texture in the collapsed sites did not differ from that of the potential risk sites.

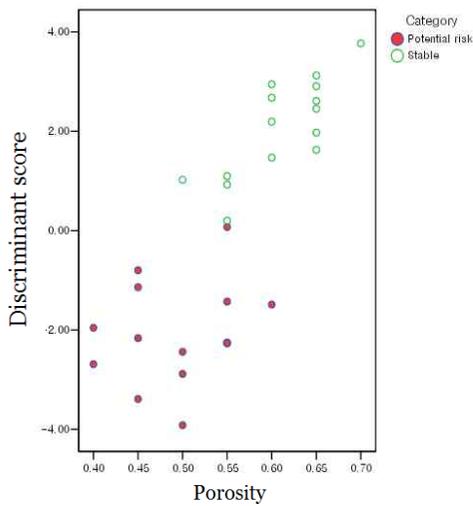
Figure 16. Scatter plot of discriminant score and porosity value.

The scatter diagram between the discriminant scores according to the discriminant function and investigated data of each indicator is shown in Figures 16 ~ 19.

The scatter diagram of the discriminant score and each indicator can be interpreted as follows: To determine a certain area as potential risk site, the value of each indicator should be less than 0.5 m<sup>3</sup>/m<sup>3</sup> of porosity, less than 1.4 kPa of tensile strength, less than 3% of soil organic matter, and less than 60% of vegetation coverage. On the other hand, to determine a certain area as stable site, the value of each indicator should be more than 0.6 m<sup>3</sup>/m<sup>3</sup> of porosity, more than 1.8 kPa of tensile strength, more than 8% of soil organic matter, and more than 96% of vegetation coverage, and .

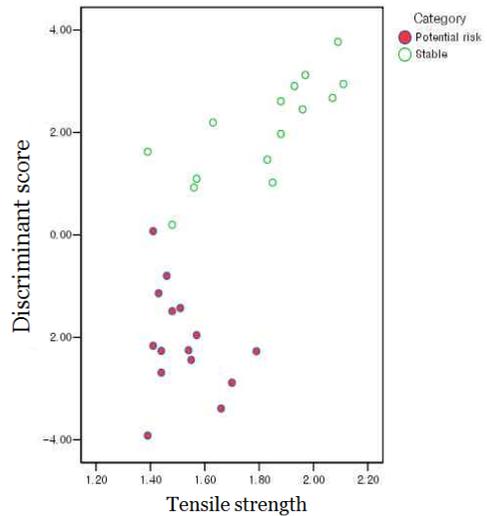
Figure 17. Scatter plot of discriminant score and tensile strength value.

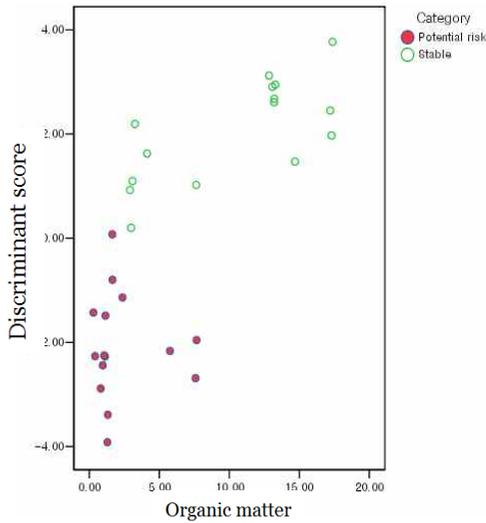
Figure 18. Scatter plot of discriminant score and soil organic matter value.

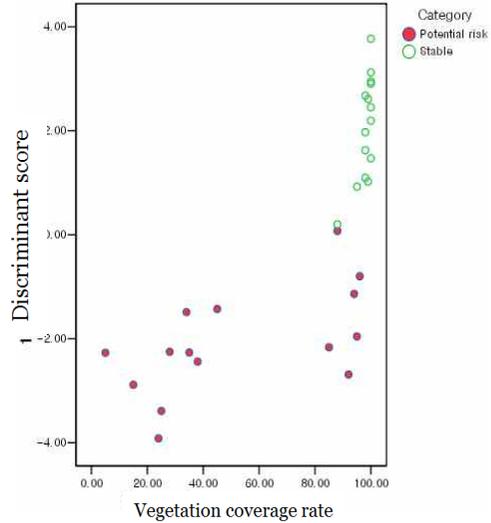
Figure 19. Scatter plot of discriminant score and vegetation coverage.

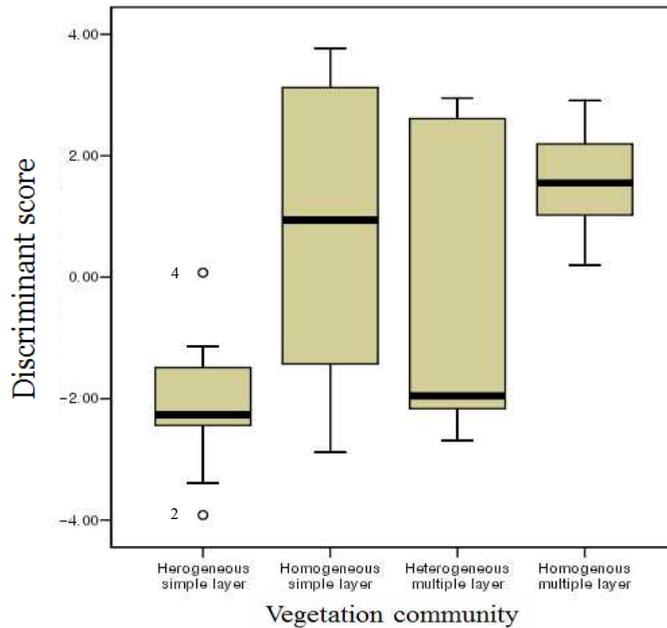
The box-plot diagram of the discriminant score and vegetation community can be interpreted as follows. All discriminant score of heterogeneous simple layer of vegetation community classification was below zero. All discriminant score of homogeneous simple layer was above zero. The discriminant score of heterogeneous multiple layer and homogeneous simple layer ranged from approximately -3 to 4. Therefore, the homogeneous simple layer of the vegetation community classification represented a stable slope whereas the heterogeneous simple layer represented a unstable slope. It was hard to judge the stability of both heterogeneous multiple layer and homogeneous simple layer since they showed broad range of discriminant score.

The discriminant score ranged from -3.92 to 0.07 for the heterogeneous simple layer, with an average of -2.12. It ranged from -2.69 to 2.95 for the heterogeneous multiple layer, with an average of -0.25. It ranged from -2.88 to 3.77 for the homogeneous simple layer, with an average of 0.74. It ranged from 0.20 to 2.91 for the homogeneous multiple layer, with an average of 1.59. In summary, a revegetated site that had both heterogeneous simple layer and discriminant score below zero could collapse whereas a revegetated site that had both homogeneous layer and discriminant score above zero could become stable.

Figure 20. Box-plot of discriminant score and vegetation community.

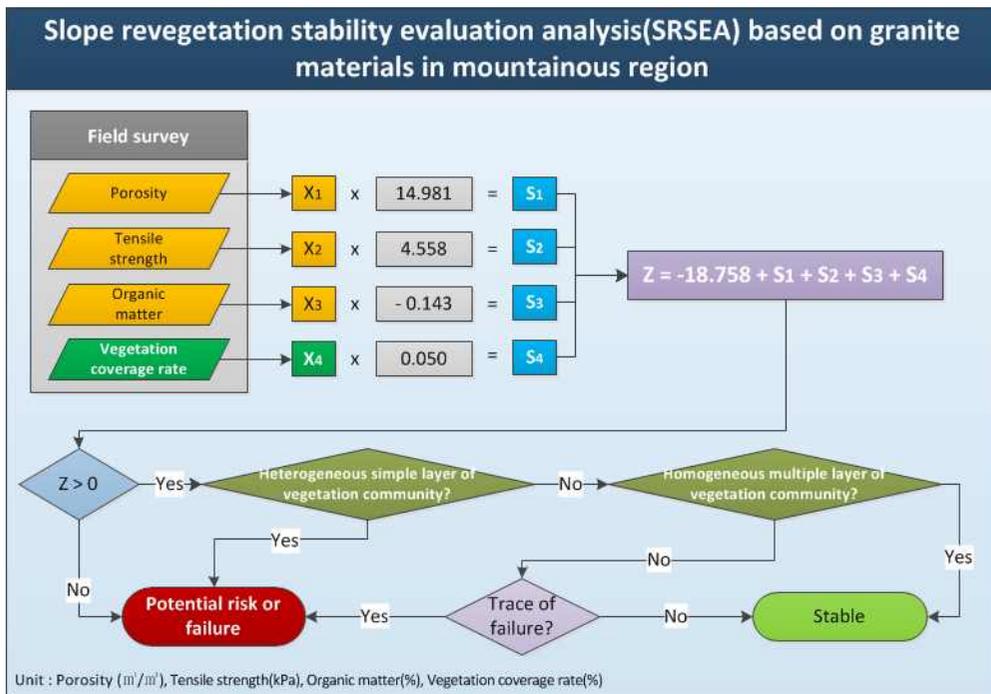
The data was collected roughly three times per slope, and the mean value from the three collections was applied to each indicator. Through the algorithm shown in the following figure, it was determined if the area was safe from failure. The R-square of the discriminant function was not complete; thus, the sites should be thoroughly investigated, even if the discriminant score ( $Z$ ) is higher than zero. If soil failure or erosion should occur, even if the discriminant score was higher than zero, the cause might be a structural problem or an unexpected drainage system problem.

Figure 21. Slope Revegetation Stability Evaluation Analysis Model (SRSEA).

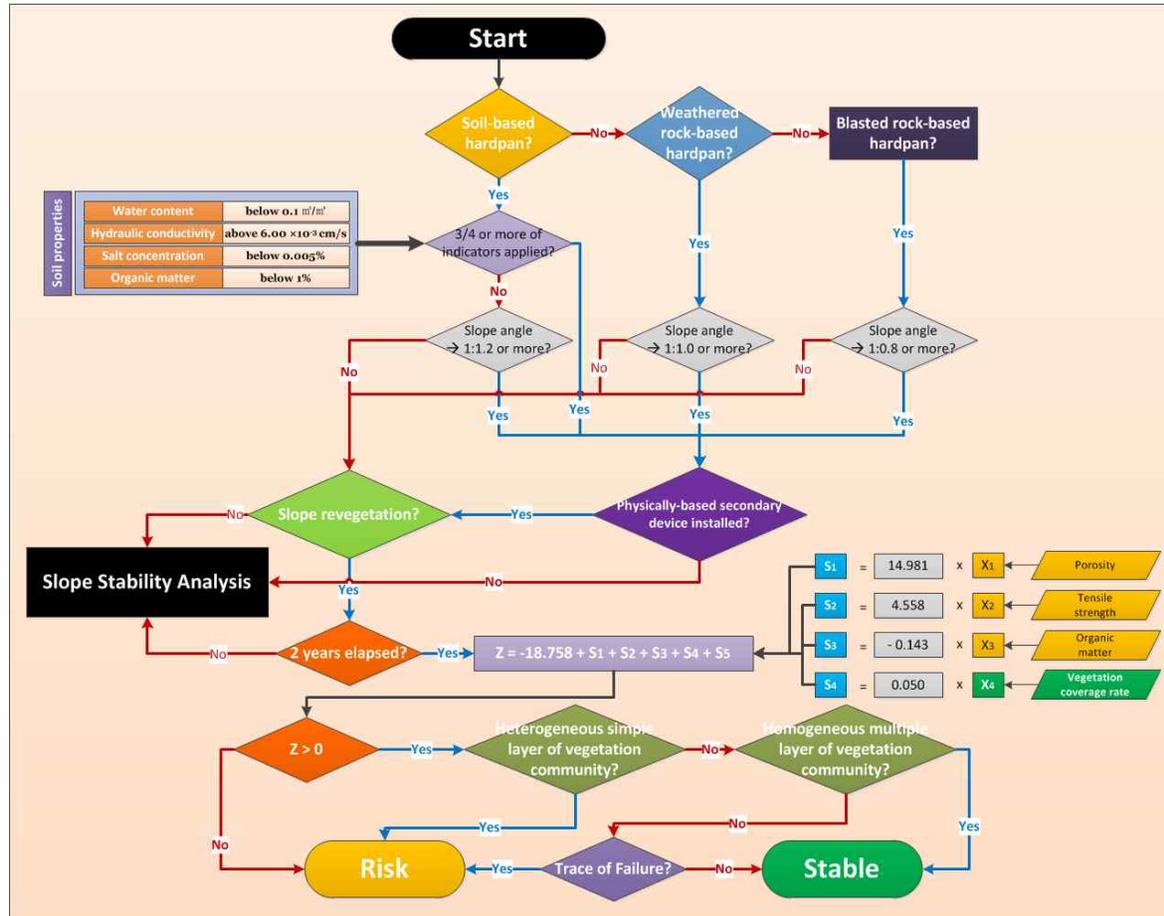
Even though the elapsed time of slope revegetation sites using artificial soil is more than two years, soil quality and vegetation establishment could be poor. In that case, the discriminant function developed in this study could identify the quality of the artificial soil and vegetation conditions to determine if the site is stable or a potential risk of soil erosion or failure. The following algorithm (Figure 22) regarding the above results was schematized.

Figure 22. Application of SRSEA.

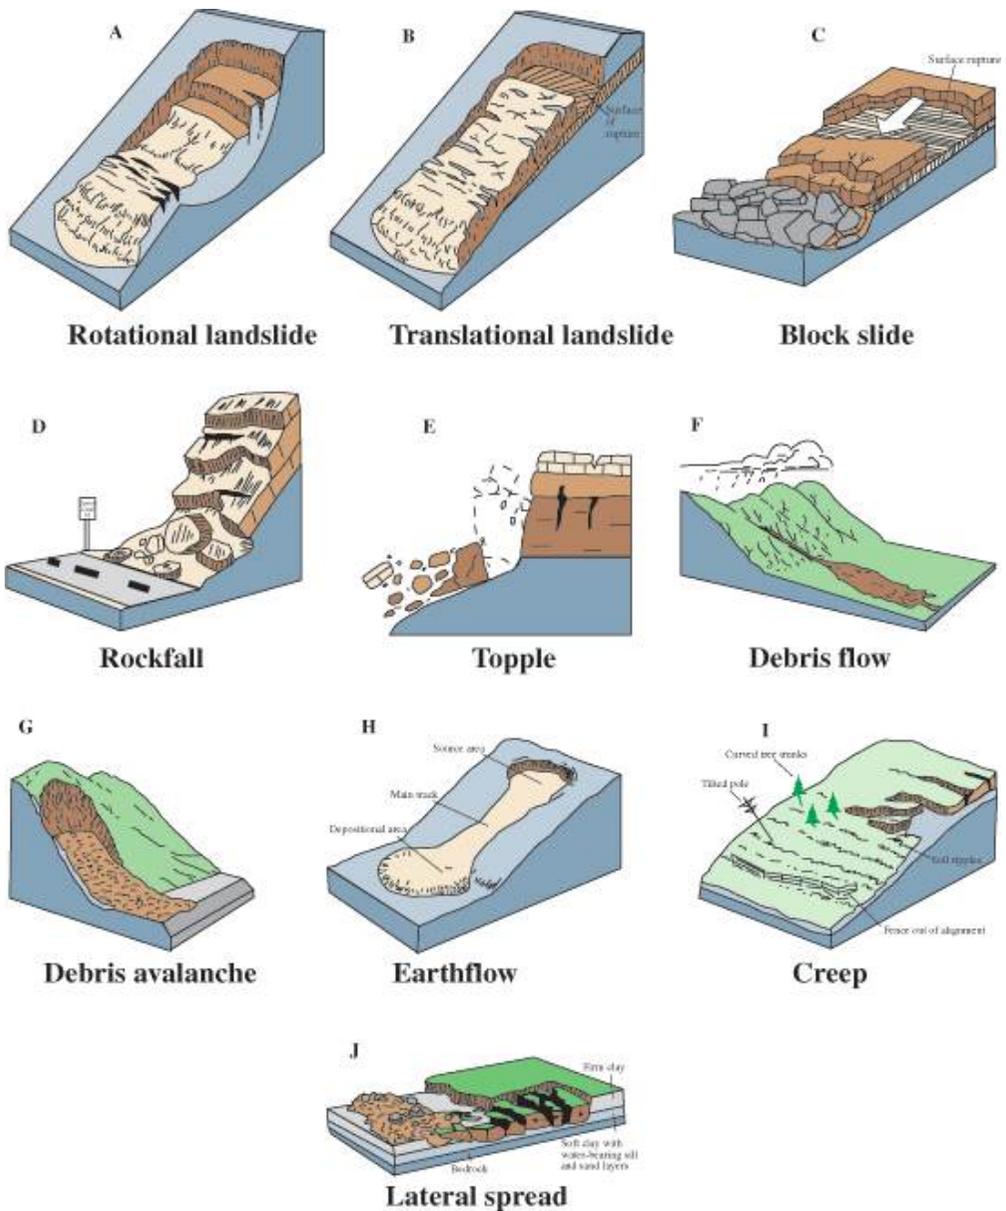
Figure 1. These schematics illustrate the major types of landslide movement(permitted by USGS, U.S. Geological Survey).

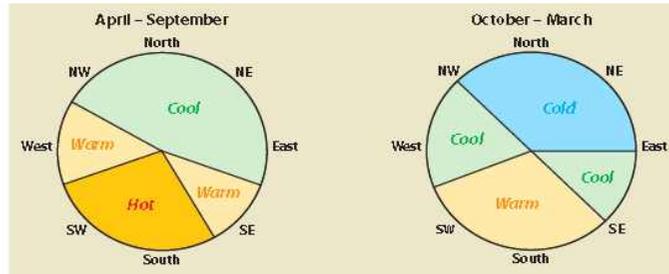
plant biomass and vegetation coverage was low in southern, south-western and south-eastern slopes. And the order was  $S < SW < SE$  (Cano et al, 2002). In addition, The aspect affects on soil cohesiveness and stability since it triggers variation in moisture content of a soil and degree of a weathered soil (Cho, N.C. et al., 2006).

Figure 2. Site climate changes throughout the year depending on aspect(David et al., 2007. p. 67.).

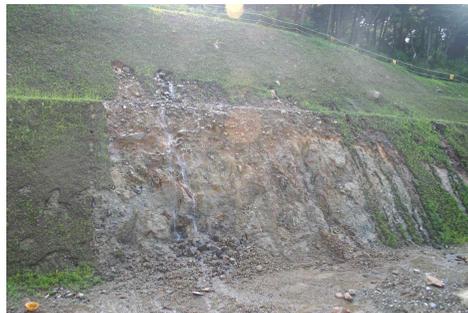
The presence of seeps in a slope could be concerned about construction faults of slope revegetation in the expert interview. The construction faults were caused by the outflow of water according to the level of underground water frequently occur. The Figure 3 below expresses well. This situation doesn't usually happen. However, arid and minute layer in ground water become saturated in rainfall and then abruptly flows water out. It makes streamlet erosion.

Figure 3. Seepage erosion (located at the side of road construction in Geo Je Island, taken by me (Aug. 12. 2010)).

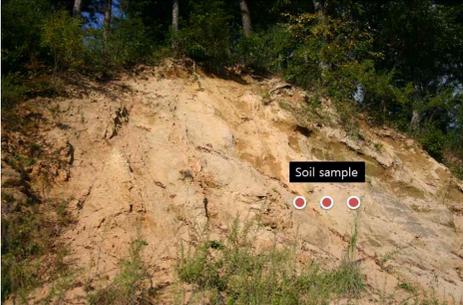
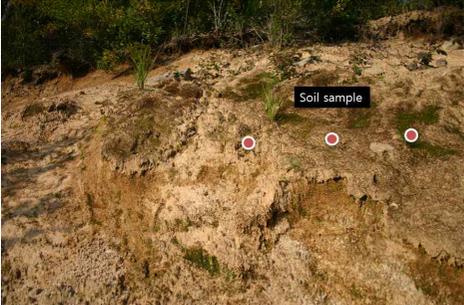
### ■ Site 1 : Pyungchang-gun Bongpyung-myeon Mui-ri San 56, Gangwon-Do

< Failure > (sample location)	< Potential Risk > (sample location)

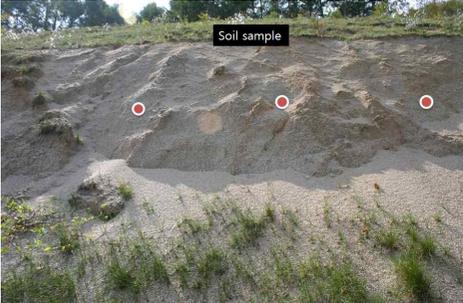
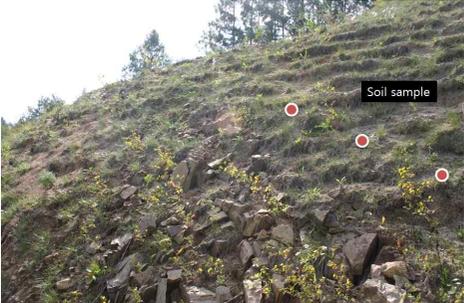
### ■ Site 2 : Pyungchang-gun Jinbu-myeon Songjung-ri San 266, Gangwon-Do

< Failure > (sample location)	< Potential Risk > (sample location)

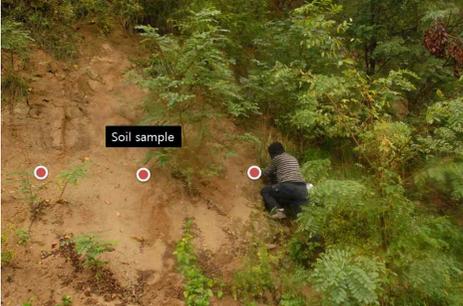
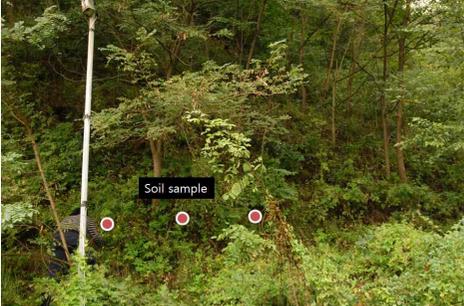
■ Site 3 : Pyungchang-gun Jinbu-myeon Hajinbu-ri San 16, Gangwon-Do

< Failure > (sample location)	< Potential Risk > (sample location)

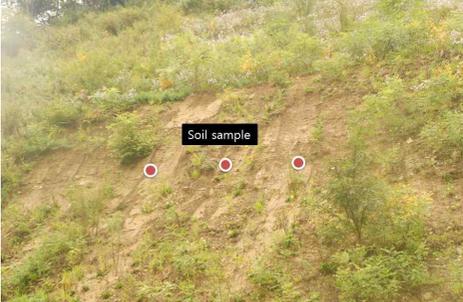
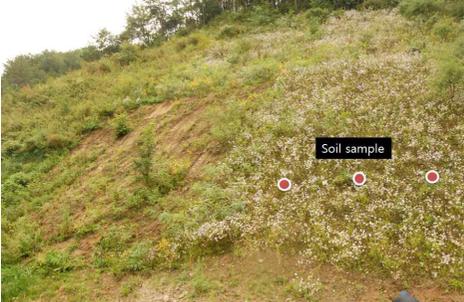
■ Site 4 : Pyungchang-gun Jinbu-myeon Hajinbu-ri San 474, Gangwon-Do

< Failure > (sample location)	< Potential Risk > (sample location)

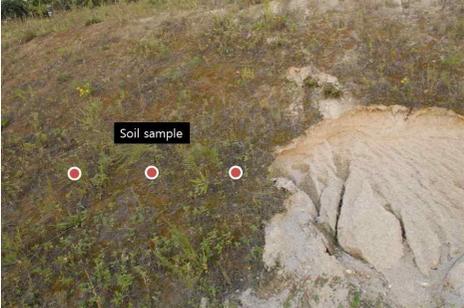
■ Site 5 : Yangyang-gun Hyunnam-myeon Juk-ri San 7-1, Gangwon-Do

< Failure > (sample location)	< Potential Risk > (sample location)

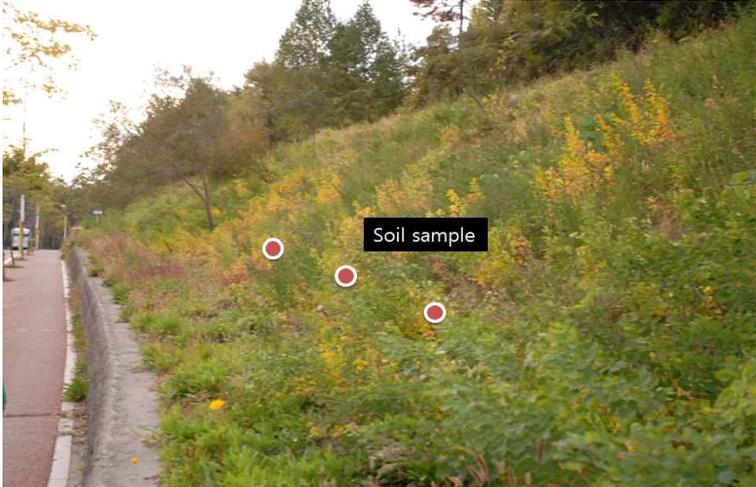
■ Site 6 : Chuncheon-si Onui-dong San 38, Gangwon-Do

< Non-failure > (sample location)
