Isolated Fracture of the Ceramic Head After Third-Generation Alumina-on-Alumina Total Hip Arthroplasty

Kyung-Hoi Koo, Yong-Chan Ha, Woon Hwa Jung, Sang-Rim Kim, Jeong Joon Yoo and Hee Joong Kim
J Bone Joint Surg Am. 2008;90:329-336. doi:10.2106/JBJS.F.01489

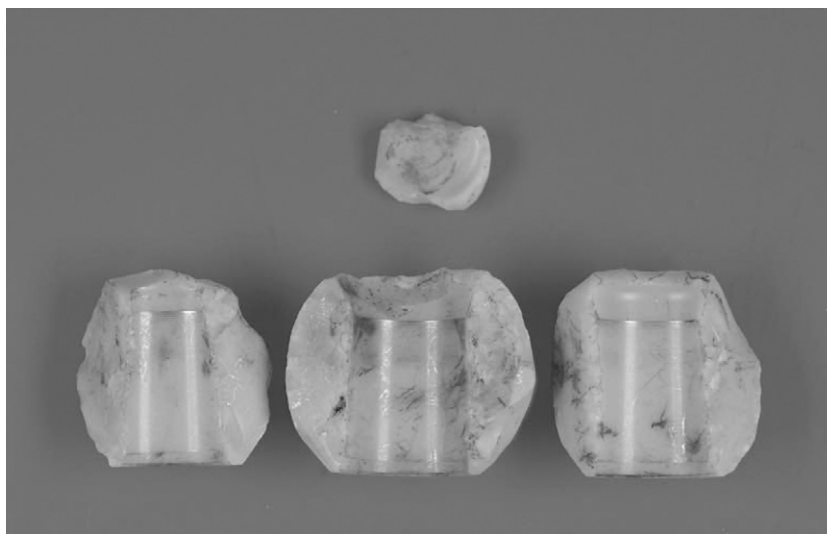
Fig. 3

Photograph of the fractured ceramic head component from one of our patients (Case 2), showing a circumferential crack at the dome and three vertical cracks. The fracture pattern suggests that the mechanism of ceramic head fracture was a brittle fracture at the thinnest circumferential portion of the head component. Dark metallic-like smears are seen on the fracture surface and the inner surface of the ceramic head.

All five ceramic head fractures demonstrated a similar pattern. A circumferential crack measuring 9 to 15 mm in diameter was found at the dome of the head, corresponding to the thinnest portion of the head adjacent to the proximal edge of the head bore. Three to five vertical cracks radiated from the circular crack to the lower edge of the head component. Consequently, the head component was fractured into one apical segment and several lateral segments (Fig. 3). In two cases (Cases 3 and 4, Table III), the apical segment was comminuted into several pieces. In all five cases, dark metallic-like smears were visible

on the fracture surface and the inner surface of the fractured ceramic head (the surface abutting the metal taper) (Fig. 3). In addition, in all five cases, dark metallic-like smears and multiple scratches were visible on the articular surface and the lip of the ceramic liner. Also, chip fractures were found at the peripheral rim of the ceramic liner in all five cases. The number of fracture sites ranged from one to three. The fractures measured 3 to 14 mm in length, 1 to 4 mm in width, and <1 mm in height. The trunion of the femoral stem was damaged with multiple scratches in all five cases.

In the present study, all five ceramic fractures occurred during normal daily activities in patients who had received a 28-mm short-neck ceramic head. The fracture involved the thinnest circumferential portion of the head adjacent to the proximal edge of the head bore, with several vertical cracks extending from the circular crack to the lower edge of the head component. The fracture pattern suggests that the mechanism of ceramic head fracture was a brittle fracture. A brittle fracture is characterized by rapid crack propagation with low energy release and without substantial plastic deformation.
