Master's Thesis of Engineering

**A Study on the Repair Method
of Roof Members
in Wooden-Structural Heritage**

**Graduate School of Engineering
Seoul National University
Architecture and Architectural Engineering**

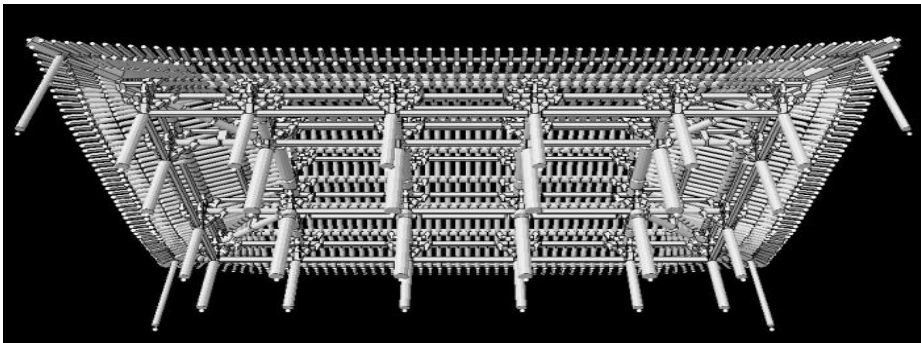
Figure 2-1 3D Modeling of Musangsujeon

As shown in the Figure 2-1, Jo et al. [4] performed 2D and 3D structural analysis of the Muryangsujeon Hall of Buseoksa Temple, a traditional wooden structure, using 『SAP 2000』, a general structural analysis program. The size of the main structural members of the building was designed using the existing drawing data. The material properties of red pine, such as the wood used for the Muryangsujeon Hall, were applied. The load was calculated by considering the tile load and the soil load. As shown in the Figure 2-2, the supporting conditions were varied according to the condition of the joint.

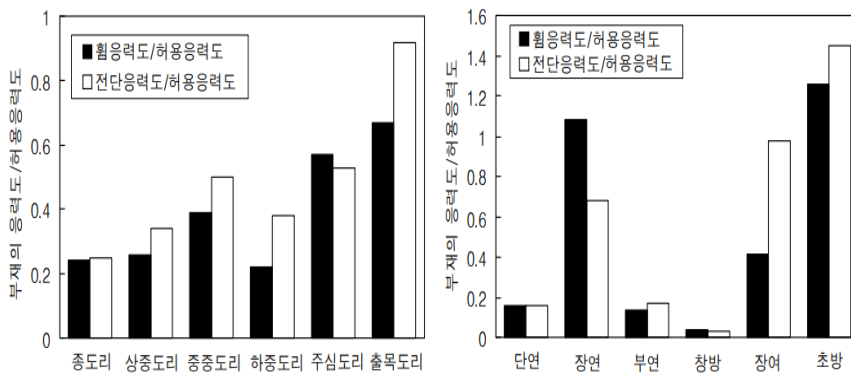
Figure 2-3 Allowable stress analysis result of roof member

As a result of the allowable stress analysis, there was little difference between the 2D and 3D structural analysis of the roof member. All Do-ri except for the Ju-sim Do-ri showed high shear stress. In the case of Yeon-mok, the bending stress was high, and in the case of the Bu-yeon, the shear stress was high. Most of the results were lower than the allowable stress, but Chul-mok Do-ri, Jang-yeon, Jang-yeo, and Cho-bang had higher than the allowable stress.

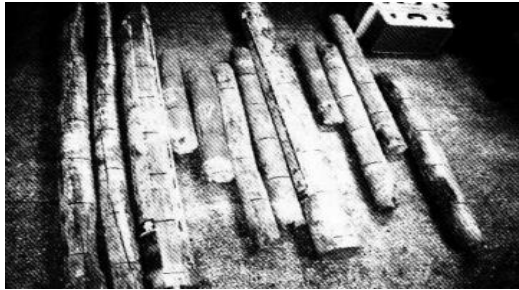
Figure 2-4 The evaluated woods for NDT study

Lee et al. [5] performed non-destructive testing of wood (Figure 2-4) used in traditional wooden structures. Non-destructive testing of main structural members was conducted by ultrasonic stress wave test, drilling resistance test, and visual inspection. The internal cross section was identified through ultrasonic stress wave test and drilling resistance test. After that, the wood was cut and visually inspected.

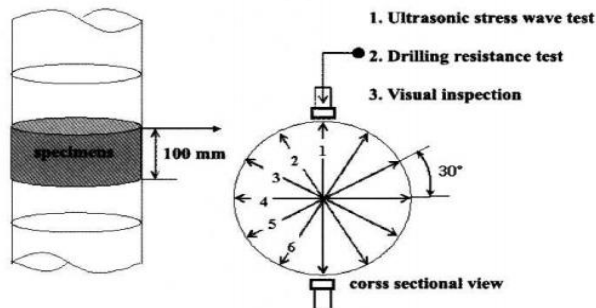
Figure 2-5 Measured positions of non-destructive testing in woods.

ultrasonic stress wave test and drilling resistance test were performed with an interval of 100mm (Figure 2-5). The drilling resistance test was carried out by moving 30 ° clockwise in the circular cross section. After the non-destructive test, the cross section was cut, and the visual inspection was performed. The results of visual inspection and non-destructive test were compared and analyzed.

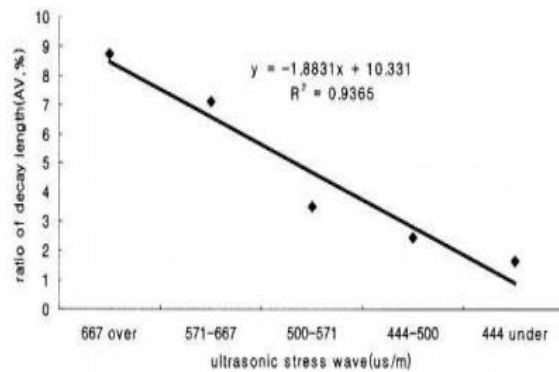
Figure 2-6 USW and ratio of decay length caused by DRT.

The correlation between the ultrasonic stress wave test and drilling resistance test was shown in the Figure 2-6. The cross section made based on the drilling resistance test result and the actual cross section are compared as shown in the Figure 2-7.

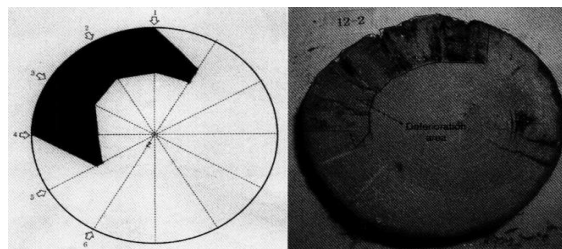
Figure 2-7 The comparison of artificial picture and real cross-section.

Comparing the results of the non-destructive test and the visual inspection, similar shapes were derived for the cross-sectional loss. Non-destructive testing can qualitatively determine the loss of a section and compare the loss of each section within the same member. To derive quantitative results, there are insufficient research results according to tree species, age, and moisture content. Therefore, there is a limit to evaluating the residual strength of a member only by non-destructive analysis.

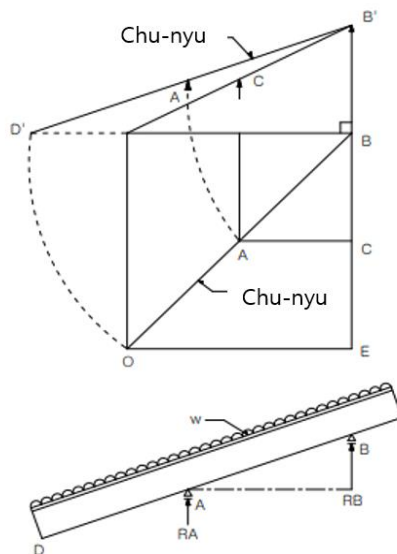
Figure 2-8 The slope of a roof and structural points of Chu-nyu

As shown in the Figure 2-8, he analyzed the structural characteristics of Chu-nyu and calculated the reaction point, the loading point, and the load. The reinforcing section of Chu-nyu was reinforced by inserting two carbon fiber bars by digging a groove on the upper surface as shown in the Figure 2-9.

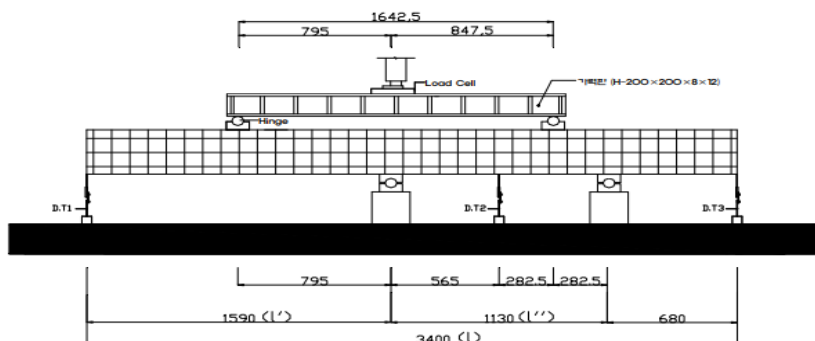
Figure 2-10 The experimental setup of Chu-nyu

As shown in the Figure 2-10, the experiment was conducted by applying a concentrated load to two points, which are the locations where the actual roof load was concentrated, using the UTM(Universal Testing Machine) as shown in the figure. Displacement was measured by installing the LVDT(Linear Vertical Displacement Transducer) at the left end, right end, and middle of the reaction point.

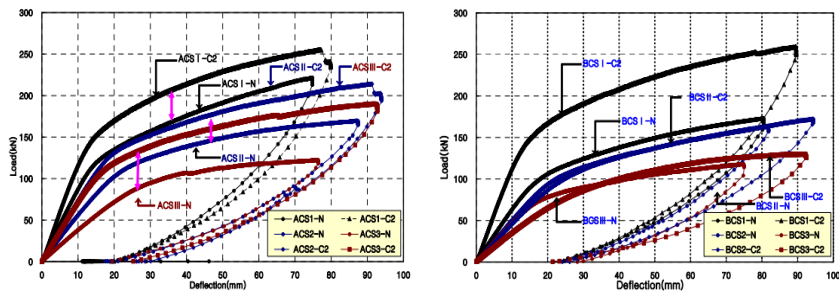
Figure 2-11 Comparison of load-deflection curves of specimens

Although there is a difference according to the ratio of the overhanging length, as shown in the Figure 2-11, the yield load and ultimate load of the

reinforced specimen were overall increased compared to the reference specimen. As the overhanging length increased, the yield load decreased. As shown in the Figure 2-12, when the overhanging length was 1:1, the reinforced specimen increased, but as the overhanging length increased, it showed a tendency to become like that of the reference specimen.

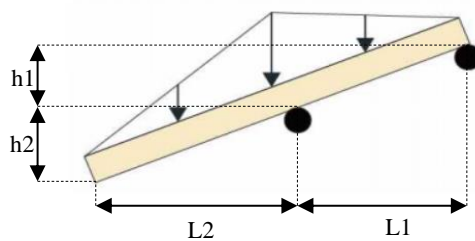
Figure 3-1 Length and height measurement for structural review of Chu-nyu

Due to the characteristics of traditional wooden structures, the Chu-nyu is a nonlinear structure, and it is difficult to accurately calculate the loads of the Yeon-mok and Chu-nyu. Therefore, the load acting on the roof surface of the square area around the Chu-nyu was assumed to be supported by the Chu-nyu and calculated conservatively. The load on the square plane with the diagonal of the Chu-nyu was replaced with a linear load, and the load was applied in a triangular shape. The Chu-nyu of Jeongyodang Hall in Dosanseowon Confucian School, Lecture Hall of Sosu Confucian Academy, Yangjindang House can be approximated in the form of a simple beam with two reaction points at the Cheoma Do-ri and at Jung Do-ri. In the case of the Namhansanseong Suengyeoljeon Hall, there is no Chu-nyu with a gable roof. The roof load was assumed to be $7.5kN/m^2$ [7].

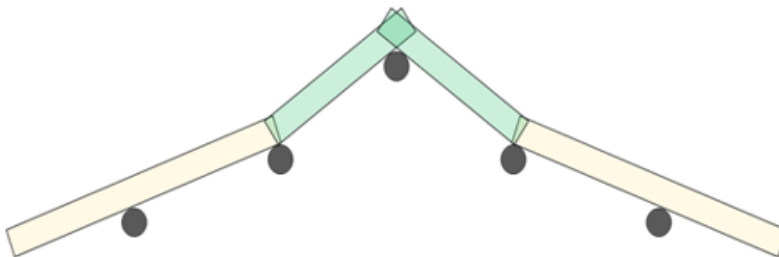
Figure 3-2 Example of Yeon-mok in the form of a simple beam

The load was considered Yeon-mok's self-weight and roof load. The roof load considered the weight of the roof tile and the weight of soil. As shown in Figure 3-2, it is assumed that the load is supported on the Do-ri as a point through the Yeon-mok in the form of a simple beam, and the load is applied to each of the Do-ri by calculating the reaction force. The soil load was assumed to be a linear distributed load, and the soil thickness ($h_1 \sim h_4$) (refer to Figure 3-3) and unit weight were assumed and reflected in the calculation.

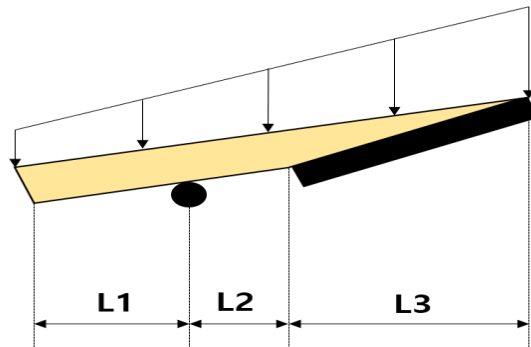
Figure 3-5 Calculation of reaction point for structural review of Bu-yeon

It is only found in Lecture Hall of Sosu Confucian Academy and Namhansanseong Suengyeoljeon Hall, which are double eaves. Structural analysis was conducted by referring to the actual drawings of Lecture Hall of Sosu Confucian Academy and Namhansanseong Suengyeoljeon Hall. In the Yeon-mok structural analysis, the soil thickness (Table 3-4) and the horizontal length (Table 3-6) were used to calculate the soil load and tile load. Modeling was performed in the form of a simple beam that is the same as the actual condition of Bu-yeon. In the case of the root part, the cross section becomes smaller toward the edge. Bu-yeon is in contact with the upper surface of Yeon-mok from the part where the cross section becomes smaller to the edge.

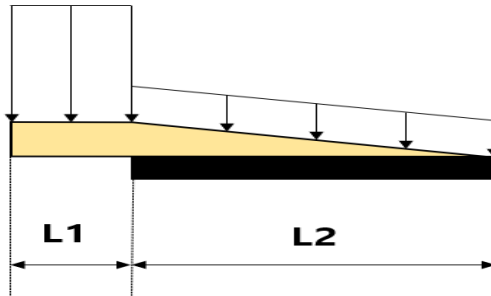
Figure 3-6 Model for measuring the horizontal length of Mok-gi-yeon

Structural analysis was performed by referring to the actual drawings of Jeongyodang Hall in Dosanseowon Confucian School, Lecture Hall of Sosu Confucian Academy, Yangjindang House, Namhansanseong Suengyeoljeon Hall. The location of Mok-gi-yeon is on the gable board, and the load of gable ridge is concentrated on the head of Mok-gi-yeon. The roof tile load was calculated by calculating the number of tiles of the ridge. The expected load was conservatively calculated by referring to the design drawings and repair reports of each structure. The structural system has a free end on the outside

and is supported on the inside based on the gable board. Therefore, it becomes a cantilever beam type.

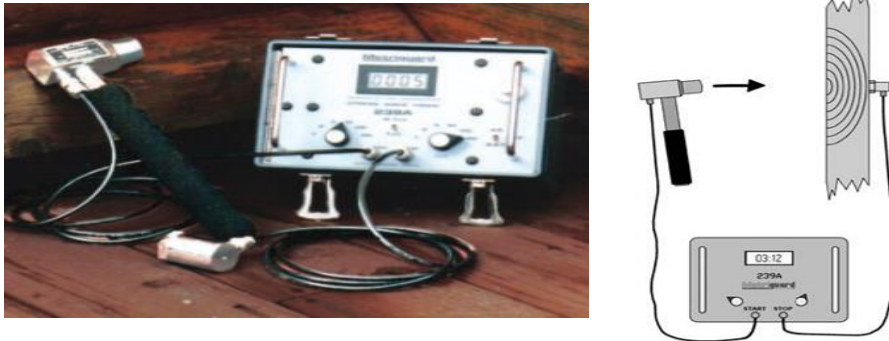
Figure 4-1 Stress wave measuring device (Metriguard 239A)

Using Metriguard's 239A model, the stress wave transmission time through the specimen was measured. This device consists of a hammer that generates a stress wave, a detector that detects the stress wave, and a main body that measures and displays the time when the stress wave generated from the hammer reaches the detector.

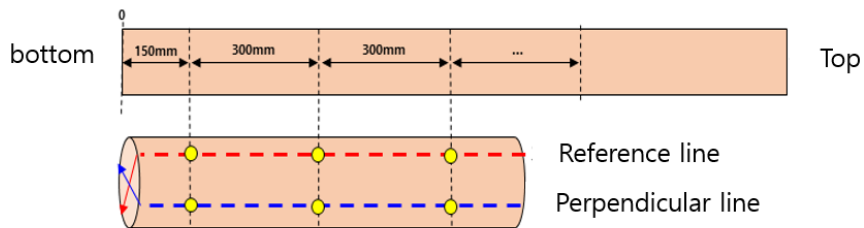
Figure 4-2 Stress wave test method

As shown in Figure 4-2, the original sphere (bottom of the column) of the dismantling member was set as 0, and the reference line was set in the longitudinal direction. The measurement was started from a position 150 mm away from the lower part in the longitudinal direction, and measurements were taken with 300 mm in the longitudinal direction. For the member of the circular cross section, a stress was applied to the reference line, and the time during which the stress wave was transmitted from the opposite side was measured. In addition, the stress was applied at a point perpendicular to the reference line and the time at which the stress wave was transmitted from the opposite side was also measured. Measurements were made five times at the same location, and the average value excluding the highest and lowest values was used as the time through which the stress wave penetrated. The distance through which the stress wave was transmitted was measured, and the measured distance was divided by the time at which the stress wave was transmitted to derive the stress

wave transmission speed. The stress wave transmission speed was obtained by the following equation.

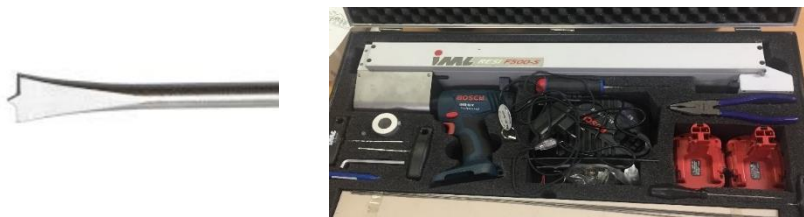
Figure 4-3 Drill resistance device (IML F500-S)

IML's F500-S model was used to measure the resistance force generated while the drill blade of the testing machine passed through the damaged member. A drill blade having a diameter of 3 mm and a length of 500 mm was used, and the experiment was conducted by selecting the tree species as softwood in the setting of the experimental device.

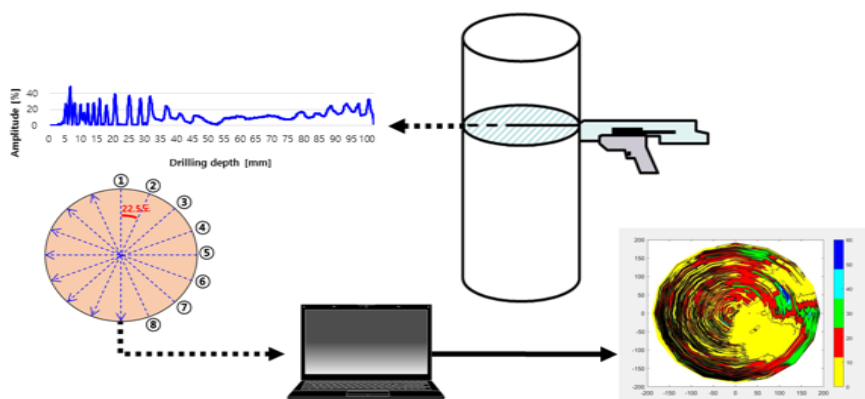
Figure 4-4 Drill resistance test

The drill resistance test was carried out at the same position as the measured position of the stress wave test. If it is judged that there is internal deterioration, to diagnose the internal condition, measure 8 times at 22.5 degree intervals on the same cross-section as shown in Figure 4-4. CT images of the cross section were constructed using the Matlab program. The internal deterioration was estimated by displaying the areas with high and low drill resistance in different colors. Low drill resistance values are expressed in yellow (approximately 10% or less), high drill resistance values are expressed in blue (approximately 50% or more), and black parts indicate normal wood.

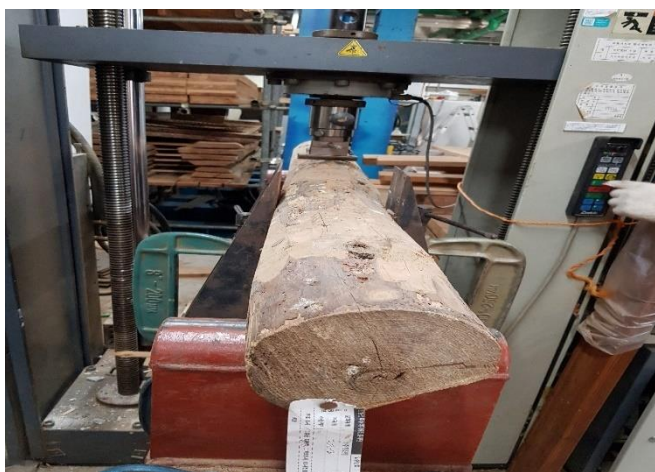
Figure 4-5 Flexural test

The whitening experiment was performed using a universal strength tester (manufactured by Zwick, maximum load 10kN). The test conditions of Yeon-mok were crosshead speed 5mm/min, span was 3,000mm, 2,400mm, and 1,600mm depending on the length of the test piece, and the load condition was centralized load, and the support condition was simple support.

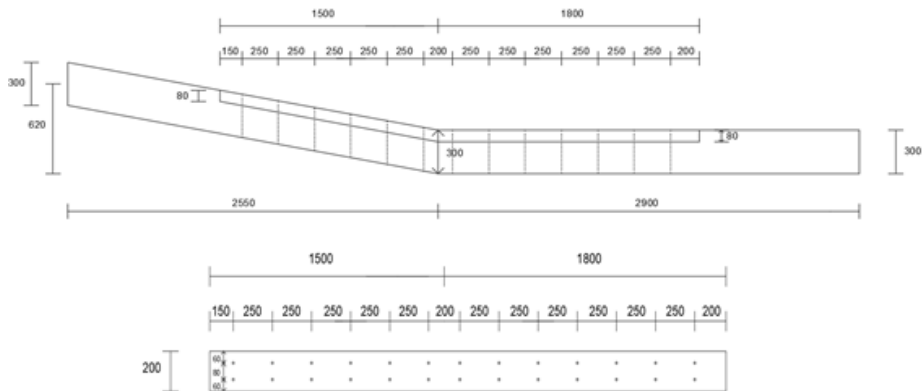
Figure 5-2 Detail of the repaired member (Chu-nyu)

The reference member (Figure 5-1) and the repaired member(Figure 5-2) were manufactured based on Chu-nyu of Jeongyodang Hall in Dosanseowon Confucian School (width b : 200mm). The decay of Chu-nyu of Jeongyodang Hall was confirmed to be about 80mm from the upper surface. When manufacturing the repaired member, it was assumed that this part was removed to insert the backing wood. The backing wood was made with a thickness of 80 mm.

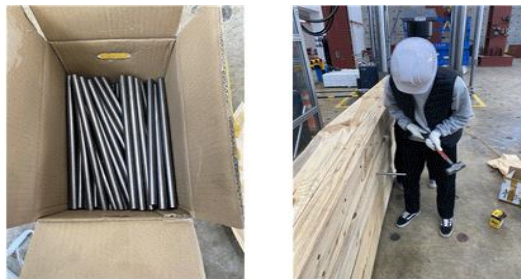
Figure 5-3 Titanium bar and inserting process

After making a hole of 14 mm in the repaired member, the titanium bar (Diameter: 15 mm, Length: 30 cm) was inserted by hitting it with a hammer (Figure 5-3).

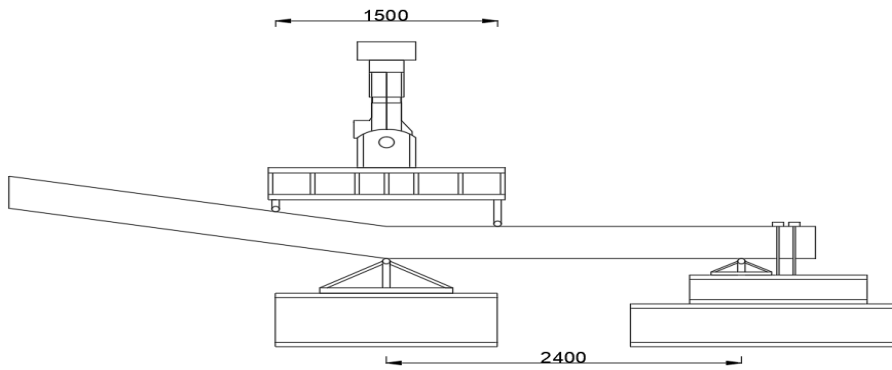
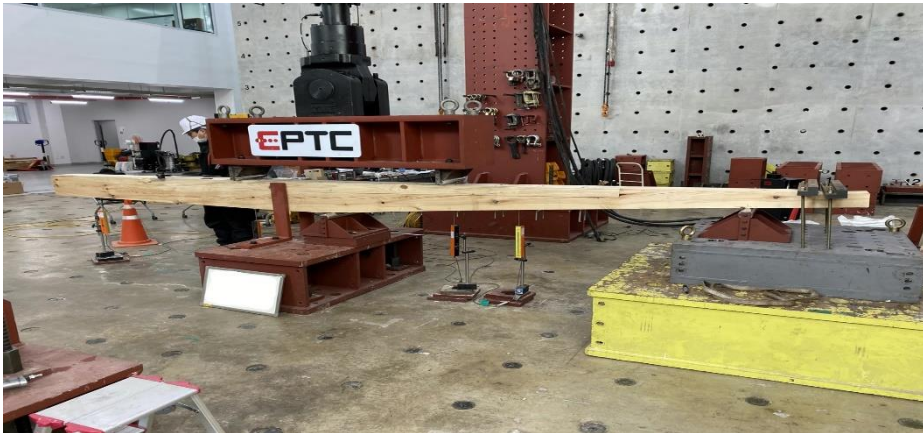
Figure 5-4 Test set-up (Chu-nyu)

The end of the specimen was set to support the root part like an actual Gang-da-ri or Chu-nyu-jeong, so, 500 mm of the root part was fixed with a steel jig as shown in the Figure 5-4, like the end condition. The reaction point was placed on the Jung Do-ri point and the Cheoma Do-ri. The distance between the

reaction points was set to 2,400 mm, and the distance between the loading points was set to be 1,500 mm. The loading was performed with a 150-ton actuator, and the loading speed was performed at 3 mm/min.

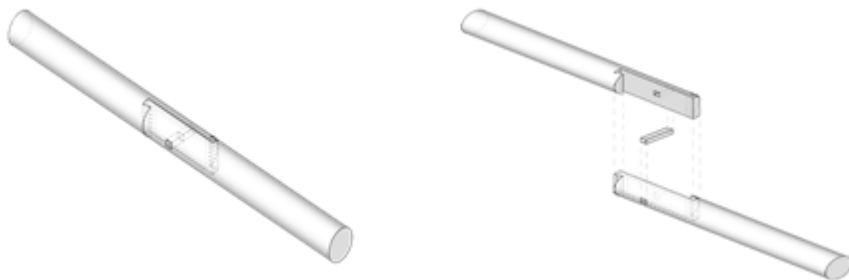
Figure 5-5 The modified butt joint

The Yeon-mok of Jeongyodang Hall in Dosanseowon Confucian School, Lecture Hall of Sosu Confucian Academy, Yangjindang House, Namhansanseong Suengyeoljeon Hall mainly have unbalanced decay of the upper surface, decay of the ends, and cracks in members. In the case of non-reusable members, after cutting the problematic part, a modified butt joint can be applied as shown in the Figure 5-5. In this experiment, Yeon-mok were designed by considering the ratio of the butt joint between Ha-jung Do-ri used in the Daejeokgwangjeon Hall of the Gwisinsa Temple. This experiment tries to figure out the bending performance of the designed Yeon-mok.

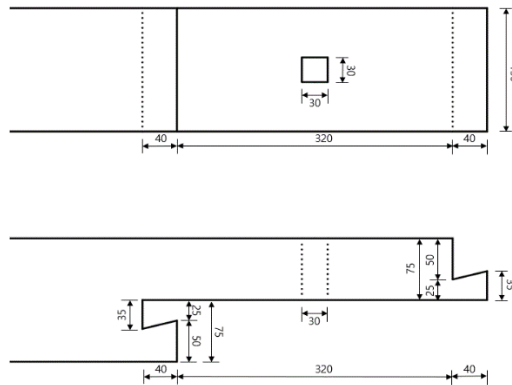
Figure 5-6 Detail of the repaired member (Yeon-mok)

The sizes of the reference member and the repaired member of Yeon-mok were produced with the average of the members provided by the foundation. The diameter was 150mm, the Jang-yeon's length was 3m, and the Dan-yeon's length was 2m. For the repaired member, referring to the actual measurement

drawings, a straight tenon was produced as much as $2/3$ of the radius, and the straight tenon was changed to the form of a rake. The joint length of the repaired member was set to 400 mm, and the length of the tenon groove was set to $1/10$ the joint length. The member of the Daejeokgwangjeon Hall was reinforced with steel nails to prevent slipping in the center part of the side. When the lower surface is exposed to the ceiling, a square wooden nail ($30\text{mm}\times 30\text{mm}$) was inserted in the actual experiment in consideration of the aesthetics of traditional wooden structure. (Figure 5-6)

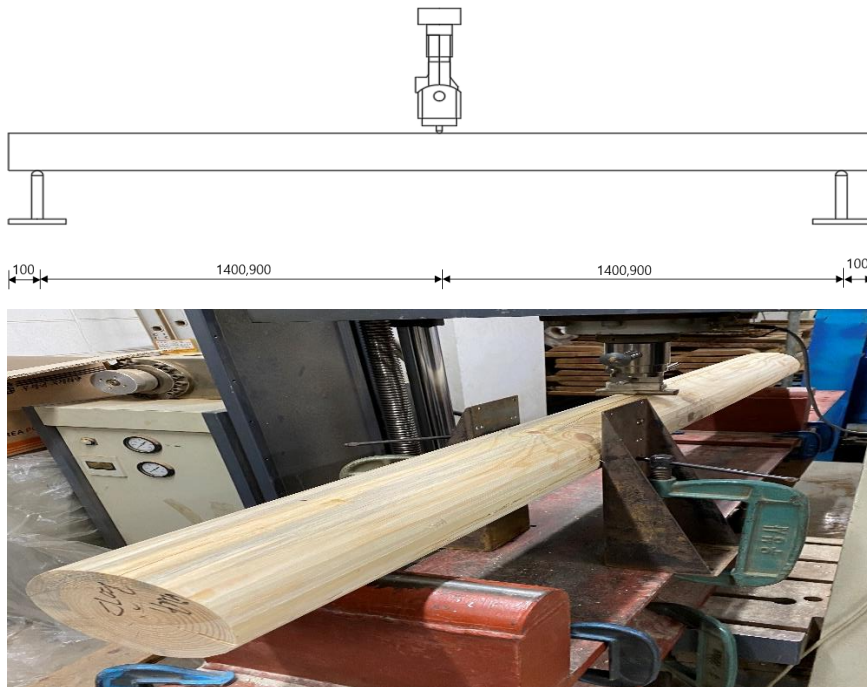
Figure 5-7 Test set-up (Yeon-mok)

test. Since the cross section of the Yeon-mok is circular, a support for preventing fall was installed at a distance of 200 mm from the center (Figure 5-7).

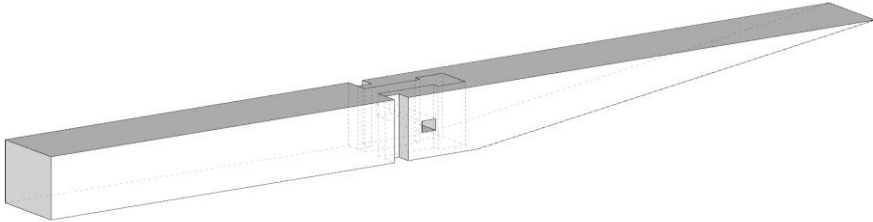
Figure 5-8 The tusk tenon joint (Bu-yeon)

It was found that the length of the Bu-yeon of Lecture Hall of Sosu Confucian Academy provided by the foundation was shortened due to damage to the fixing nail part of the back root, and the cross section was reduced due to severe damage to the side part. If the repair method is considered based on this, it is difficult to apply the oblique scarf joint and the butt joint. Therefore, this

experiment tries to figure out the flexural and shearing performance of the designed Bu-yeon by applying a tusk tenon joint (Figure 5-8).

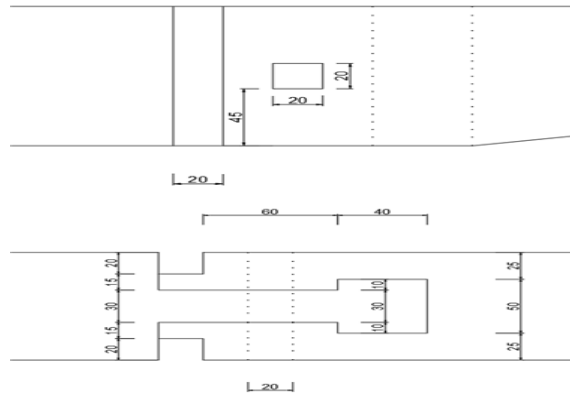
Figure 5-9 Detail of the repaired member (bu-yeon)

The sizes of the reference member and the repaired member of Bu-yeon were manufactured based on the experimental members provided by the foundation. The cross section (width \times height) of Bu-yeon was set to be 100mm \times 110mm, the length was 1200mm, the head to Bu-yeon Chak-go was set to 500mm, and the groove to the Bu-yeon Chak-go was set to 20mm \times 20mm. From Bu-yeon Chak-go to the root, 680 mm was set, among which, the section with a constant section was set to 100 mm, and the section with a decreasing section was set to 580 mm. The repaired member was made using tusk tenon joint. The total length of the tenon is 120mm, of which the length of the tenon neck is 80mm, the width of the tenon neck is 30mm, the length of the tenon head is 40mm, and the width of the tenon head is 50mm. A square wooden nail (20mm \times 20mm) was inserted because a gap occurred due to a manufacturing error when the head and the root of the repaired material were combined.

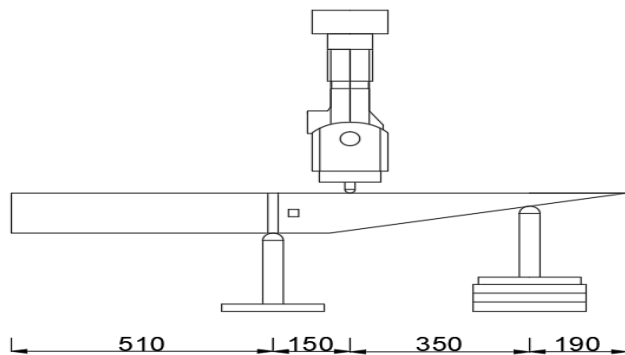
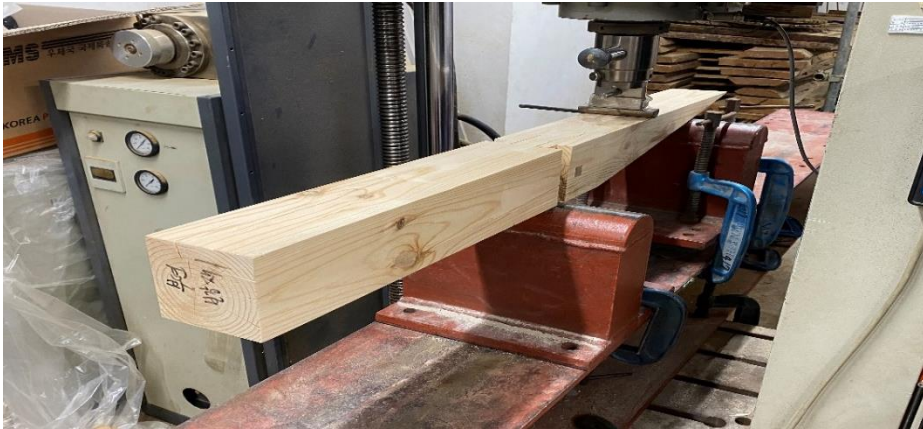
Figure 5-10 Test set-up (Bu-yeon)

The members of Bu-yeon had a length of 1200 mm and a reaction point of 510 mm at the head, which is the Bu-yeon Chak-go, and 190 mm at the root, referring to the shear force diagram in Chapter 3. Structural Analysis. The loading point was set at 540 mm from the root, which is the center of the resultant force of the tile load and the soil load. The loading was carried out using a 10-ton UTM machine, and the loading speed was 5 mm/min.

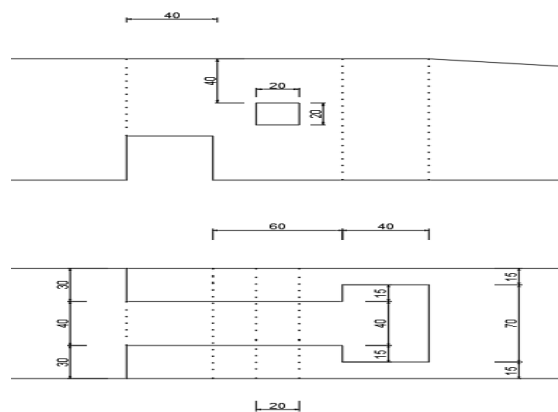
Figure 5-12 Detail of the repaired member (Mok-gi-yeon)

The size of the reference member and the repaired member of Mokgi Yeon was manufactured based on the experimental members provided by the foundation. The cross section (width \times height) of Mok-gi-yeon was set to 100mm \times 110mm, the length was 1340mm, the head to the gable board was 200mm, and the gabled groove was set to 40mm \times 40mm. The length from the gable board to the root was 1100 mm. Among them, the section in which the cross section of the root part is constant was set to 100 mm, and the section in which the cross section was decreased was set to 1000 mm. The repaired member was made using tusk tenon joint. The total length of the tenon is 140mm, of which the length of the tenon neck is 100mm, the width of the tenon neck is 40mm, the length of the tenon head is 40mm, and the width of the tenon head is 70mm. A square wooden nail (20mm \times 20mm) was inserted because a gap occurred due to a manufacturing error when the head and the root of the repaired material were combined.

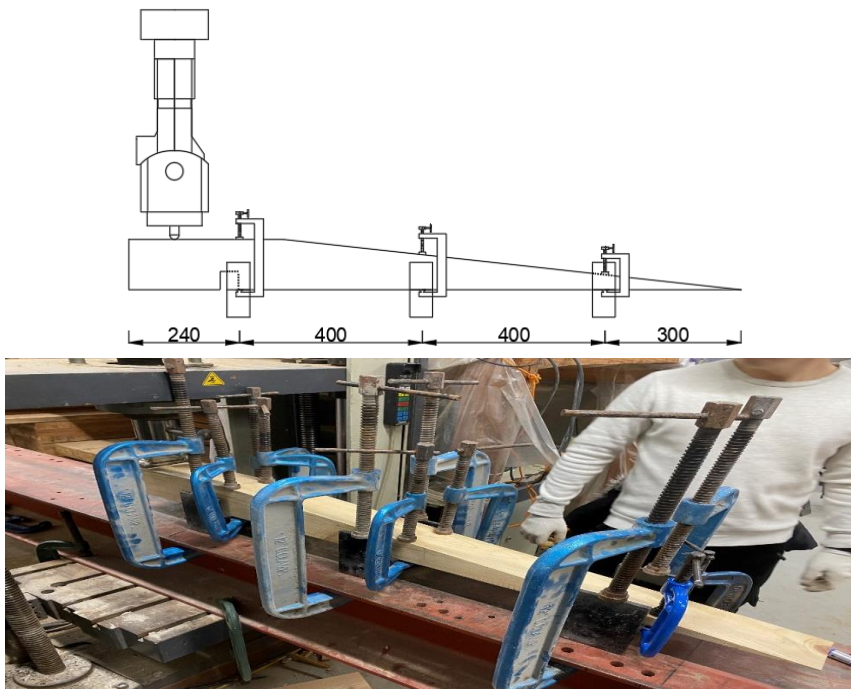
Figure 5-13 Test set-up (Mok-gi-yeon)

The members of mok-gi-yeon are 1340 mm. With reference to the actual measurement drawings, the upper surface of Jang-yeon, which is the actual reaction point of Mok-gi-yeon, was assumed as the reaction point. The assumed reaction point is 240mm from the head, which is the gable board point, and 300mm and 700mm from the end of the root, which is the upper surface of Jang-yeon. Since the lifting of the root part occurs when the head part is loaded, the steel jig and the member were fixed with clamps. The loading point was set as the 100mm point of the head where the load of the gable ridge is concentrated. The loading was carried out using a 10-ton UTM machine, and the loading speed was 5 mm/min.

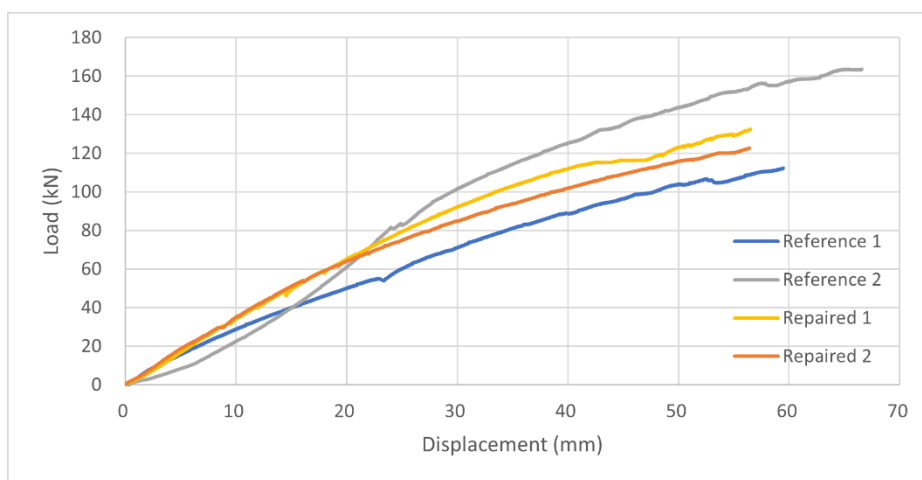
Figure 5-14 Load-Displacement curve (Chu-nyu)

The load-displacement curve (Figure 5-14 - Figure 5-18) was analyzed for the results of the Flexure test. Analysis of the results will proceed in the order of yield load, ultimate load, stiffness, and stress.

The reference member of Chu-nyu has a yield load of 90.44kN and an ultimate load of 138.02kN. The yield load of the repaired member was 80.96kN, which decreased by 10.5%. The ultimate load was 127.65kN, which decreased by 7.5% (Table 5-4).

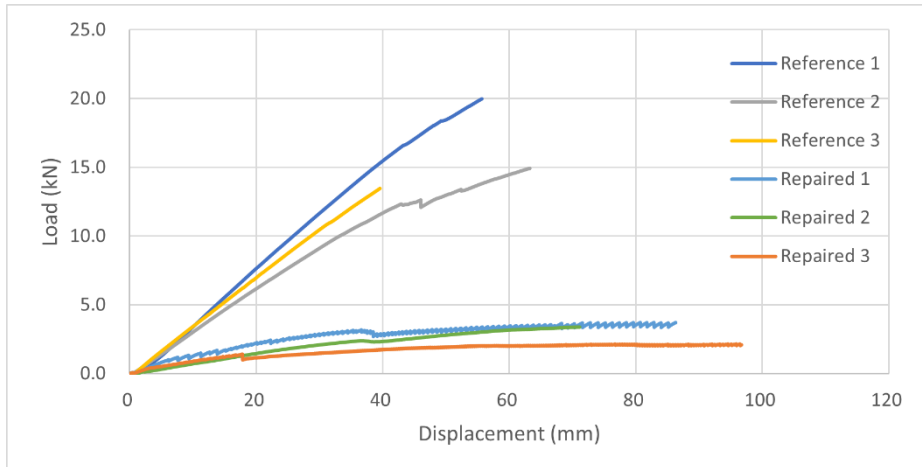
Figure 5-15 Load-Displacement curve (Jang-yeon)

The reference member of Jang-yeon has a yield load of 10.19kN and an ultimate load of 16.12kN. The yield load of the repaired member was 1.84kN, which decreased by 81.9%. The ultimate load was 3.09kN, which decreased by 80.9% (Table 5-5).

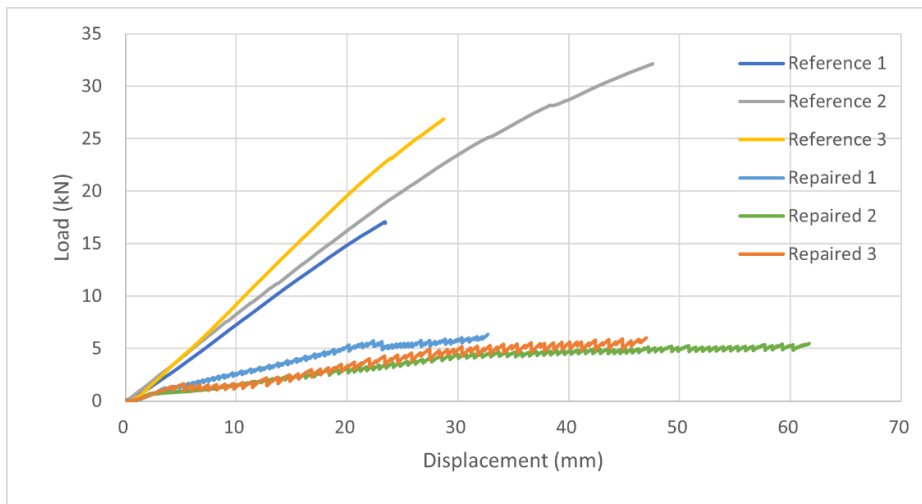
Figure 5-16 Load-Displacement curve (Dan-yeon)

The reference member of Dan-yeon has a yield load of 16.31kN and an ultimate load of 25.36kN. The yield load of the repaired member was 4.93kN, which decreased by 69.8%. The ultimate load was 5.95kN, which decreased by 76.5% (Table 5-6).

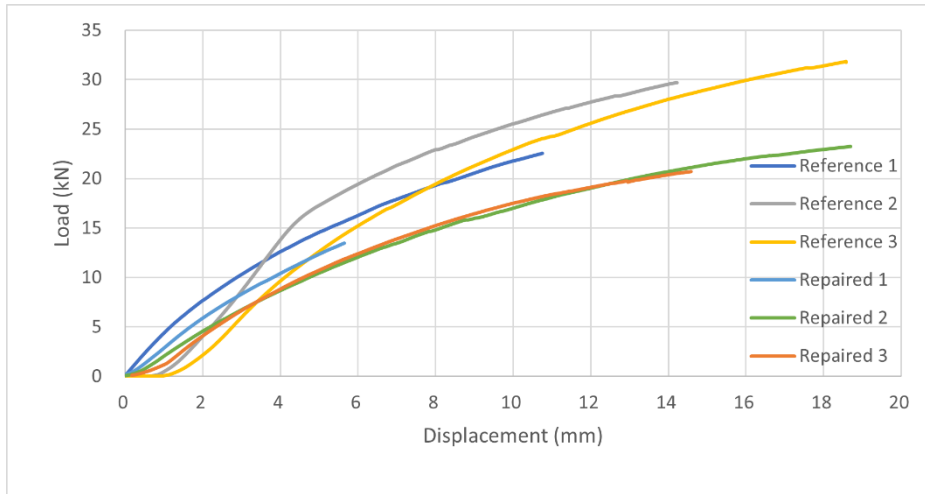
Figure 5-17 Load-Displacement curve (Bu-yeon)

The reference member of Bu-yeon has a yield load of 13.67kN and an ultimate load of 28.03kN. The yield load of the repaired member was 10.81kN, which decreased by 20.9%. The ultimate load was 19.14kN, which decreased by 31.7% (Table 5-7).

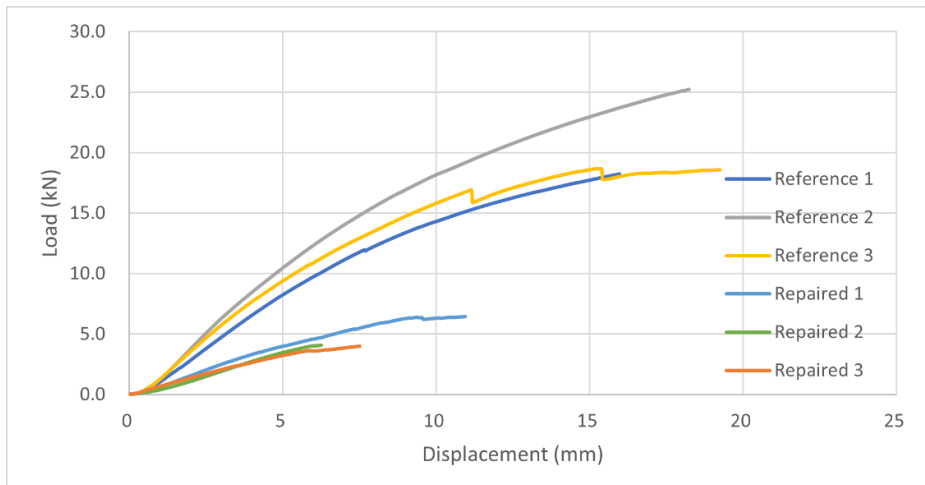
Figure 5-18 Load-Displacement curve (Mok-gi-yeon)

The reference member of mok-gi-yeon has a yield load of 12.18kN and an ultimate load of 20.72kN. The yield load of the repaired member was 3.02kN, which decreased by 75.2%. The ultimate load was 4.85kN, which decreased by 76.6% (Table 5-8).

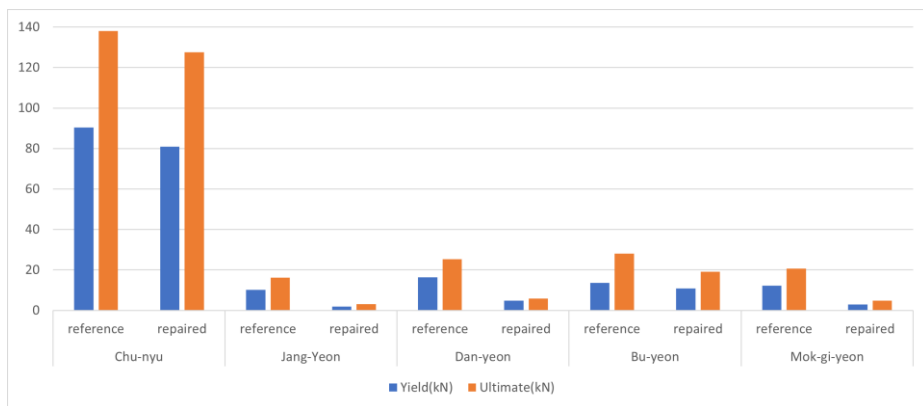
Figure 5-19 Comparing the yield and the ultimate load

As a result of comprehensive testing of roof members, it was found that the flexural strength of the repaired members by the traditional carpentry method

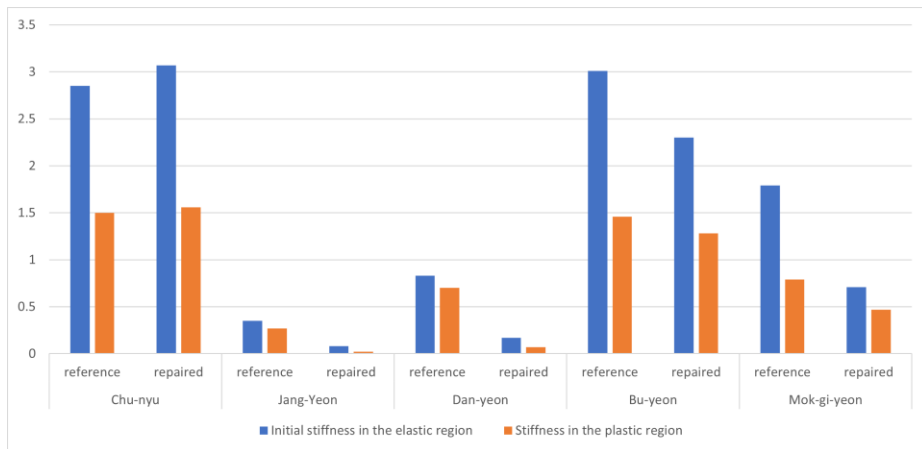
Figure 5-20 Comparing the stiffness

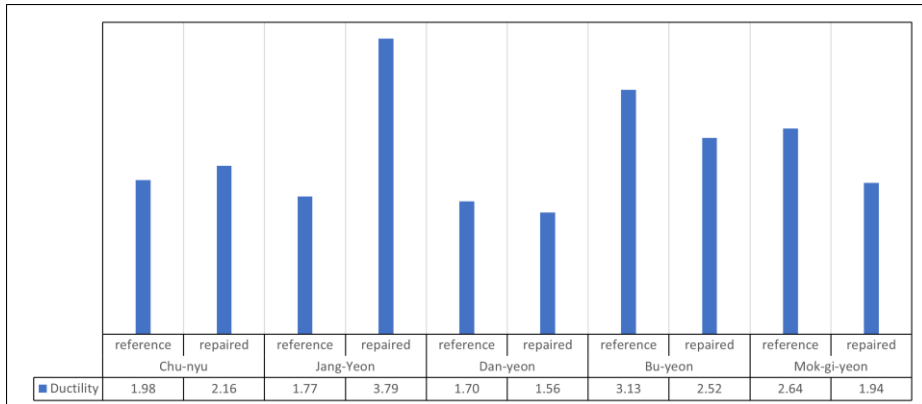
Figure 5-21 Comparing the ductility

Ductility (μ_u) applies the concept that a structure will fail when it can no longer support the load. Through the displacement (δ_y) at yield and the displacement (δ_u) at fracture of the member, the ductility coefficient was calculated by the following equation.

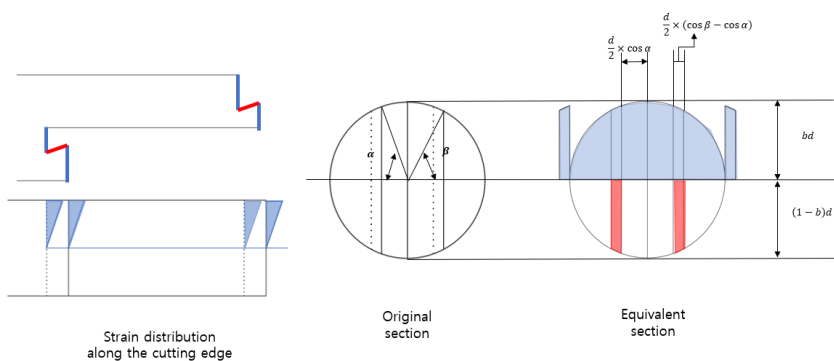
Figure 5-22 Equivalent section of modified butt joint

For modified butt joint, an equivalent cross-sectional model at the joint can be applied as shown in the Figure 5-22. Through the equivalent sectional model of the modified butt joint, the flexural strength ratio and flexural stiffness ratio between members can be estimated. If the curvature(k) at the joint and the height of the neutral axis are constant within the section, the position of the neutral axis and the moment of inertia of the equivalent section can be calculated through the force equilibrium condition. Additionally, it is assumed that the red area projected into the cross section of Yeon-mok resists bending. α is the angle between the neutral axis and the tenon neck, and β is the angle between the neutral axis and the tenon head. b is the ratio of the neutral axis, and d is the diameter of the Yeon-mok. In the Figure 5-22, the neutral axis passes through the center of the circle, but it is located closer to the top surface than the center of the circle. The equation derived by the force equilibrium condition is as follows.

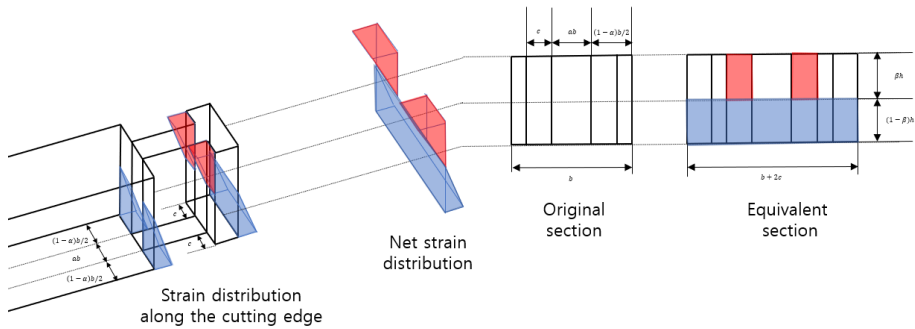
Figure 5-24 Equivalent section of tusk tenon joint

For tusk tenon joint, an equivalent cross-sectional model at the joint can be applied as shown in the Figure 5-24. If the curvature(k) at the joint and the height of the neutral axis are constant within the section, the position of the neutral axis and the moment of inertia of the equivalent section can be calculated through the force equilibrium condition. α is the ratio of the length of the tenon neck to the width of the member, β is the ratio of the height of the neutral axis, b is the width of the member, c is the width of the tenon head minus the width of the tenon neck, and h is the height of the member.

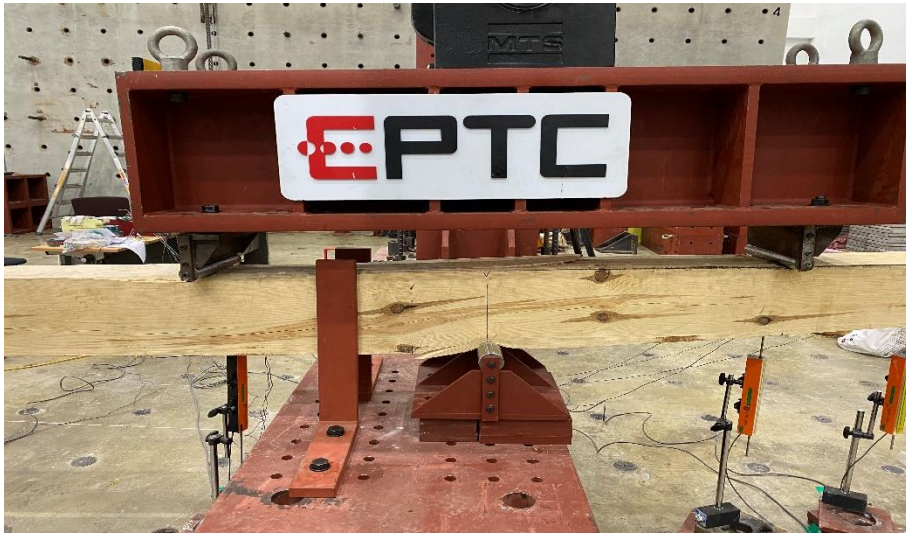
Figure Appendix.B. 1 Reference 1 of Chu-nyu

All measurement data were collected by a data logger through a LVDT (Linear Vertical Displacement Transducer). By converting the collected data, the relationship between load and stress and strain was analyzed. Since the yield load is not clear on the load-displacement graph, the intersection of the initial stiffness in the elastic region and the tangent in the plastic region was calculated as the yield load. The initial stiffness and stiffness in plastic region of the member were calculated with reference to ACI committee 363. The failure mode occurred as a flexural failure in the structural vulnerable part (Refer to Appendix. B.).

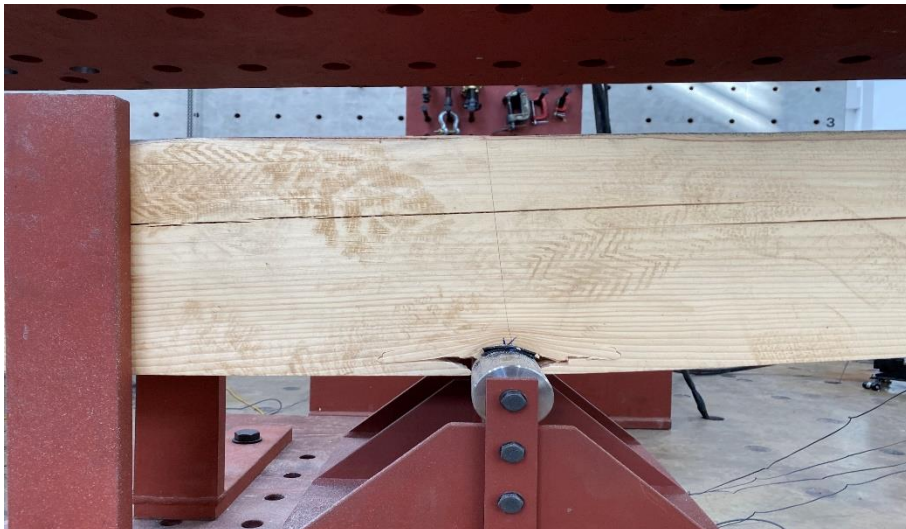
Figure Appendix.B. 2 Reference 2 of Chu-nyu

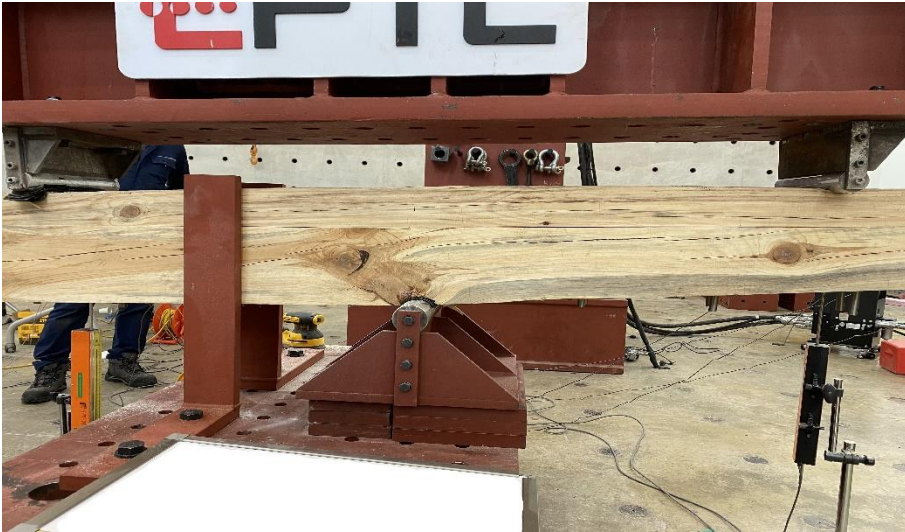
Figure Appendix.B. 3 Repaired 1 of Chu-nyu

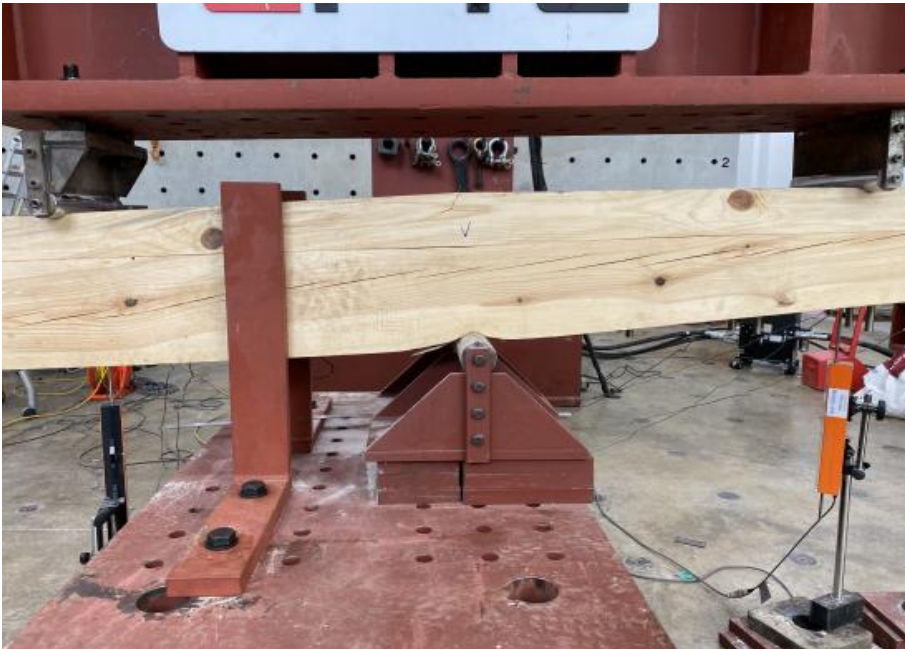
Figure Appendix.B. 4 Repaired 2 of Chu-nyu

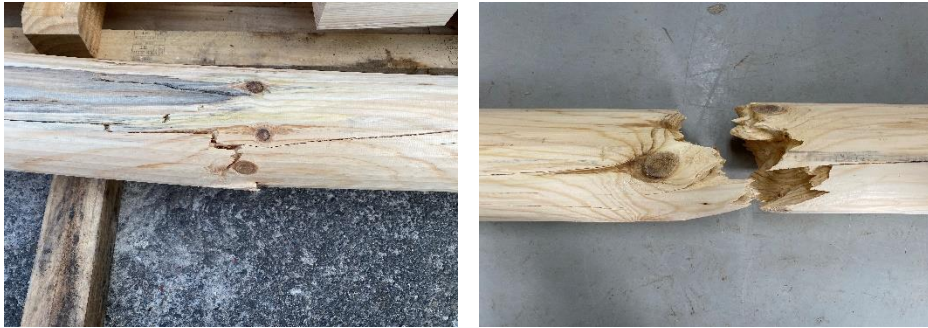
Figure Appendix.B. 5 Reference 1 (left), Reference 2 (right) of Jang-yeon

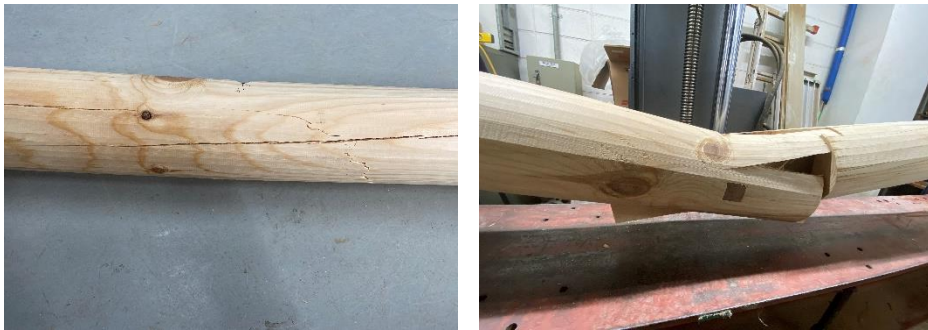
Figure Appendix.B. 6 Reference 3 (left), Repaired 1(right) of Jang-yeon

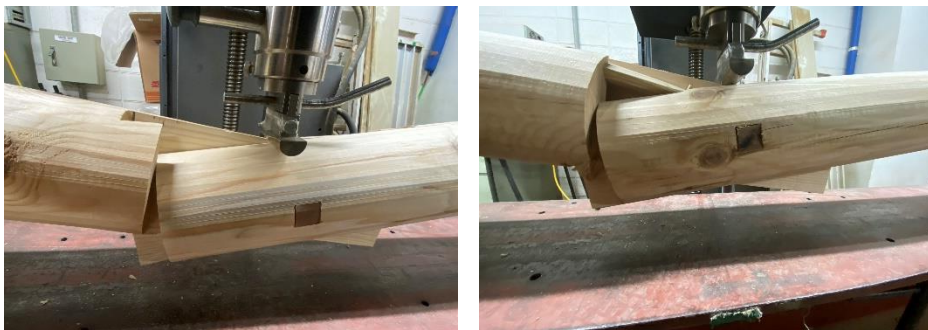
Figure Appendix.B. 7 Repaired 2 (left), Repaired 3 (right) of Jang-yeon

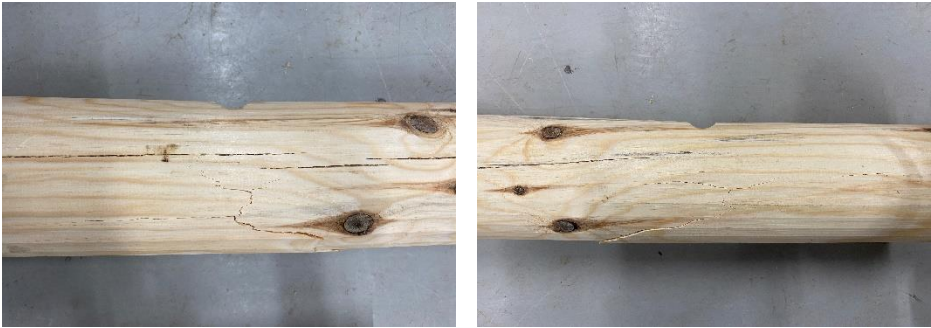
Figure Appendix.B. 8 Reference 1 (left), Reference 2 (right) of Dan-yeon

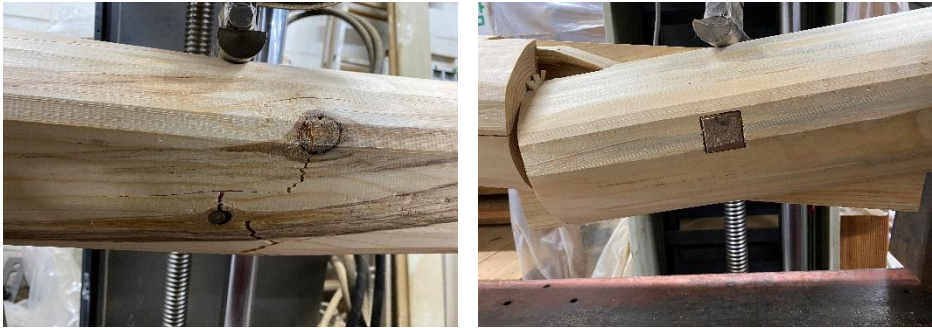
Figure Appendix.B. 9 Reference 3 (left), Repaired 1 (right) of Dan-yeon

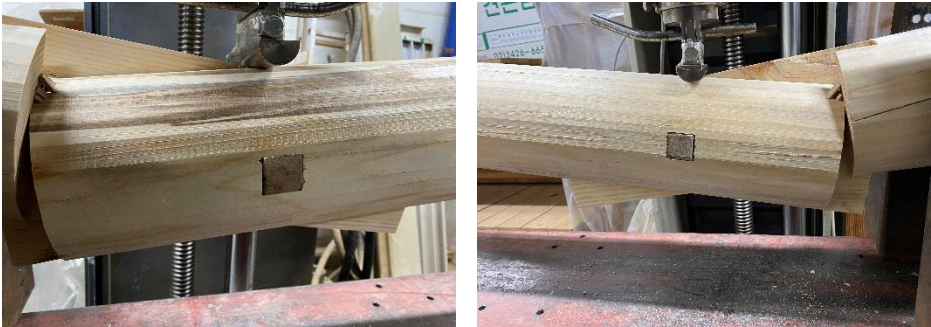
Figure Appendix.B. 10 Repaired 2 (left), Repaired 3 (right) of Dan-yeon

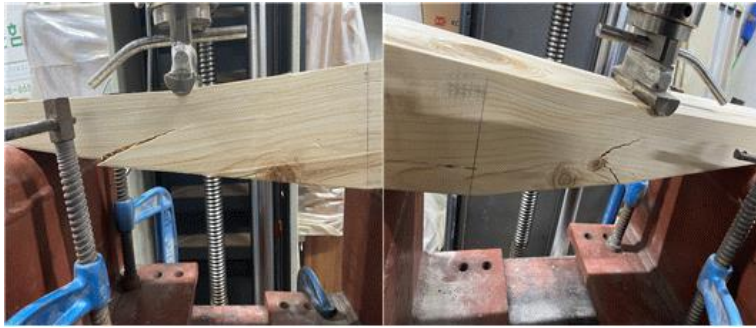
Figure Appendix.B. 11 Reference 1 of Bu-yeon
