Master's Thesis of Engineering

**A Study on the Repair Method
of Roof Members
in Wooden-Structural Heritage**

**Graduate School of Engineering
Seoul National University
Architecture and Architectural Engineering**

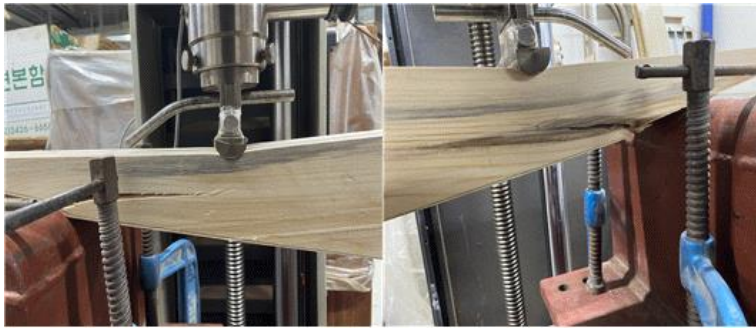
Figure Appendix.B. 12 Reference 2 of Bu-yeon

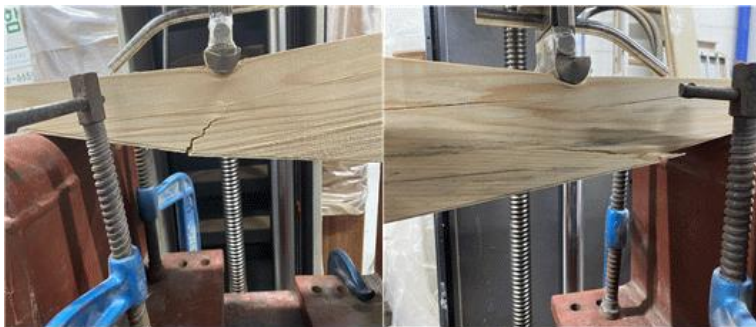
Figure Appendix.B. 13 Reference 3 of Bu-yeon

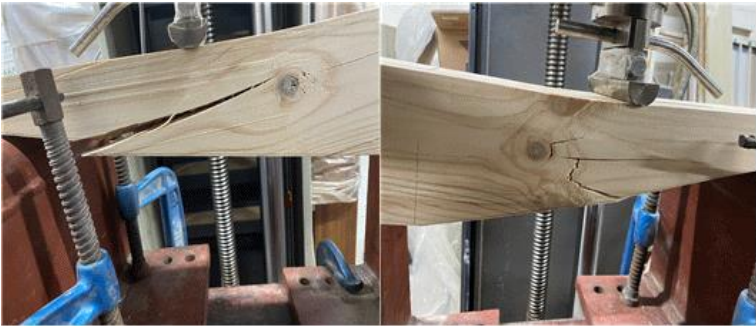
Figure Appendix.B. 14 Repaired 1 of Bu-yeon

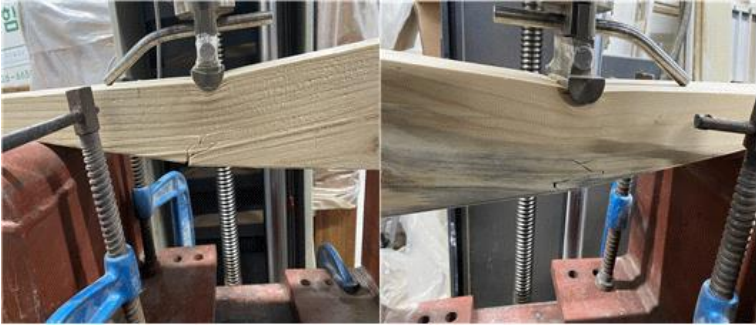
Figure Appendix.B. 15 Repaired 2 of Bu-yeon

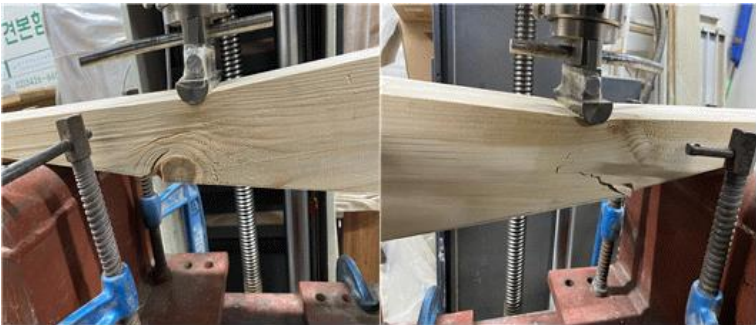
Figure Appendix.B. 16 Repaired 3 of Bu-yeon

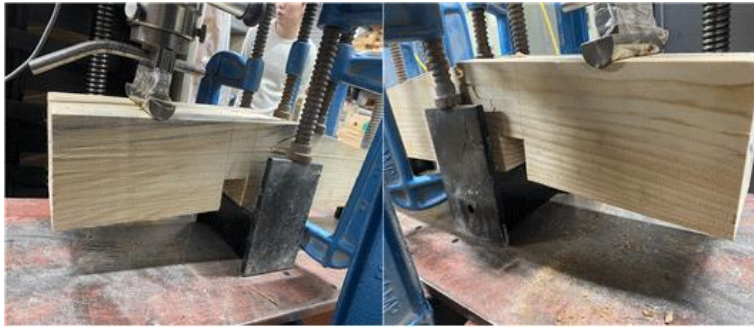
Figure Appendix.B. 17 Reference 1 of Mok-gi-yeon

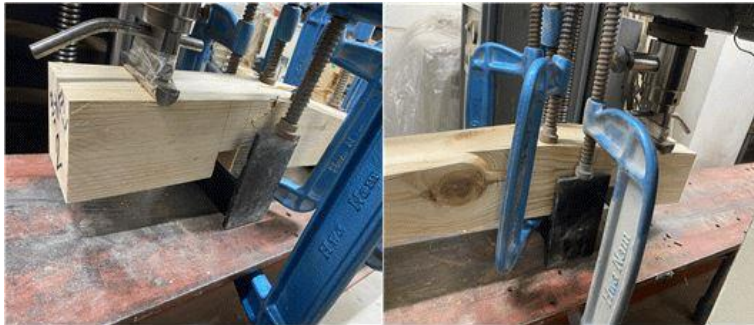
Figure Appendix.B. 18 Reference 2 of Mok-gi-yeon

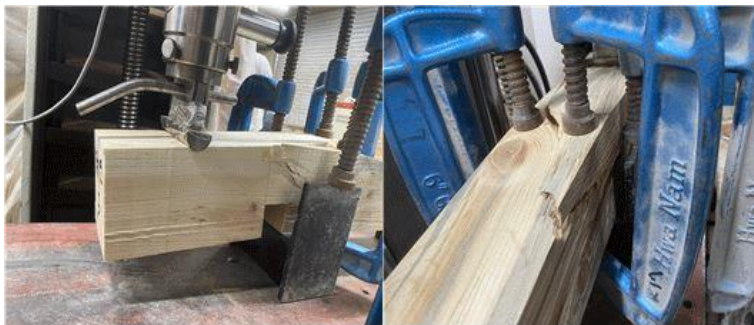
Figure Appendix.B. 19 Reference 3 of Mok-gi-yeon

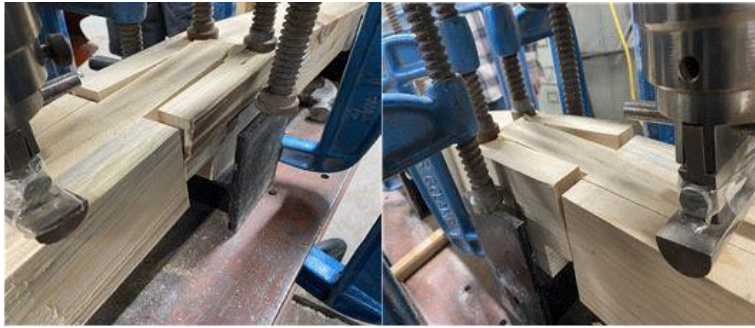
Figure Appendix.B. 20 Repaired 1 of Mok-gi-yeon

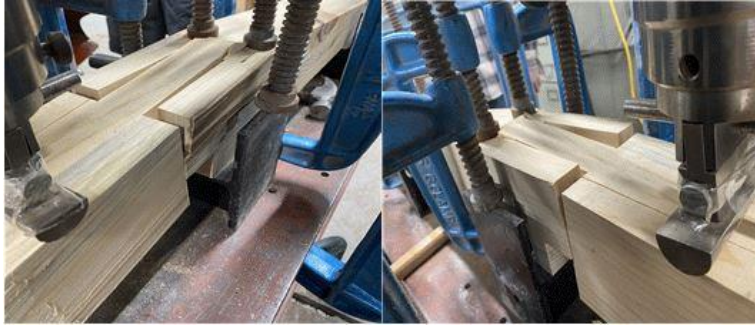
Figure Appendix.B. 21 Repaired 2 of Mok-gi-yeon

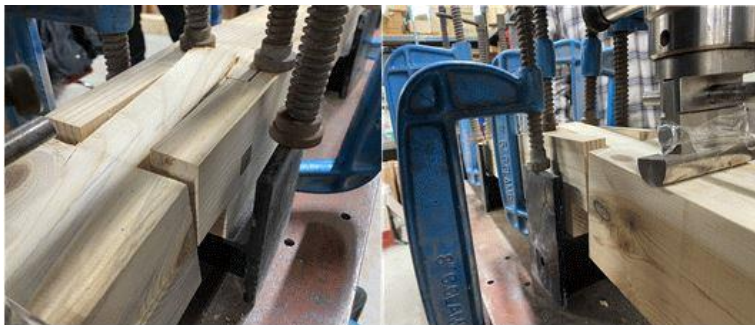
Figure Appendix.B. 22 Repaired 3 of Mok-gi-yeon
