# Seismic Fragility Analysis of Precast RC Shear Wall-Frame Structures with Connection Defects

**ABSTRACT:** As observed in many evidences during past earthquakes, the quality of precast concrete (PC) connections is one of the main factors that affect the seismic reliability of PC structures. In the context of China's rapid development of PC structures in high seismic regions, it is important to assess the effect of connection deficiency on their seismic performance. This paper proposes a framework for seismic fragility analysis of PC shear wall-frame structures whose wall panels are assembled through grout sleeve connections that are susceptible to insufficient grouting. The uncertainties associated with the defected sleeve connections are taken into account, and then the probabilistic response of shear wall model is estimated through Point Estimate (PE) method. Then, a generic shear wall-frame building is modeled on platform of OpenSees. Seismic fragility analysis is performed to the structures with different degrees of connection deficiency, showing that the seismic performance is significantly affected by connection deficiencies, and great effort should be taken for the qualit

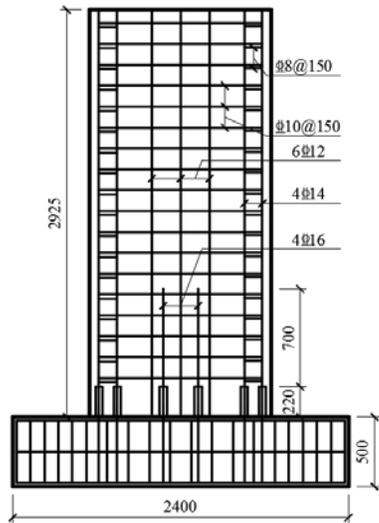
(a) Dimensions of PC shear wall (mm)

(b) Locations of sleeve connections (mm)

Figure 1: Dimensions of PC shear wall and locations of grout sleeve connections.

The PC shear wall considered in this research is 2.925m high and 1.3m wide, whose dimensions and locations of gout sleeve connections are shown in Figure 1. The loading behavior of this PC shear wall specimen with fully grouted sleeves had been investigated experimentally (Peng 2010).

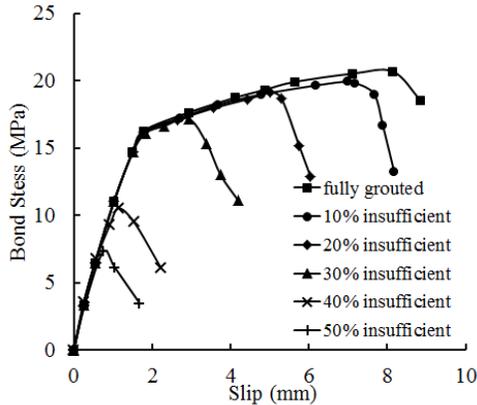
Figure 2: Bond behavior of defected grout sleeve connections.

Various grouting defects could take place in sleeve connections, such as deviation of reinforcement from the center of sleeve and insufficient grouting, which affect the behavior of connections significantly (Zhu and Ye 2007). Experiment studies had been carried out to investigate the loading response of defected grout sleeve connections (Xu et al. 2018). As the defective degree that defined in terms of volume-ratio of insufficient grouting increases from 0 to 50%, the loading behaviors of defected connections are presented in Figure 2.

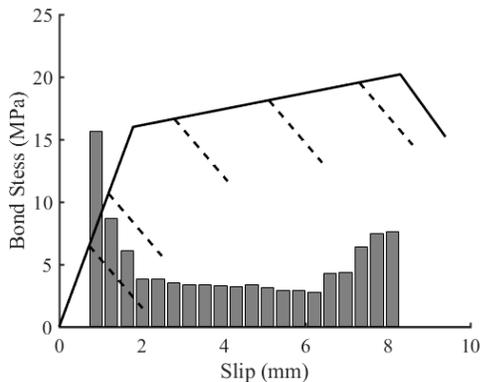
assumed as uniformly distributed between 0 and 50%. The behavior of defected connection is characterized by the dropping of strength at smaller slip, so the uncertainty associated with the loading behavior is reflected in the probabilistic distribution of the slip at ultimate stress. The probabilistic model was obtained through Monte Carlo (MC) simulation with 10,000 samples, which is shown in Figure 3.

Figure 3: Probabilistic model of defected grout sleeve connection.

With  $E[X_a^0] = 1$ ,  $E[X_a] = 4.18$ ,  $E[X_a^2] = 24.35$ ,  $E[X_a^3] = 161.80$ ,  $E[X_a^4] = 1139.4$  and  $E[X_a^5] = 8278.6$ , which were determined according to Figure 3, sampled values  $(x_{a,1}, x_{a,2}, x_{a,3})$  and probability concentrations  $(w_{a,1}, w_{a,2}, w_{a,3})$  could be calculated by solving Eq. (3):

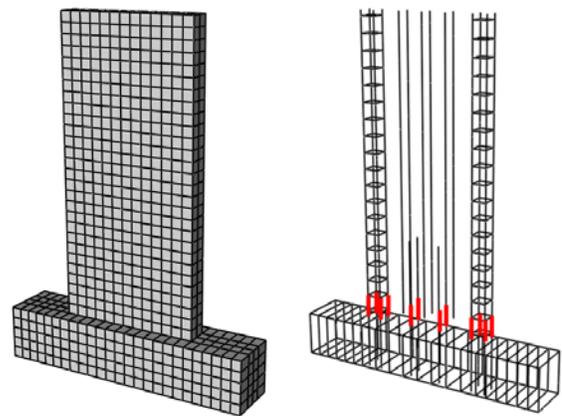
Numerical simulations based on Finite Element (FE) analysis were performed at the platform of ABAQUS (HKS 2014), as depicted in Figure 4.

The 8-node solid elements with reduced integration (C3D8R) were used for the simulation of concrete, and the Concrete Damaged Plasticity (CDP) model was used to present the constitutive relationship. Steel bars were modeled by two-node truss elements (T3D2), and a bilinear model was adapted for the stress-strain relationship. The loading behavior of grout sleeve connections is also simulated by T3D2 elements with material properties specifically defined to be consistent with the bond behavior shown in Figure 3.

Figure 4: FE model of PC shear wall.

The FE analysis of the nonlinear model in Fig.4 is time-consuming, and the MC simulation to investigate its loading behavior statistically imposes a significant computation burden to computer. To solve this problem, Point Estimate (PE) method, first proposed by Rosenblueth (1981), was adopted to analyze the response of PC shear wall in the following.

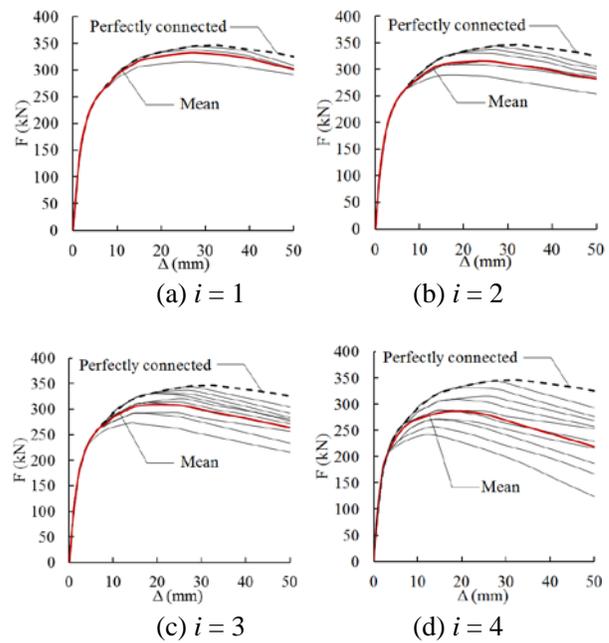
Figure 5: Sample force-displacement curves using PE method.

Some typical sampled force-displacement curves are shown in Figure 5 for cases of  $i=1$ ,  $i=2$ ,  $i=3$  and  $i=4$ . The influence of connection deficiency on the response of PC shear wall was reflected in the decrease of the ultimate strength and the slope of descending section in force-displacement curves. So the displacement increment from yielding point to ultimate point ( $\Delta'=(\Delta_u - \Delta_y)$ ) and the slope of descending section ( $K'$ ) were adopted as response measurement ( $\Theta$ ), and were treated as log-

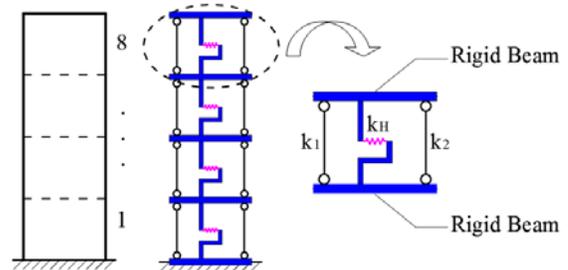
Figure 7: Macro-element modeling of shear wall.

The influence of insufficiently grout sleeves on seismic performance of PC shear wall-frame structures was investigated by means of nonlinear time history analysis, which was performed on the platform of OpenSees (McKenna and Fenves 2009). The plasticity-distributed fiber beam-column element (Spacone et al. 1996) was used to model the beams and columns in the structure. The shear wall was discretized into eight macro-elements, and each was representative of one floor of the structure, as shown in Figure 7. The macro-element for shear wall had two uniaxial sub-elements at the two sides of the wall which were used to model the flexural behavior, and one spring sub-element at the center which was used to model the shifting of neutral axis. The material properties of the uniaxial sub-elements ( $k_1$  and  $k_2$ ) and the spring element ( $k_H$ ) were treated as random variables, with values determined according to the sampled response of PC shear wall with defected grout sleeve connections.

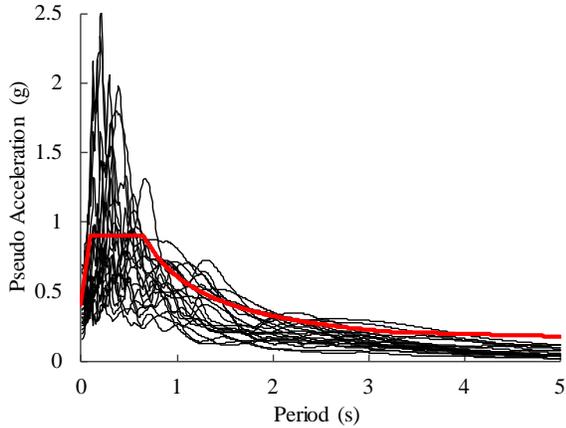
Probabilistic seismic demand analysis was conducted for the PC shear wall-frame structure with different degrees of connection deficiency. 20 natural earthquake ground motion records were selected according to the design acceleration spectrum specified in the seismic design code (GB50011-2010), whose spectral accelerations are shown in Figure 8. Nonlinear time history analyses of PC shear wall-frame structures were performed using the selected ground motions in OpenSees.

Figure 8: Acceleration spectra of earthquake ground motions.

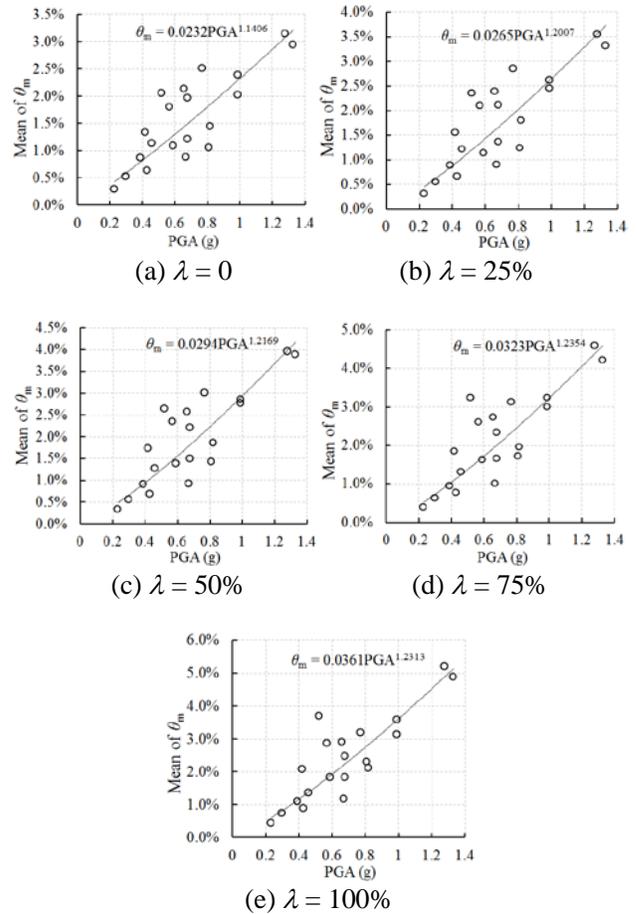
earthquake ground motion. The mean values of  $\theta_m$  under the excitation of 20 selected earthquake ground motions are presented in Figure 9 for different occurrence rates of defected sleeve connection, e.g.,  $\lambda = 0, 25\%, 50\%, 75\%$  and  $100\%$ , which are functions of PGA:

$$\begin{aligned} \theta_m &= 0.0232\text{PGA}^{1.14}, \quad \sigma_{\ln \varepsilon} = 0.312 \quad \text{for } \lambda = 0 \\ \theta_m &= 0.0265\text{PGA}^{1.20}, \quad \sigma_{\ln \varepsilon} = 0.329 \quad \text{for } \lambda = 25\% \\ \theta_m &= 0.0294\text{PGA}^{1.22}, \quad \sigma_{\ln \varepsilon} = 0.342 \quad \text{for } \lambda = 50\% \\ \theta_m &= 0.0323\text{PGA}^{1.24}, \quad \sigma_{\ln \varepsilon} = 0.347 \quad \text{for } \lambda = 75\% \\ \theta_m &= 0.0361\text{PGA}^{1.23}, \quad \sigma_{\ln \varepsilon} = 0.338 \quad \text{for } \lambda = 100\% \end{aligned} \quad (10)$$

Figure 9: means of peak inter-story drift ratio for different occurrence rates of defected grout sleeve connection.

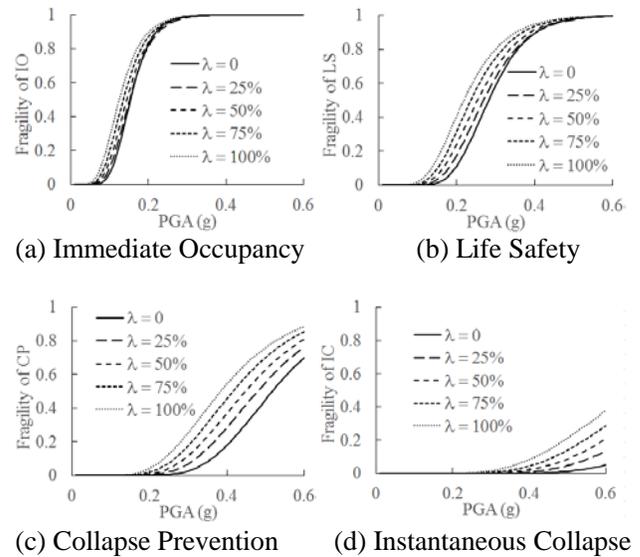
The seismic fragilities of PC shear wall-frame structures with different occurrence rates of defected connections for four performance levels are presented in Figure 10. It is observed that the connection deficiency generally affect

the seismic performance of PC shear wall-frame structures, in terms of increasing the probability of exceeding a certain damage state, especially for severe damage states. However, the influence of construction deficiency on seismic fragility is negligible for slight damage state.

Figure 10: Seismic fragilities for IO, LS, CP and IC of PC shear wall-frame structure with different occurrence rates of defected connections.

As the building was design for seismic intensity of 8, the probability of reaching damage state of LS subjected to the earthquake with design intensity (0.2g) should be sufficiently small (e.g. less than 10%), and the probability of reaching CP should be almost 0 (e.g. less than 0.1%). The structure without construction deficiency meets this requirement with probability of LS being 9.2% and probability of CP being 0.04%; however, the two probabilities increase to 17.5% and 0.31%, 24.2% and 0.88%, 33.6% and 1.92%, and 42.7% and 4.17% respectively as the deflection occurrence rate increases to 25%, 50%, 75% and 100%, indicating that the seismic performance may no longer meet the requirement of seismic design as the deflection occurrence rate exceeds 25%. These comparisons demonstrate the importance of construction quality inspection and quality control of grout sleeve connections for PC shear wall-frame structures.
